THE CITY OF WALTHAM  
MASSACHUSETTS

**Engineering DESIGN for the a) Immediate Stabilization Measures and b) a Full Replacement of the Rt. 60 Trapelo Road Culvert over Beaver Brook.**

**ADDENDUM NO. 2**

STRUCTURES INSPECTION FIELD REPORT

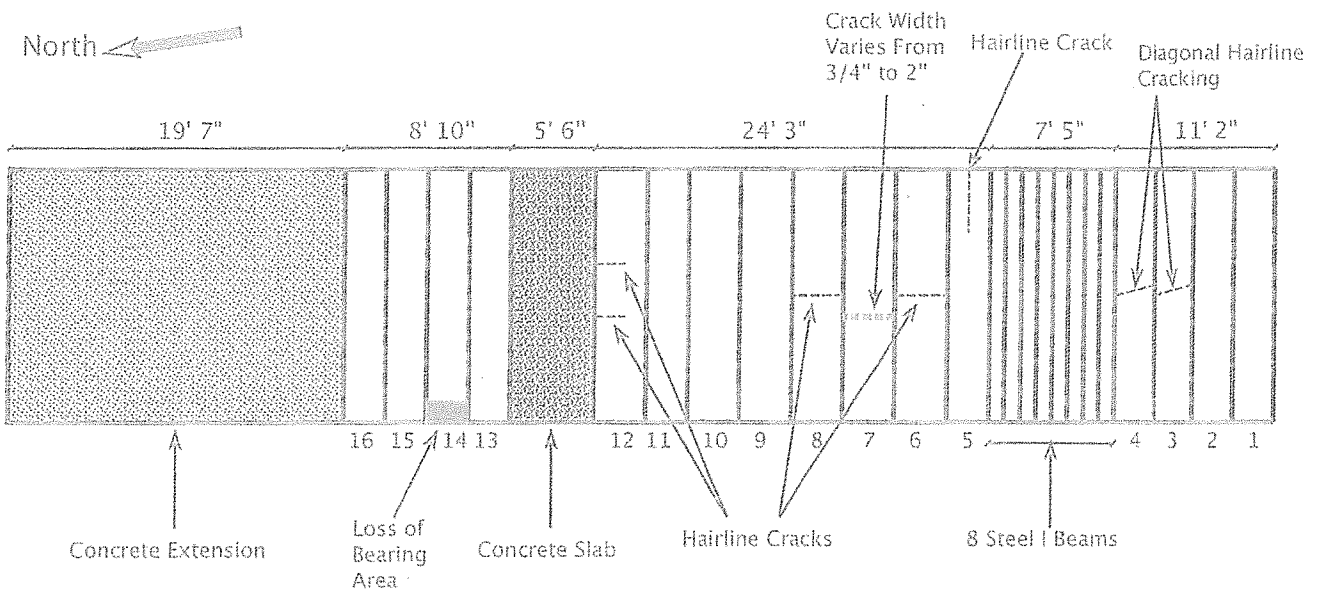
Sketch 1: Super structure composition (Granite beams numbered south to north).

The superstructure is composed of a combination of the following four elements: 16 Granite slabs which are numbered from south to north, 8 steel I beams, 1 reinforced concrete section measuring 5-1/2' wide, and a concrete culvert extension at the north end (see sketch 1 and 2 for locations).

Beams Labeled 1-16 Are Granite Slabs

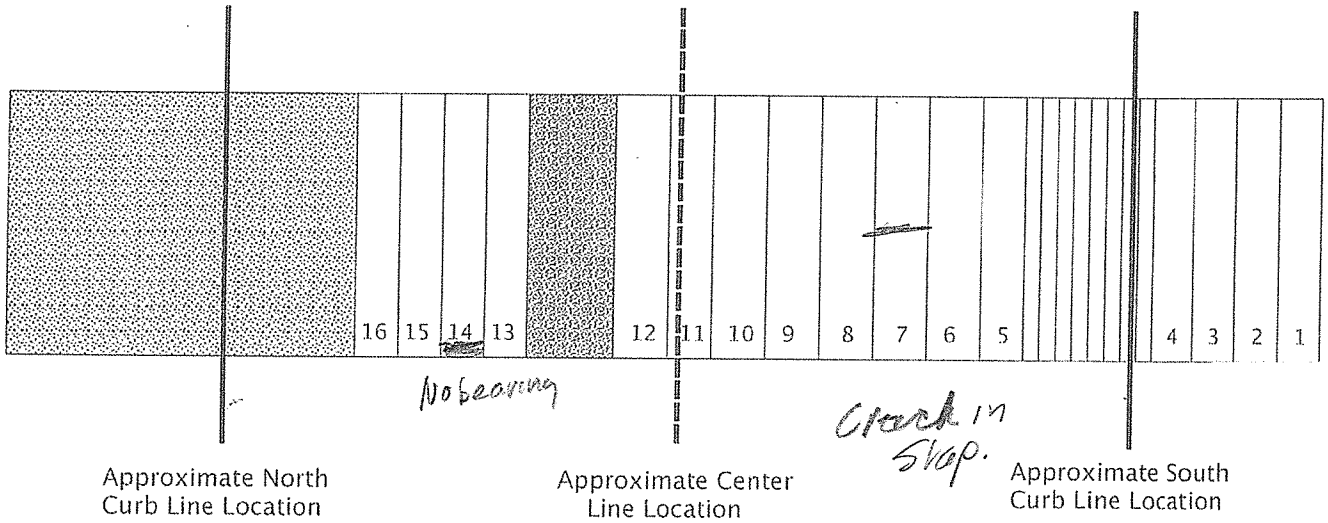
Sketch 2: Approximate Curb Line Locations

The north granite curb has settled several inches and has a 3" reveal. The south granite curb has an 8" reveal (see photos 1 and 2).

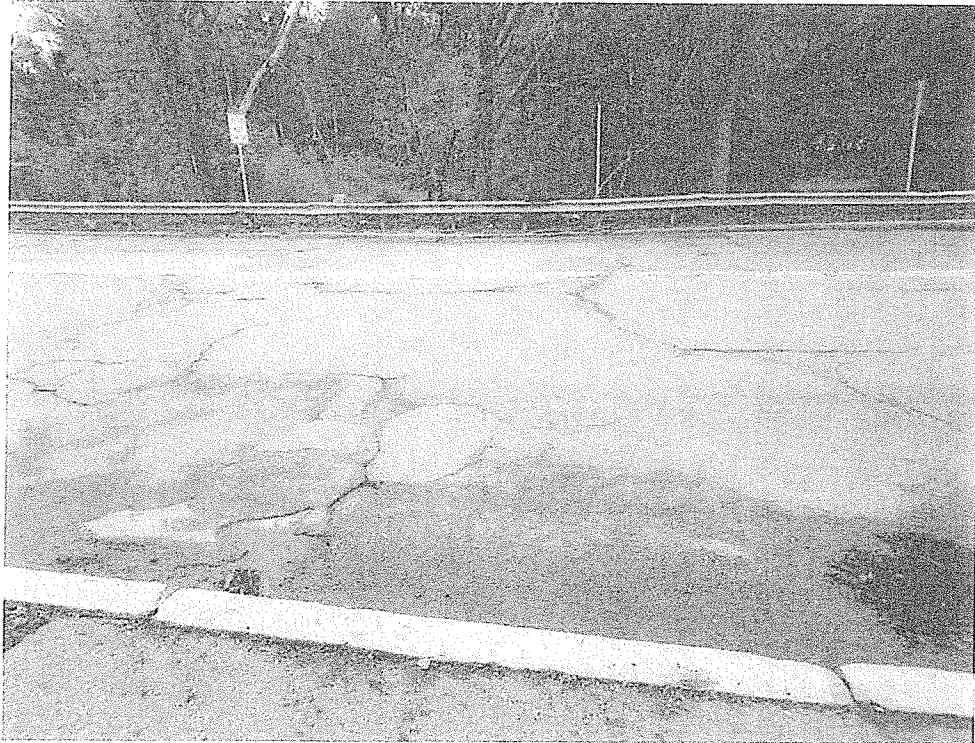
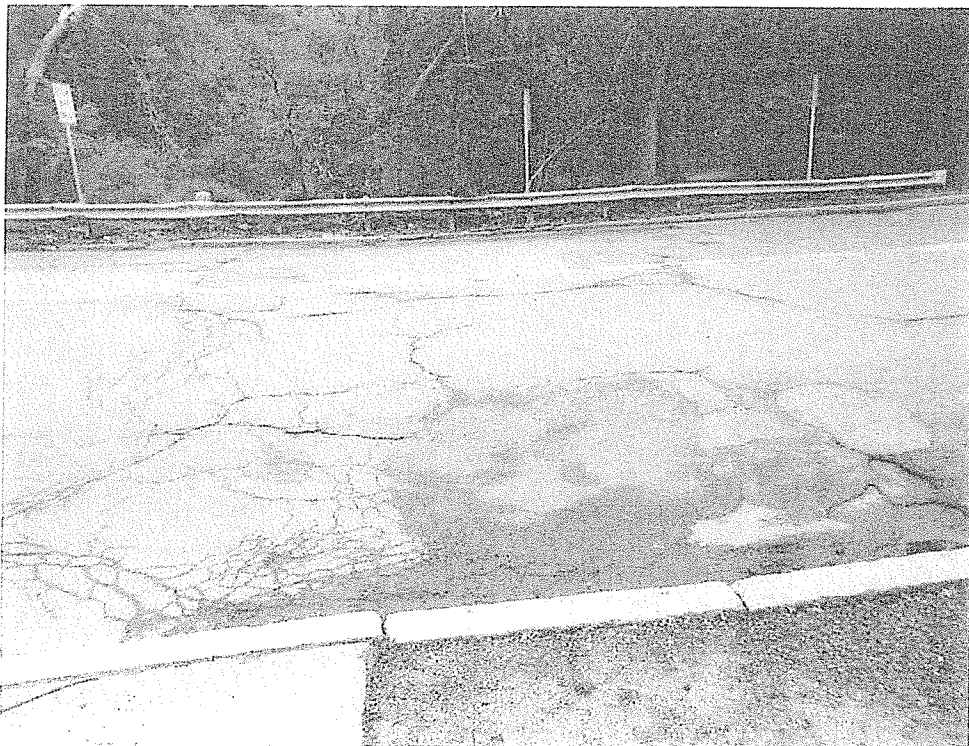
There are numerous transverse, longitudinal and map cracks throughout the bituminous wearing surface (see photos 1 and 2).

There is minor settlement along the curbs (see photos 1 and 2).

Photo 1: Typical wearing surface photo showing heavy cracking throughout.

Photo 2: Typical wearing surface photo showing heavy cracking throughout.

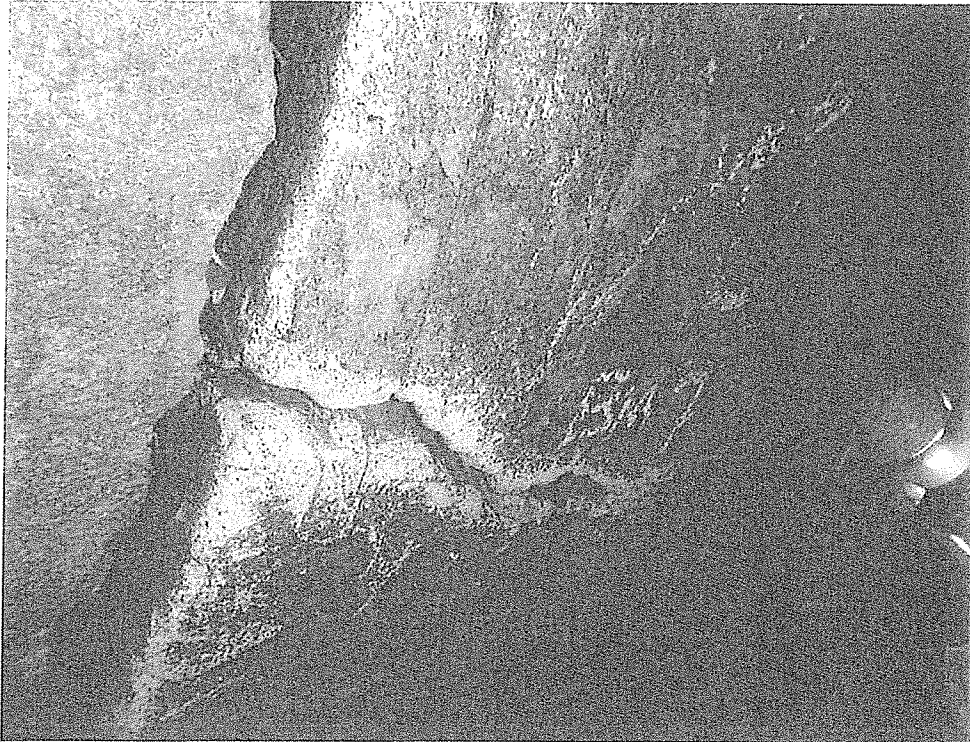
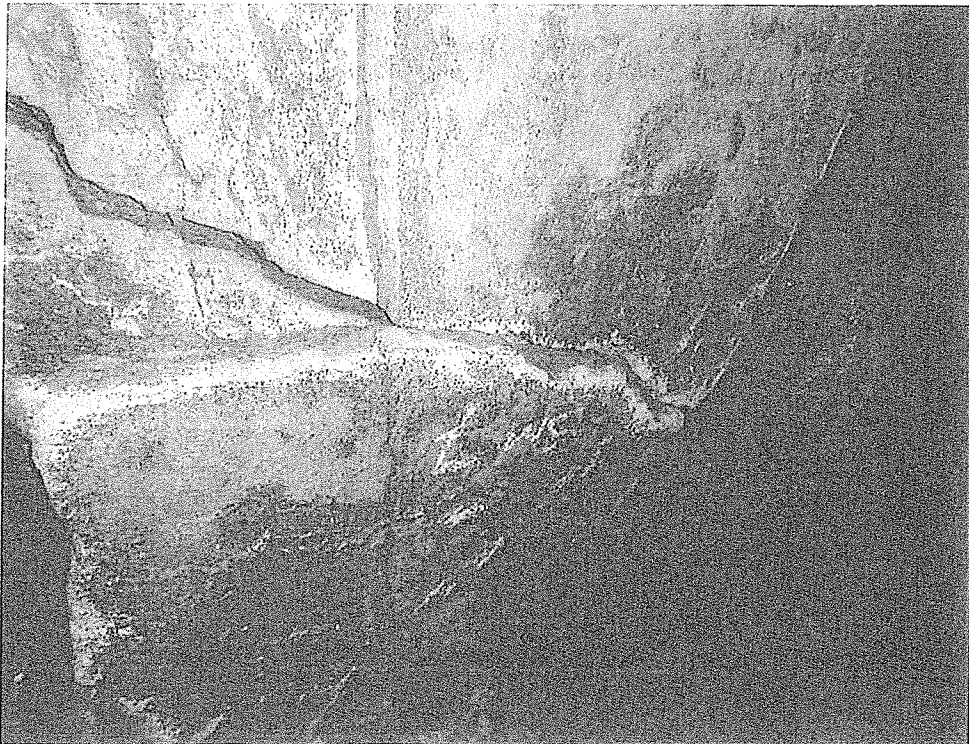
There was an Initial Routine and Special Member Report performed on August 27, 2002. In this report, it was documented that granite slab number 7 had a 3/4" wide crack, 4' from the east breastwall. This crack has increased in width to a maximum of 2" wide. This crack is beneath the eastbound roadway. There are also several full width small (hairline) cracks near mid-span located on slab number 3, 4, 5, 6, and 8. Slab 12 has 2 partial width cracks that run approximately half way across the slab near mid-span.

The seventh granite slab from the south end of the bridge has a split through it (see photos 3 and 4). The split ranges from 3/4" up to 2" wide which is larger than the reported 3/4" wide split in the 2002 inspection report. The split is located 4' from the east breastwall and is below the eastbound roadway. Because it is evident that the split has grown, the rating of the 59.1 is now serious.

Photo 3: Slab 7-Full width transverse crack ranging from 3/4" to 2" wide.

Photo 4: Slab 7-Full width crack ranging from 3/4" to 2".

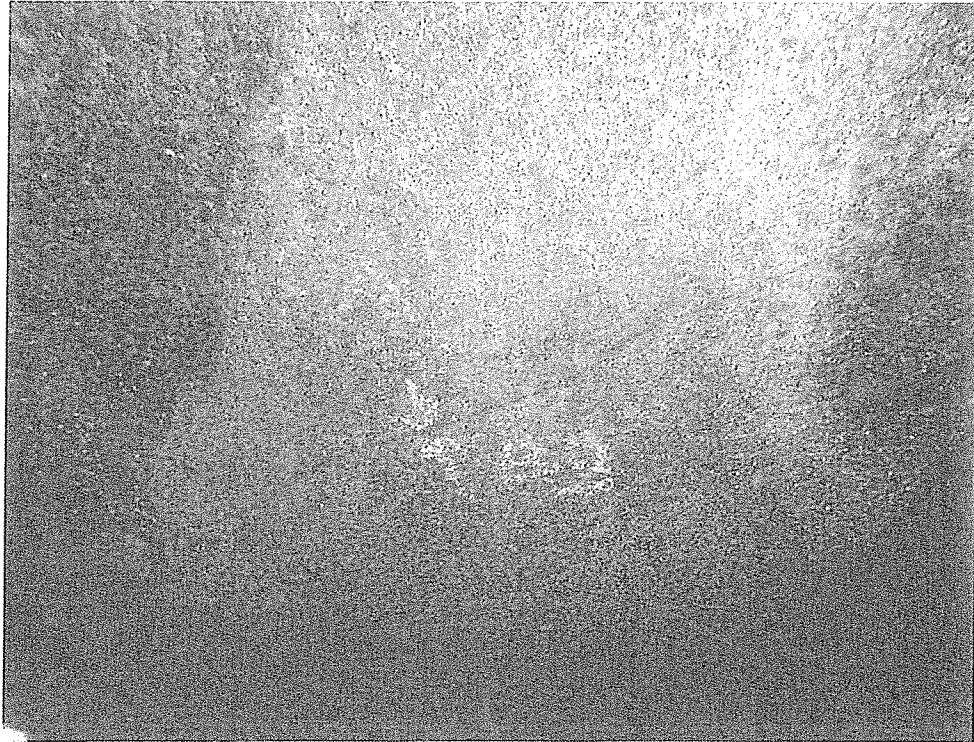
Also, slab number 3, 4, 5, 6 and 8 all have full width hairline cracking at or near mid-span. (see sketch 1 and photos 5 through 9).

Photo 5: Slab 3-Hairline diagonal crack at mid-span.

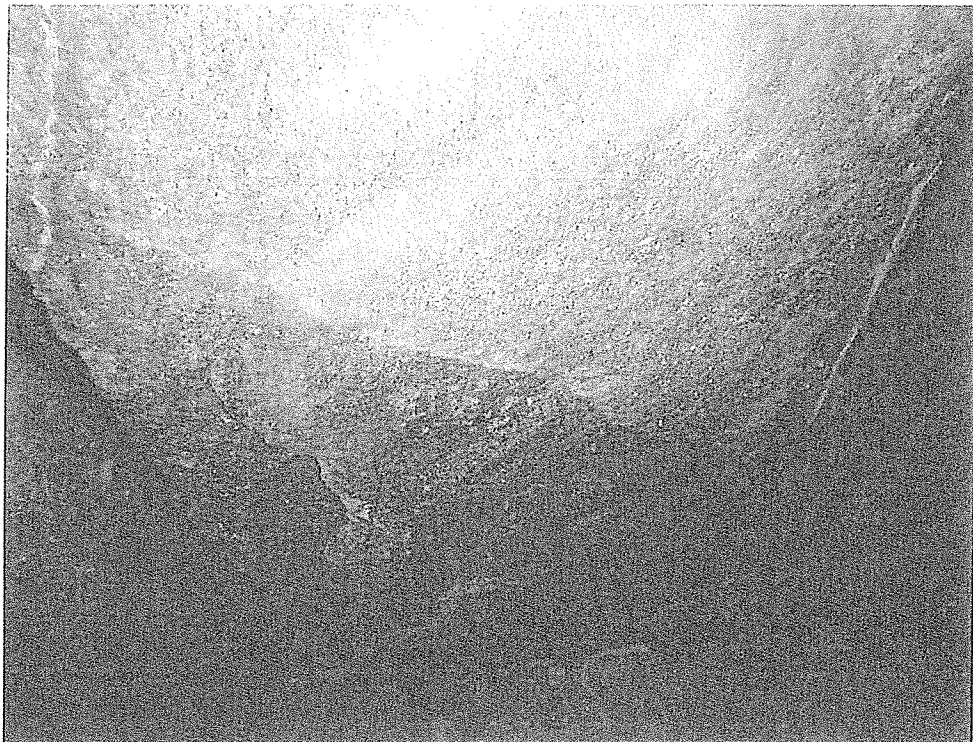
Photo 6: Slab 4-Hairline diagonal crack at midspan.

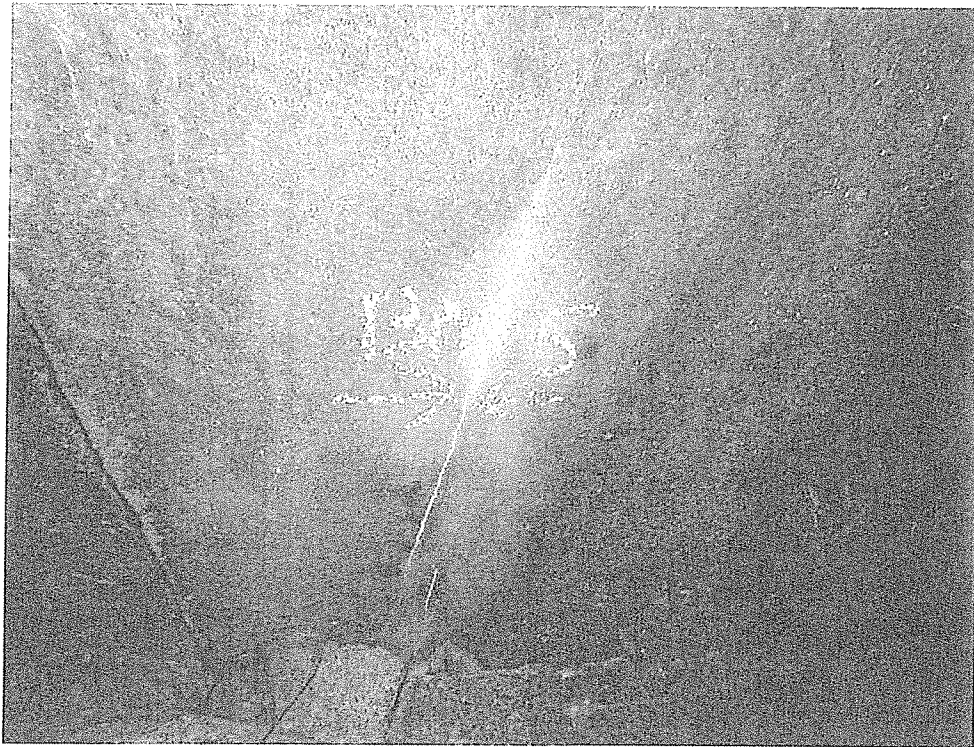
Photo 7: Slab 5-Longitudinal hairline crack at the east end measuring 2' long.

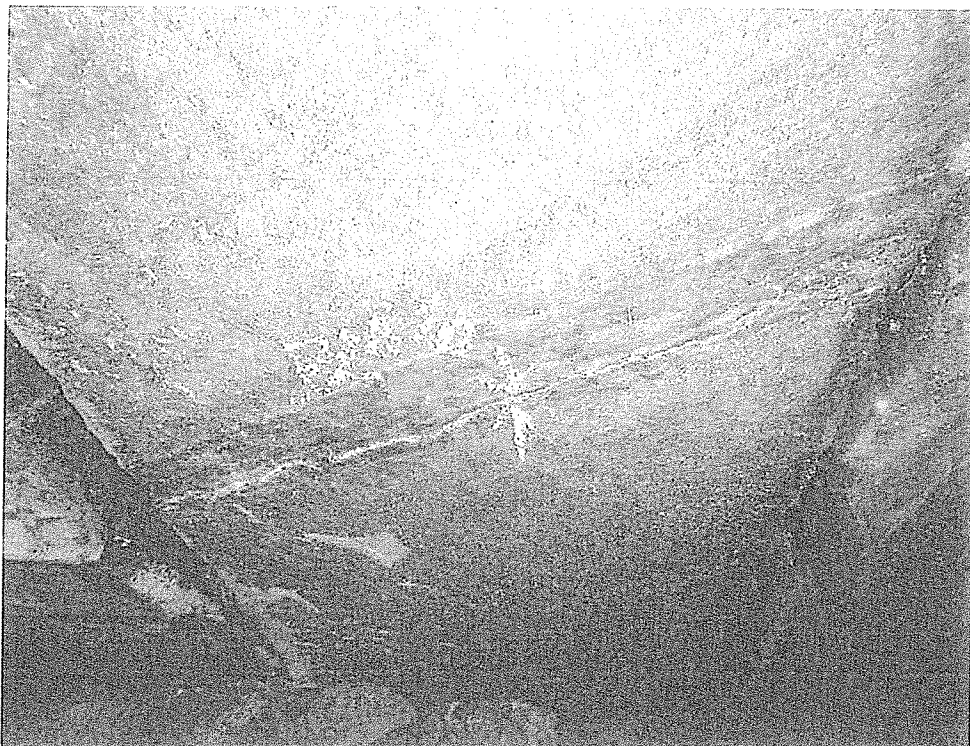
Photo 8: Slab 6-Hairline transverse crack near mid-span

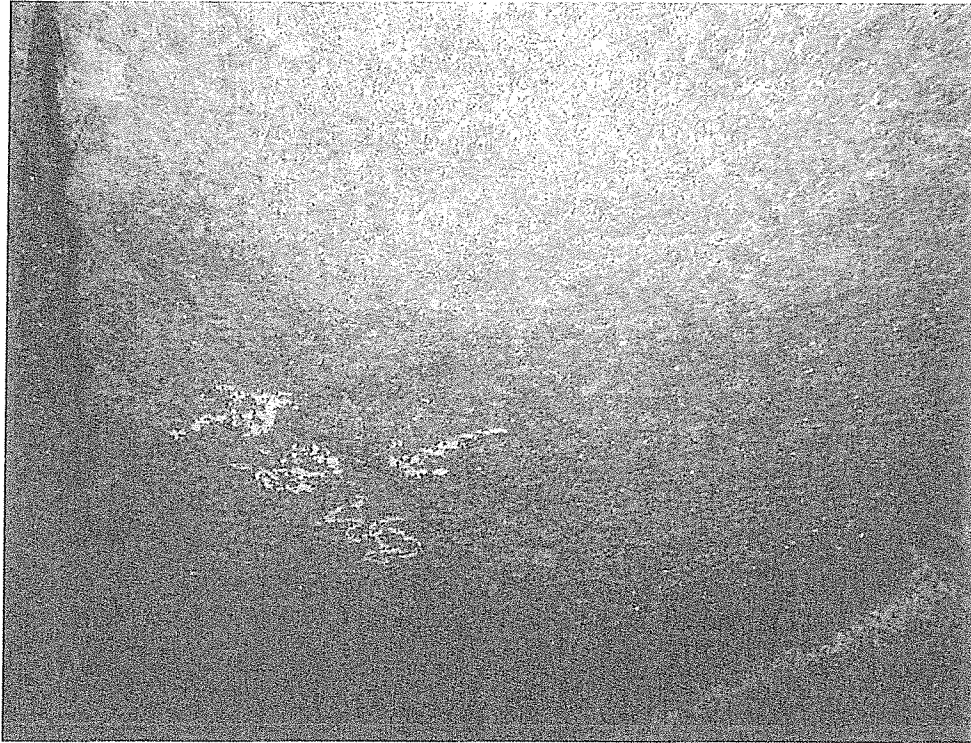
Photo 9: Slab 8-Full width partial transverse crack near mid-span.

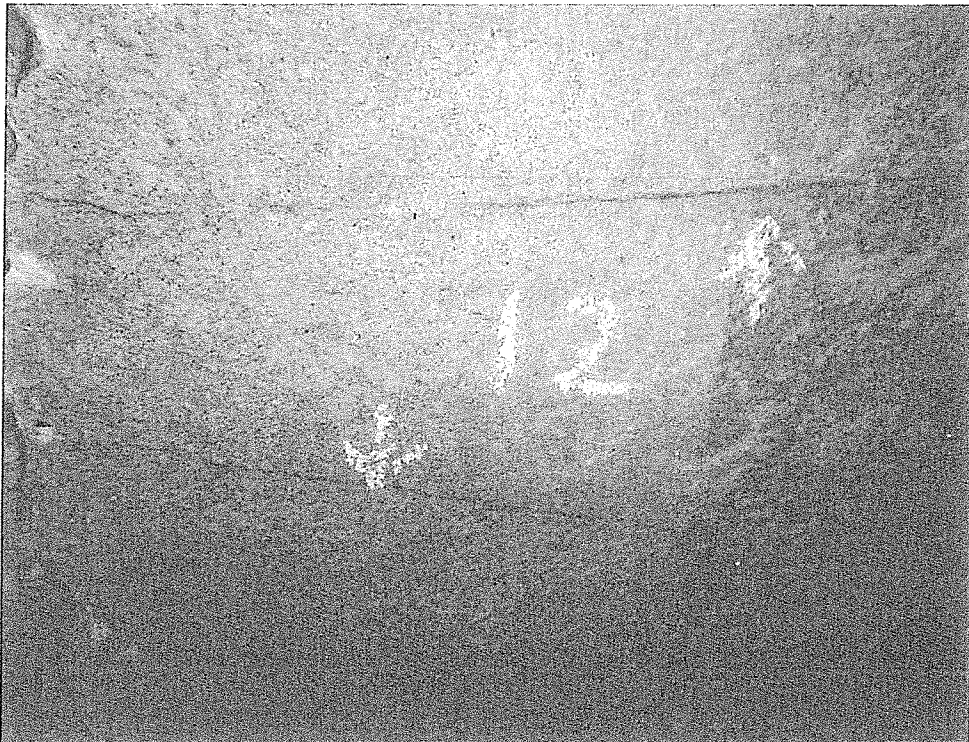
Slab number 12 has 2 partial width transverse cracks near midspan. (see sketch 1 and photo 10).

Photo 10: Slab 12-2 partial width hairline transverse cracks near midspan.

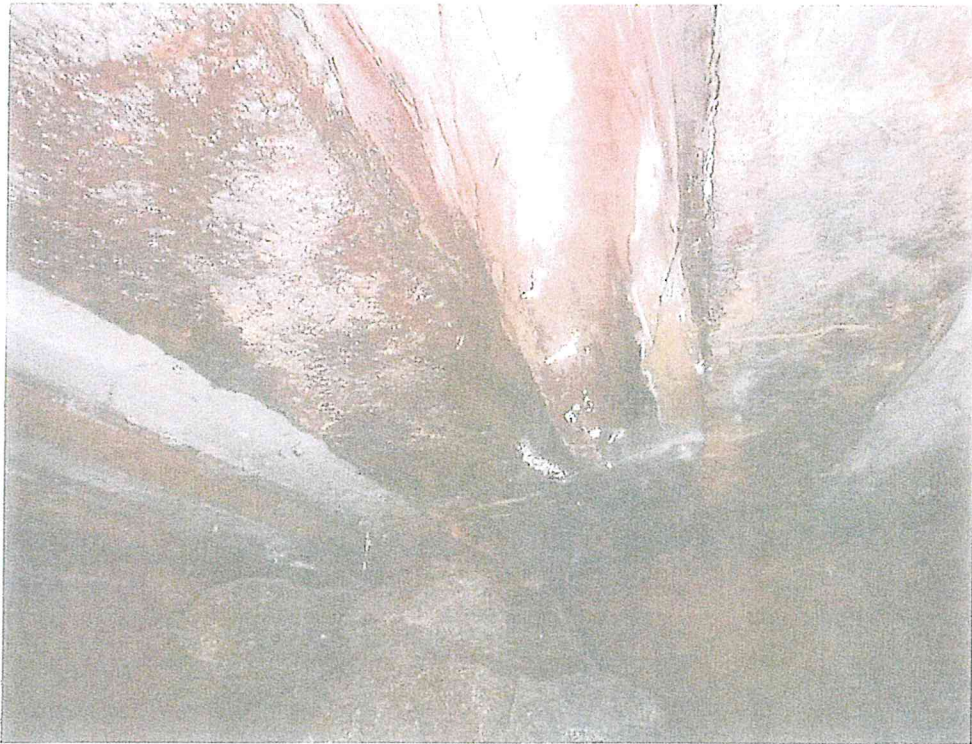
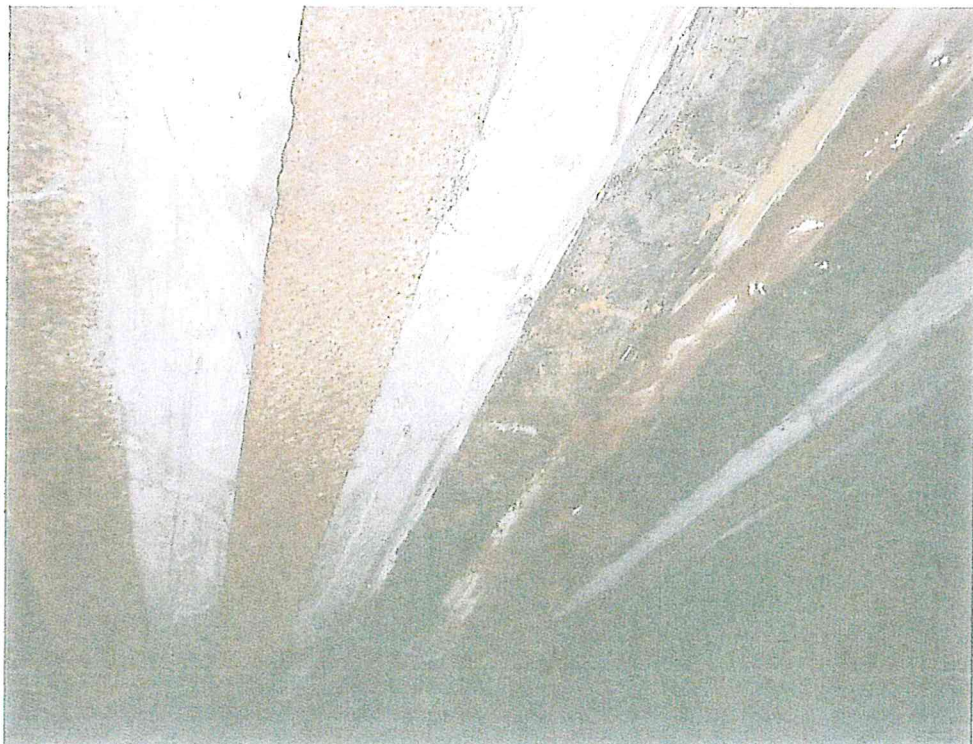
There are 8 steel I Beams below the eastbound roadway. Several of these beams exhibit severe rust, lamination and some section losses on the bottom flanges (see photos 11 and 12).

There are wooden planks between the beams so the condition of the webs is unknown.

Photo 11: Typical condition of the bottom flanges of the steel I-Beams showing severe rust, lamination, and some section loss/ Wooden planks between beams.

Photo 12: Typical condition of steel I-Beams showing severe rust on the bottom flanges of several beams with lamination. Note: webs are hidden due to wooden planks between.

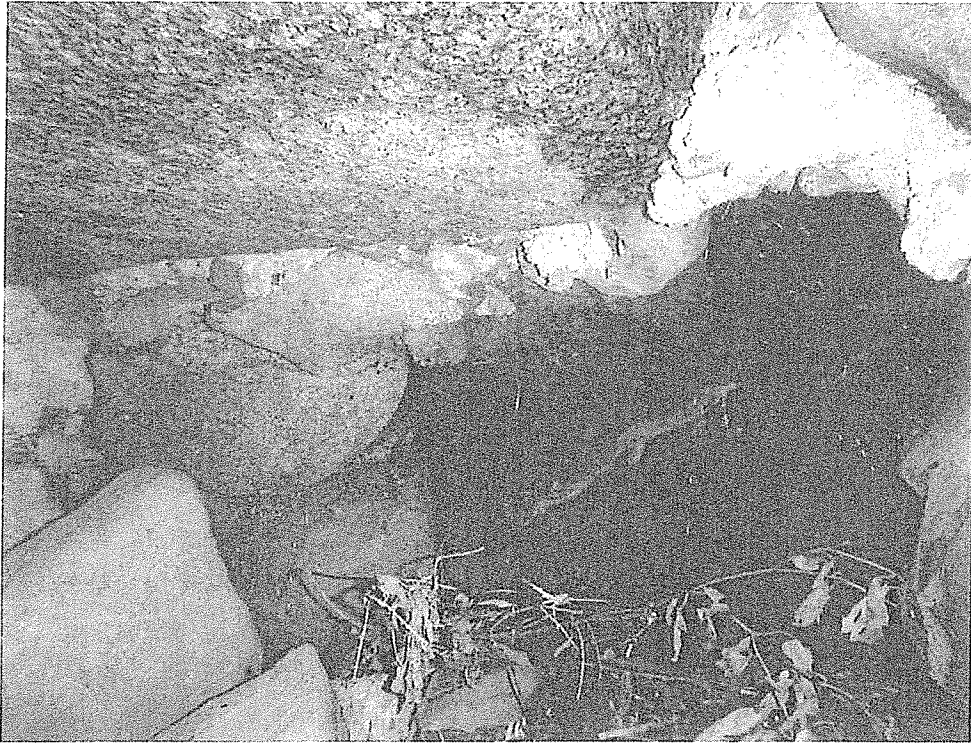
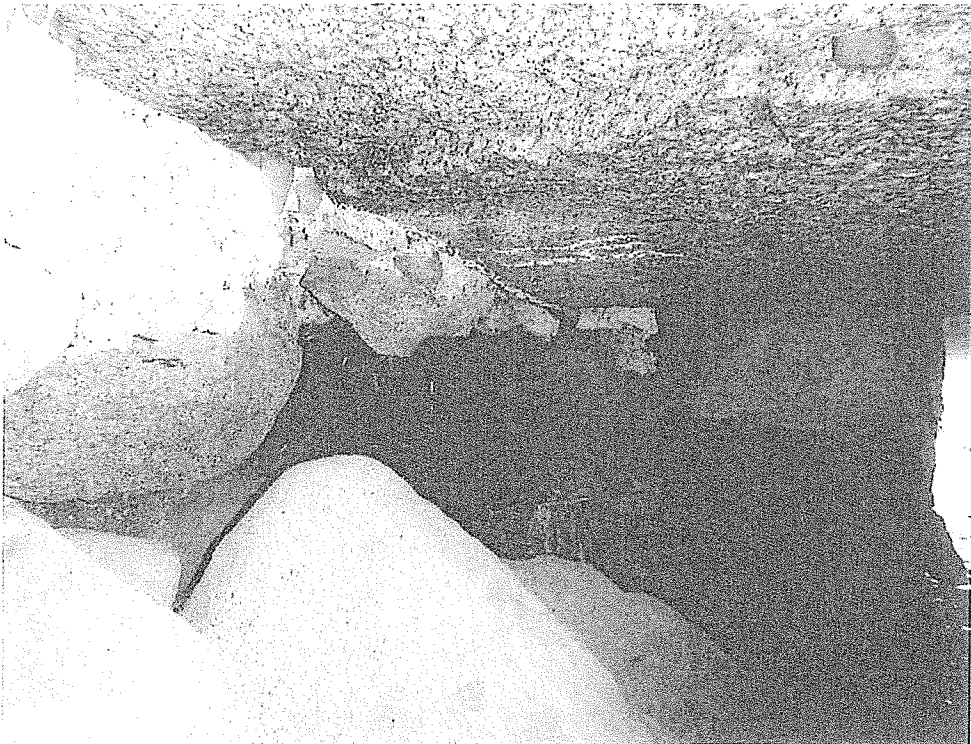
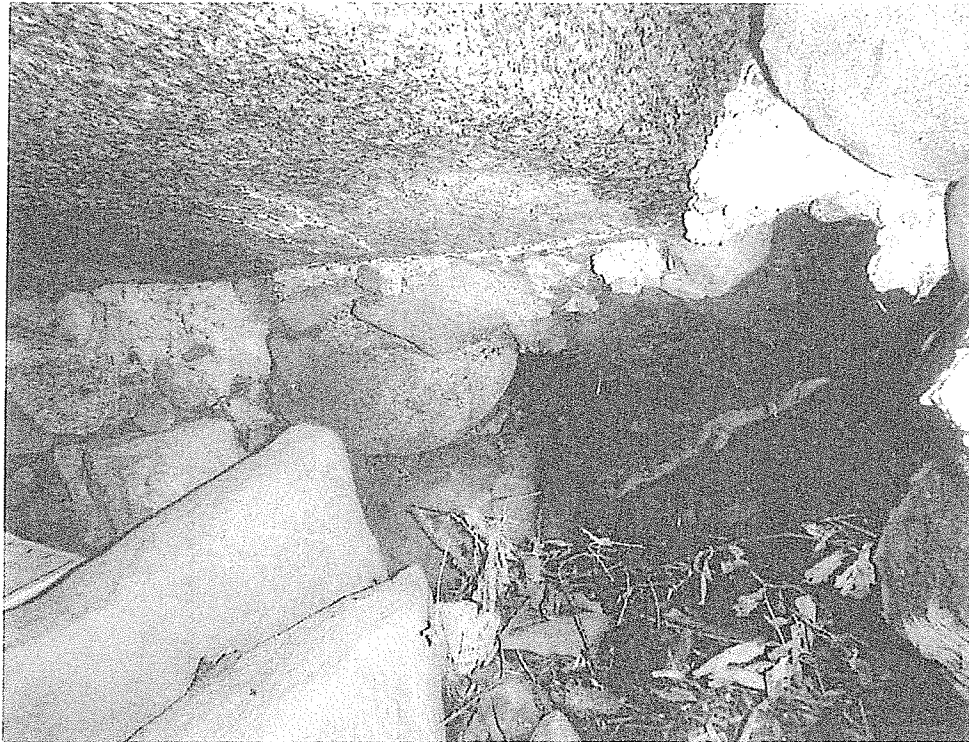
Repairs have been made to the east breastwall, repairing the undermined slabs 13 and 14. However, slab number 14 has a loss of bearing area at the west breastwall and for this reason the rating for the substructure will remain a "2" until repairs are made.

There is a large wash out at the top of the west breastwall below beam 14 measuring 40" L x 30" H x 50" D. This washout has caused the bearing area of beam 14 to be non existant (see photos 13, 14, and 15). Because beam 14 is essentially being only supported at the east end, the rating for the breastwalls will remain a 2.

Photo 13: Slab 14-Complete loss of bearing area at the west breastwall.

Photo 14: Slab 14-Complete loss of bearing area at the west breastwall.

Photo 15: Slab 14-Complete loss of bearing area at the west breastwall.

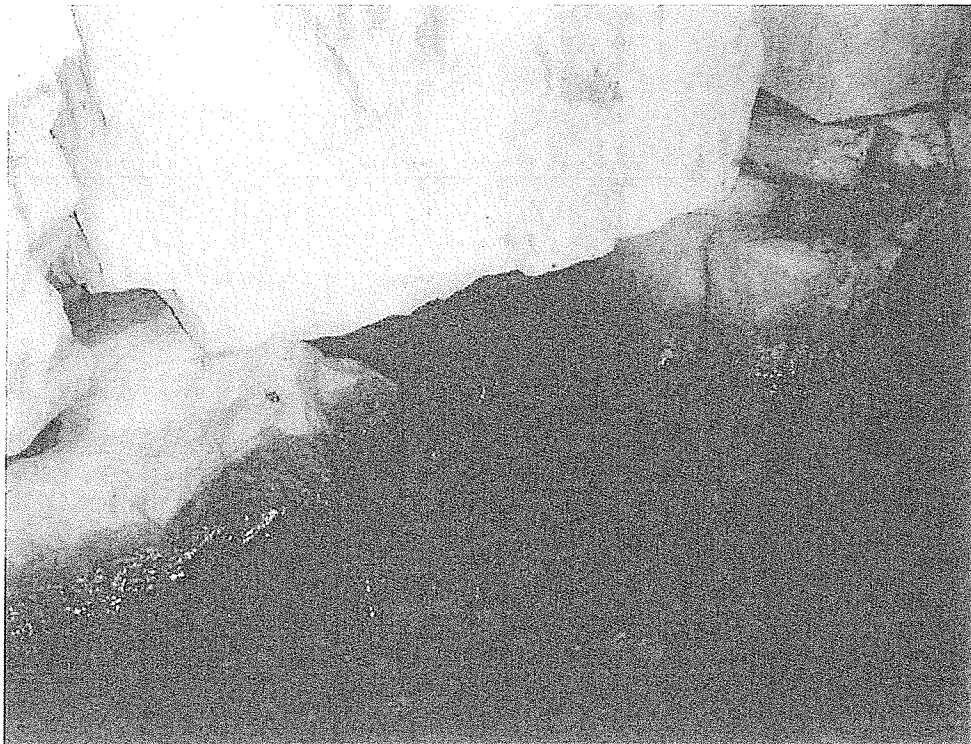
West breastwall-Void below the reinforced concrete slab measuring: 20" W x 15" H x 24" D (see photo 16).

Photo 16: West breastwall-Void below the reinforced concrete slab measuring:  
20" W x 15" H x 24" D.

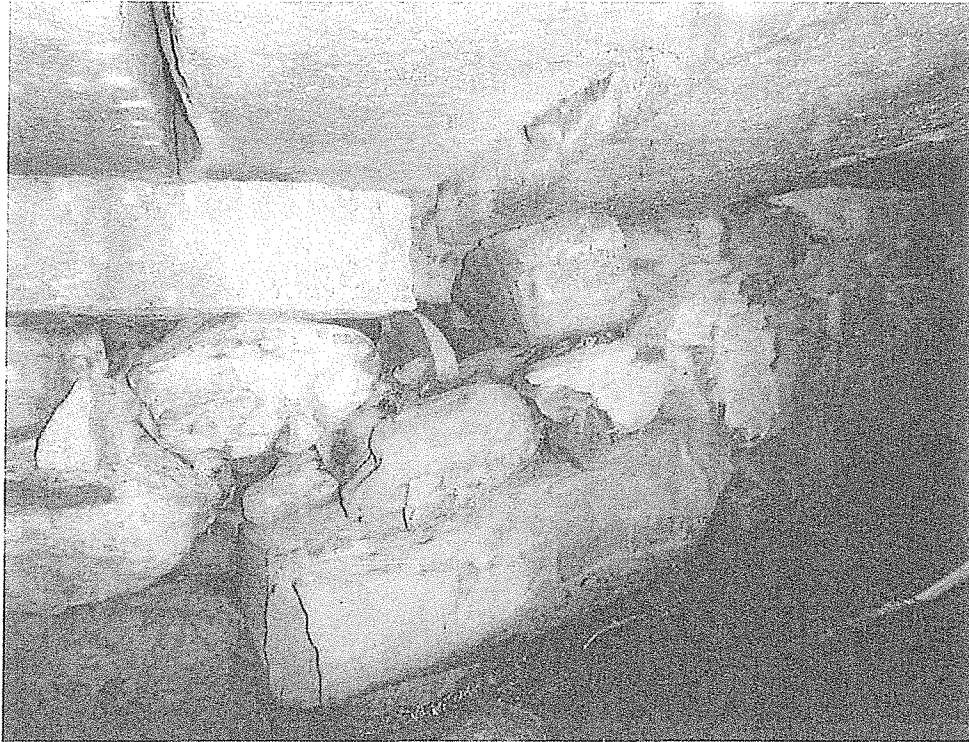
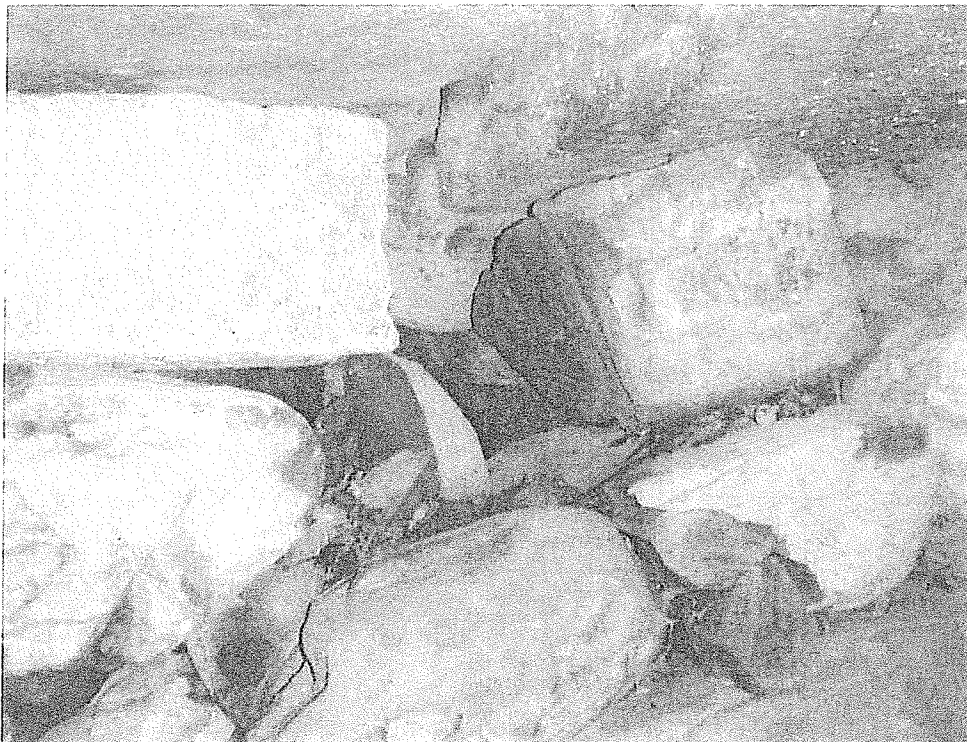
West breastwall-Void at the top measuring: 15" W x 21" H x 30" D (see photo 17 and 18).

Photo 17: West breastwall-Void at the top measuring: 15" W x 21" H x 30" D.

Photo 18: West breastwall-Void at the top measuring: 15" W x 21" H x 30" D.

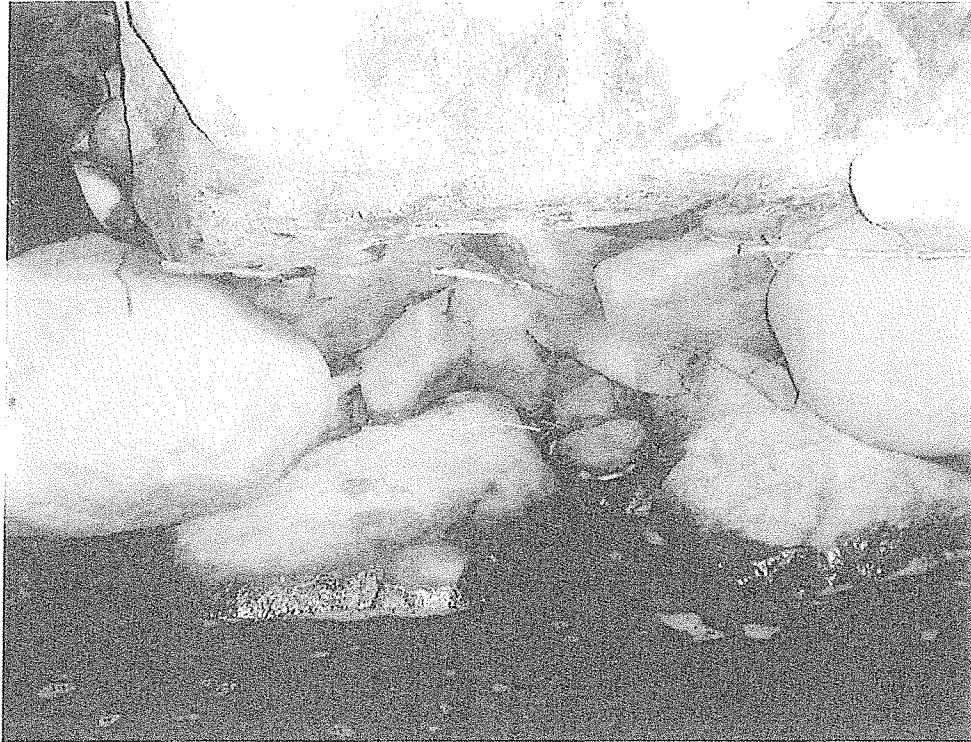
West breastwall-Void below beam 5-Void measuring: 27" W x 17" H x 14" D (see photo 19).

Photo 19: West breastwall, below beam 5-Void measuring: 27" W x 17" H x 14" D.

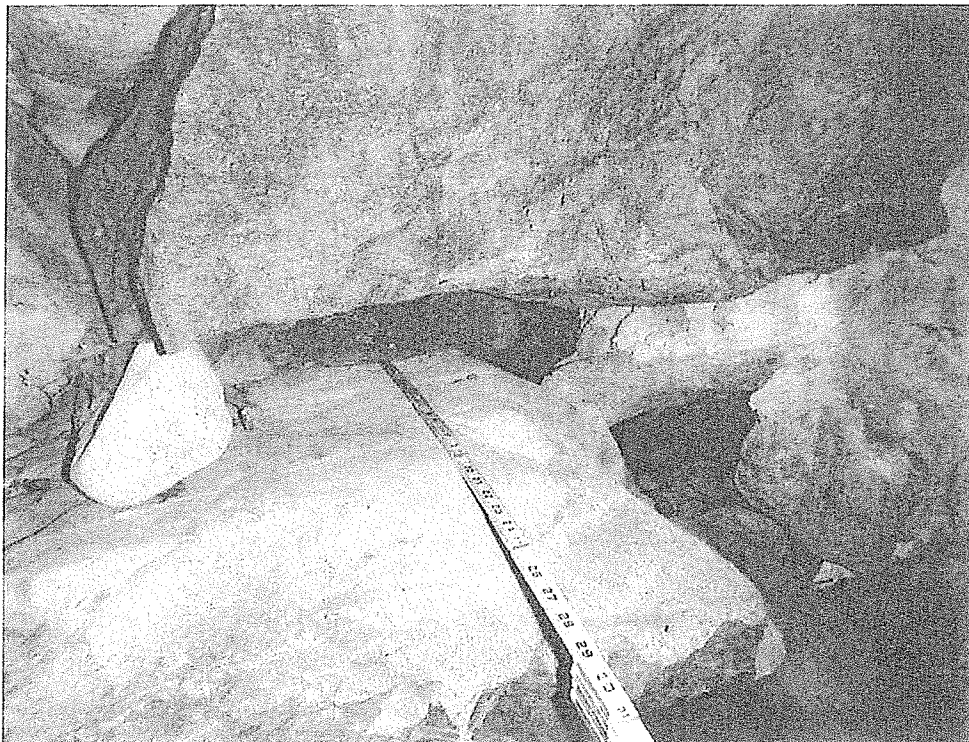
West breastwall, south end-Large void measuring: 2.5' x 8" H x 20" D (see photo 20).

Photo 20: West breastwall, south end-Large void measuring: 2.5' x 8" H x 20" D.

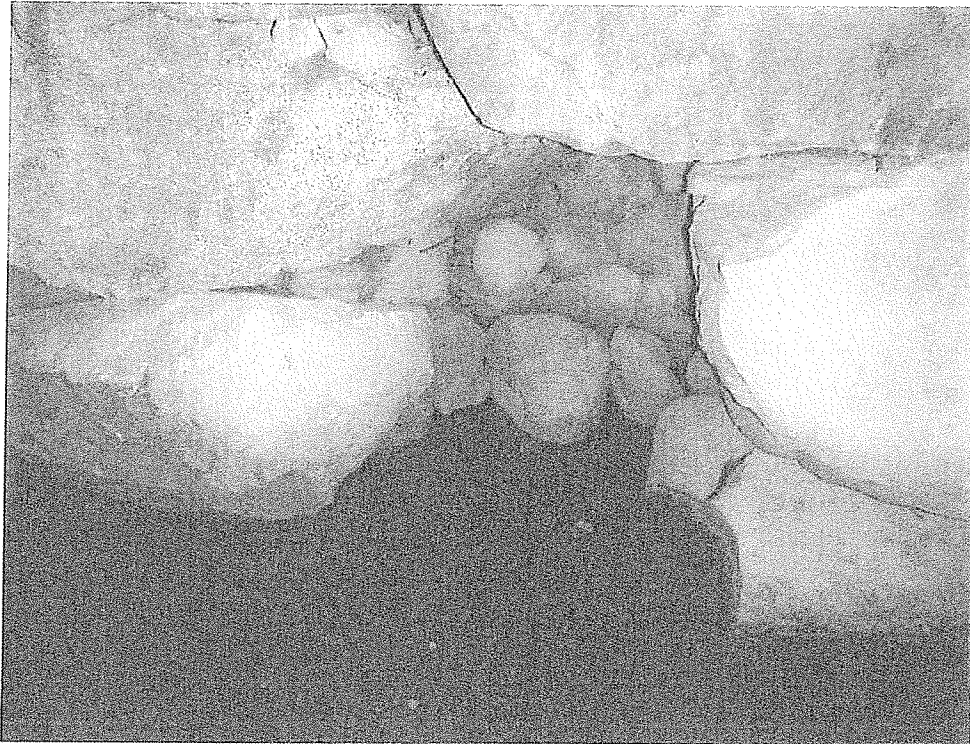
East breastwall-Large void at the bottom starting 18' 7" from the south end measuring: 2.5' W x 3' D x 4' H (see photo 21).

Photo 21: East breastwall-Large void at the bottom starting 18' 7" from the south end measuring: 2.5' W x 3' D x 4' H.

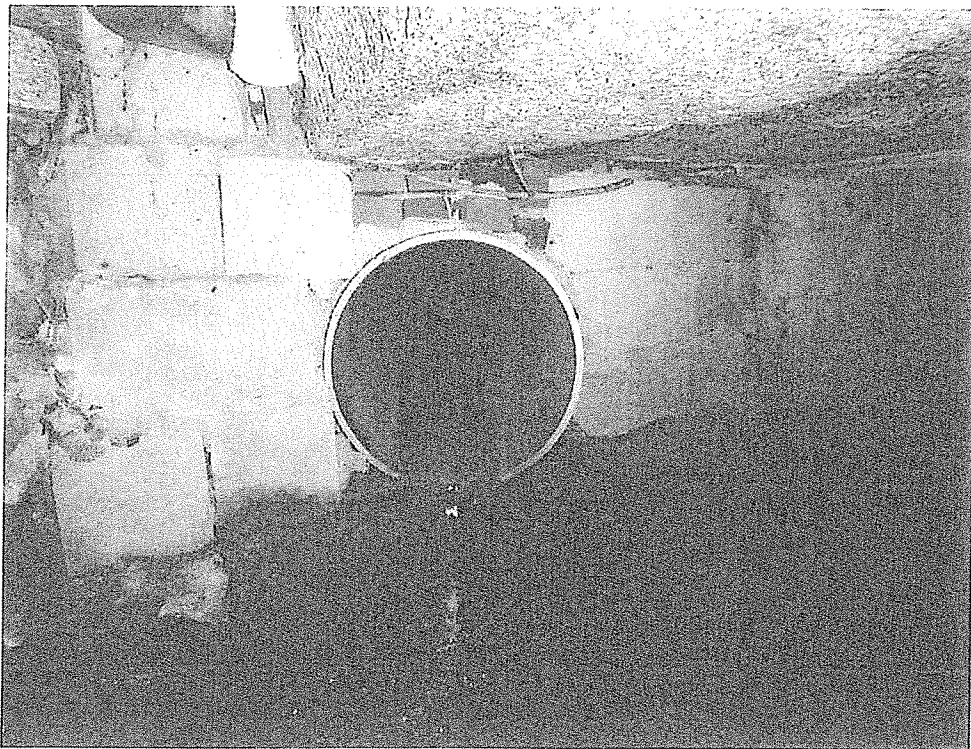
The east breastwall washout has been repaired since the last inspection below beams 13 and 14 (see photo 22).

Photo 22: East breastwall-Repaired area.

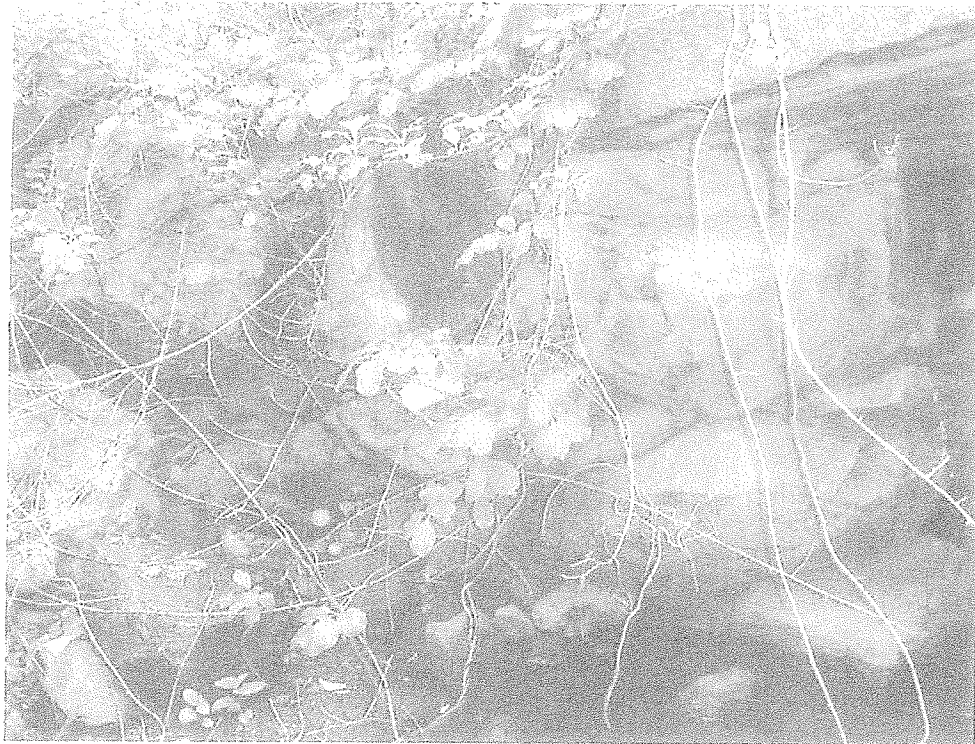
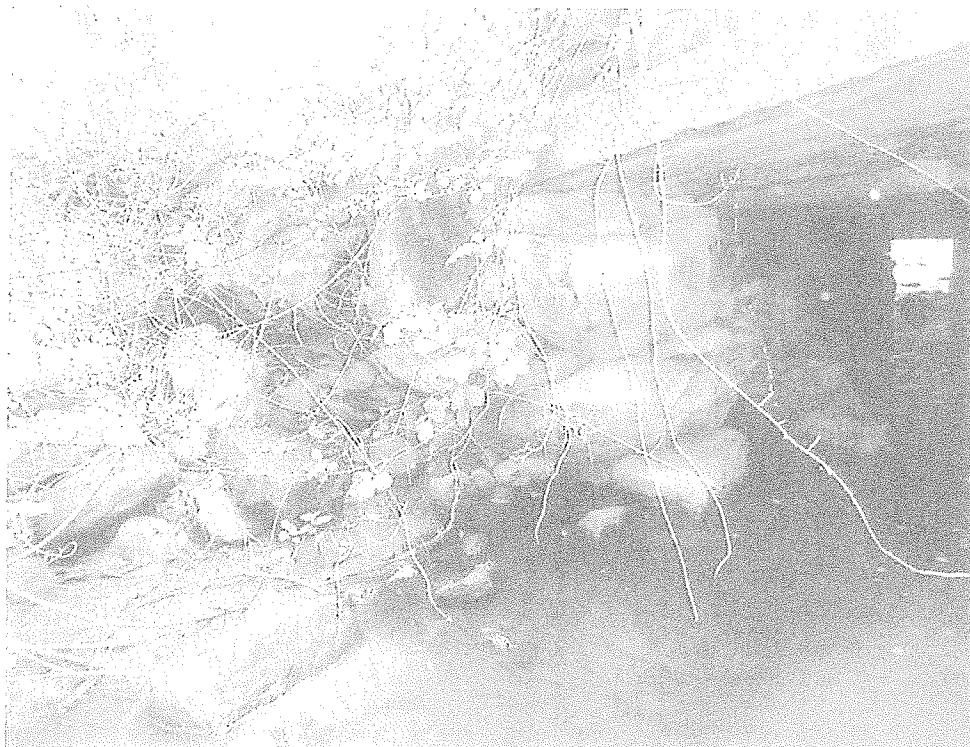
The southeast wingwall has several displaced blocks (see photo 23 and 24).

Photo 23: Southwest wingwall-Several displaced stones.

Photo 24: Southwest wingwall-Several displaced stones.
