STRUCTURES INSPECTION FIELD REPORT

2-DIST 04 B.I.N. 7YW

BR. DEPT. NO. W-04-016

CITY/TOWN <b>WALTHAM</b>	8-STRUCTURE NO. <b>W04016-7YW-MUN-BRI</b>	11-Kilo. POINT <b>000.000</b>	90-ROUTINE INSP. DATE <b>Sep 3, 2014</b>	INSPECTION DATE <b>Oct 7, 2014</b>
07-FACILITY CARRIED <b>HWY BEAVER ST</b>	MEMORIAL NAME/LOCAL NAME	27-YR BUILT <b>1850</b>	106-YR REBUILT <b>1900</b>	*YR REHAB'D (NON 106) <b>0000</b>
06-FEATURES INTERSECTED <b>WATER BEAVER BROOK</b>	26-FUNCTIONAL CLASS <b>Urban Minor Arterial</b>	DIST. BRIDGE INSPECTION ENGINEER T. G. Weil		
43-STRUCTURE TYPE <b>219 : Concrete continuous Culvert</b>	22-OWNER City/ Municipal <b>Highway A</b>	21-MAINTAINER City/ Municipal <b>Highway A</b>	TEAM LEADER <i>L. Hayes</i>	
107-DECK TYPE <b>1 : Concrete Cast-in-Place</b>	WEATHER <b>cloudy</b>	TEMP. (air) <b>21°C</b>	TEAM MEMBERS <b>A. MARLIN</b>

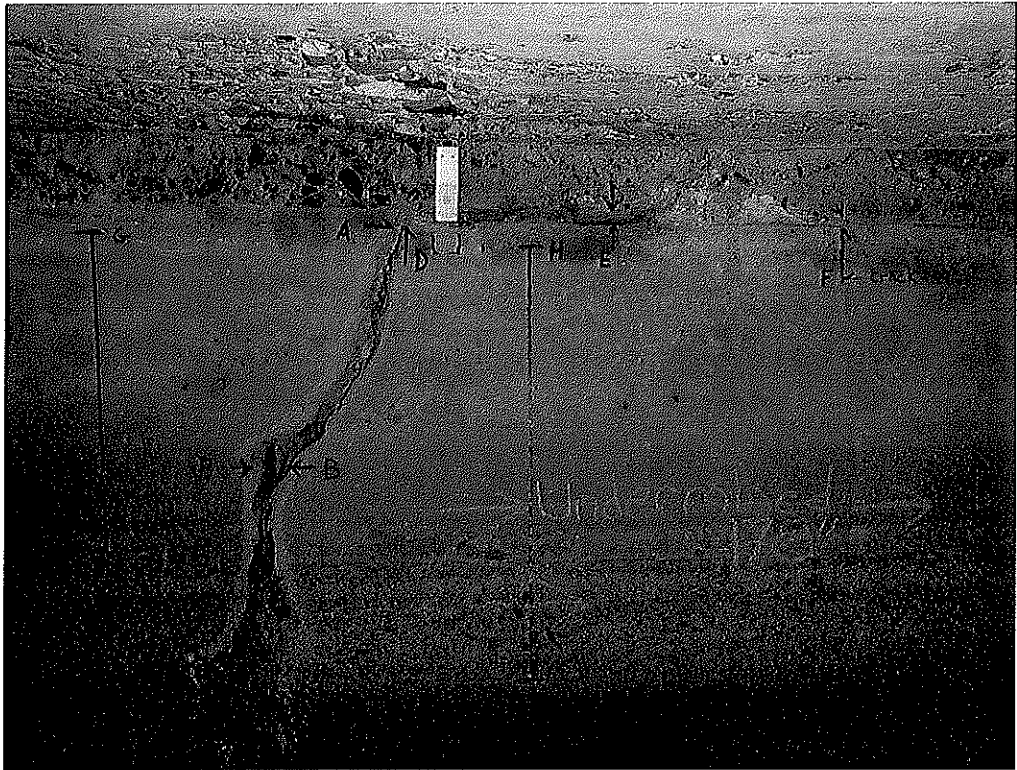
The South wall has a full height crack located 14'-10" from the West edge of the culvert that has split the South wall into two sections. The base of both sections of the South wall are leaning in towards the channel. There is visible movement of the Western end of the South wall at the location of the crack; there is a 1" displacement at the waterline. The Eastern section of the wall consistently measures 9/16" over 24" out of plumb and the Western section measures 1-1/4" over 24" out of plumb. There is settlement of the Western section of wall at the location of the crack; the crack between the top of wall and roof is 3/4" thick for a length of 25" and transitions to a 1/8" wide crack for another 49" going towards the Southwest corner.

Several locations were marked on both of the North and South Walls during the inspection on 9-30-14 in order to have an exact location to document the measurements of the cracks and displacement of the walls at the chosen locations. Crack gauges were installed at both walls on 9-30-14 across these noted cracks to monitor movement. These locations will be observed weekly and measurements recorded in order to maintain a weekly record of the above noted deficiencies (see Photos # 1, #2 & #3).

**Photo 1: South wall, locations of measurements being taken at settlement cracks**

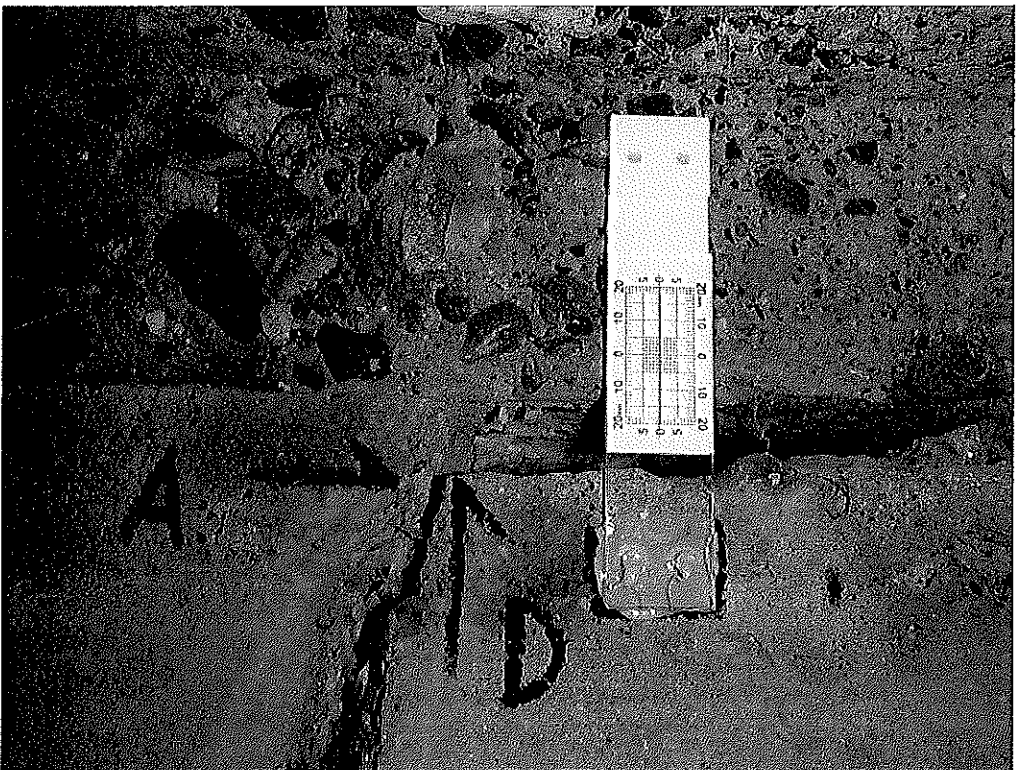
**Photo 2: South wall showing the crack gauge that was installed on 9-30-14**

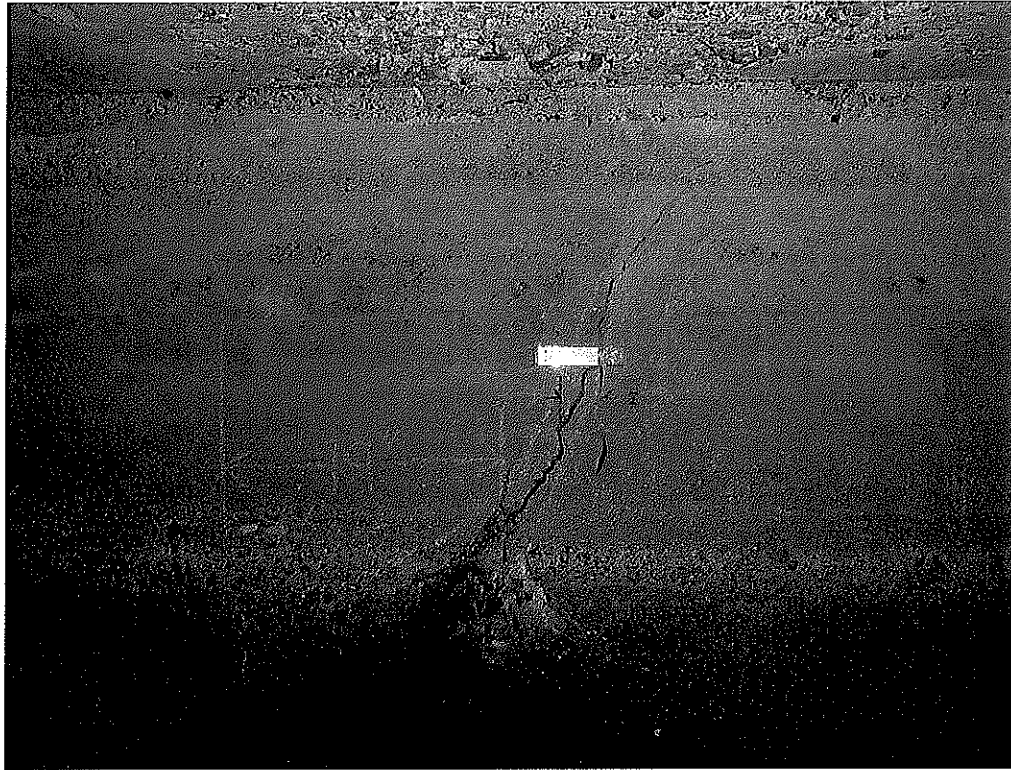
There is a full height crack in the North wall that is located 14'-4" from the West edge of the culvert. There is a spall in the face of the wall at the waterline measuring 26" wide x 3" deep that continues down to the footing. The footing is undermined and spalled below this location.

**Photo 3:** North wall, locations of measurements being taken at settlement crack

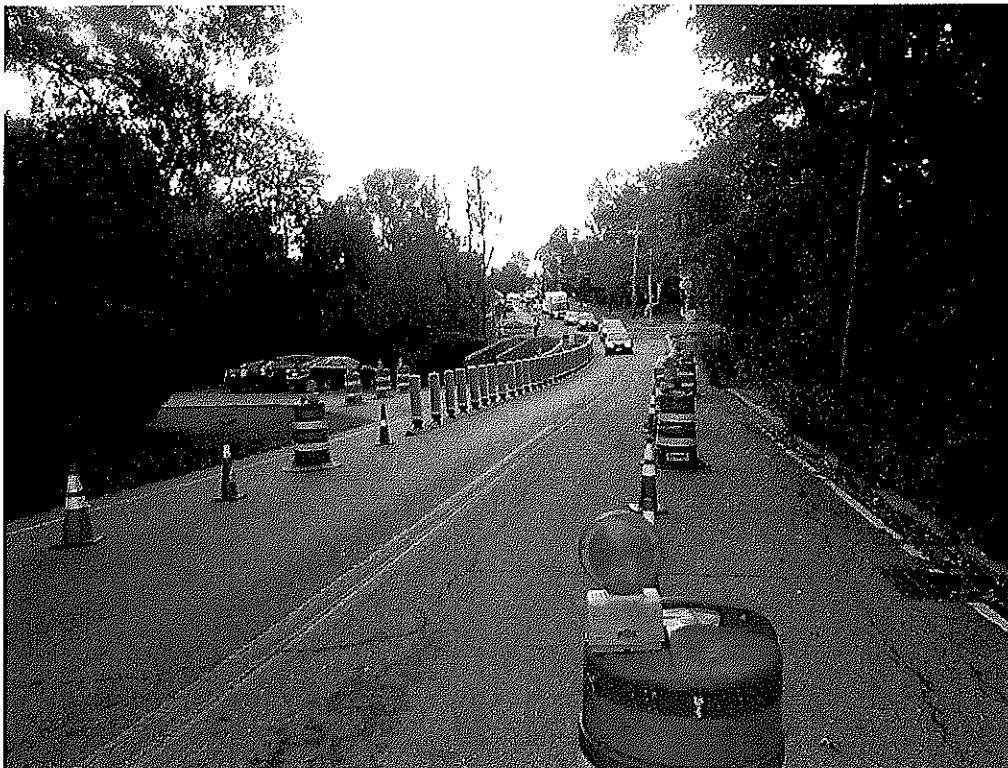
The roadway has been reduced to a single lane over the center of the culvert to move traffic away from the edges of the culvert roof. Traffic is travelling Northbound only and is not being allowed to drive over the steel plates located on the East side of the culvert (see Photos #4, #5 & #6). Beaver Street has been closed to Southbound traffic from Waverley Oaks Road and a City of Waltham Police Detail has been present at the North side of the culvert.

**Photo 4:** Traffic has been restricted to a single lane travelling Northbound over the center of the culvert

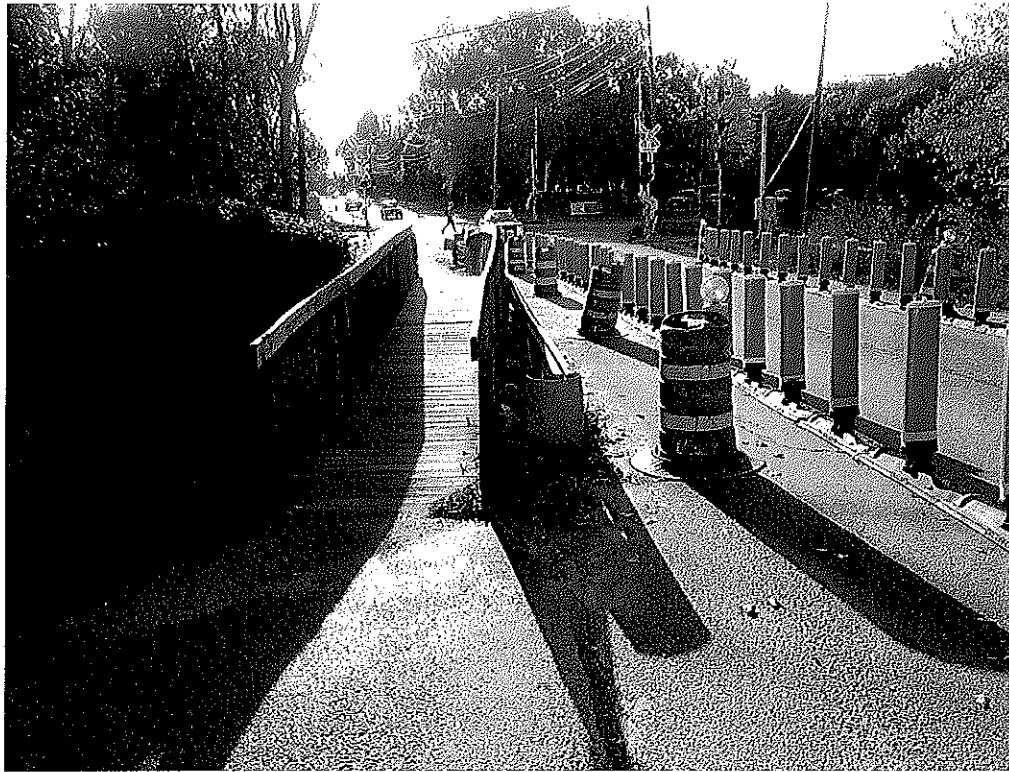
**Photo 5:** Traffic has been restricted from driving over the steel plates located on the East side of the culvert

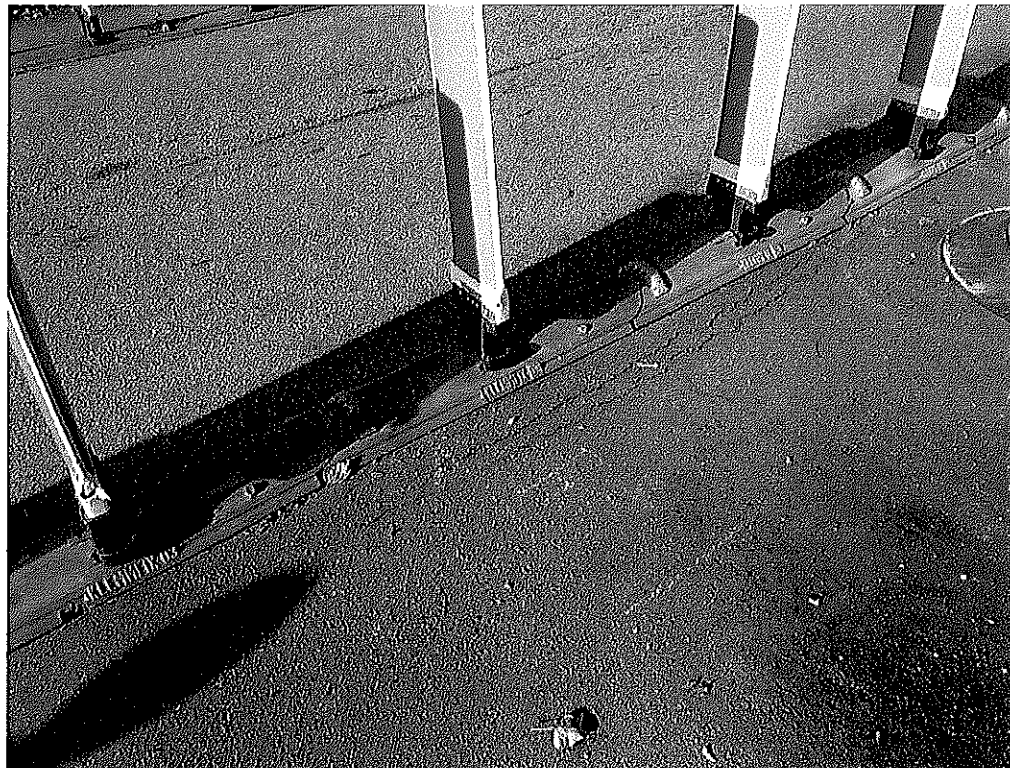
**Photo 6:** Cracks in pavement indicate the approximate limits of the steel plates present under the wearing surface
