Deval L. Patrick, Governor  
Richard A. Davey, Secretary & CEO  
Frank DePaola, Administrator

September 12, 2014

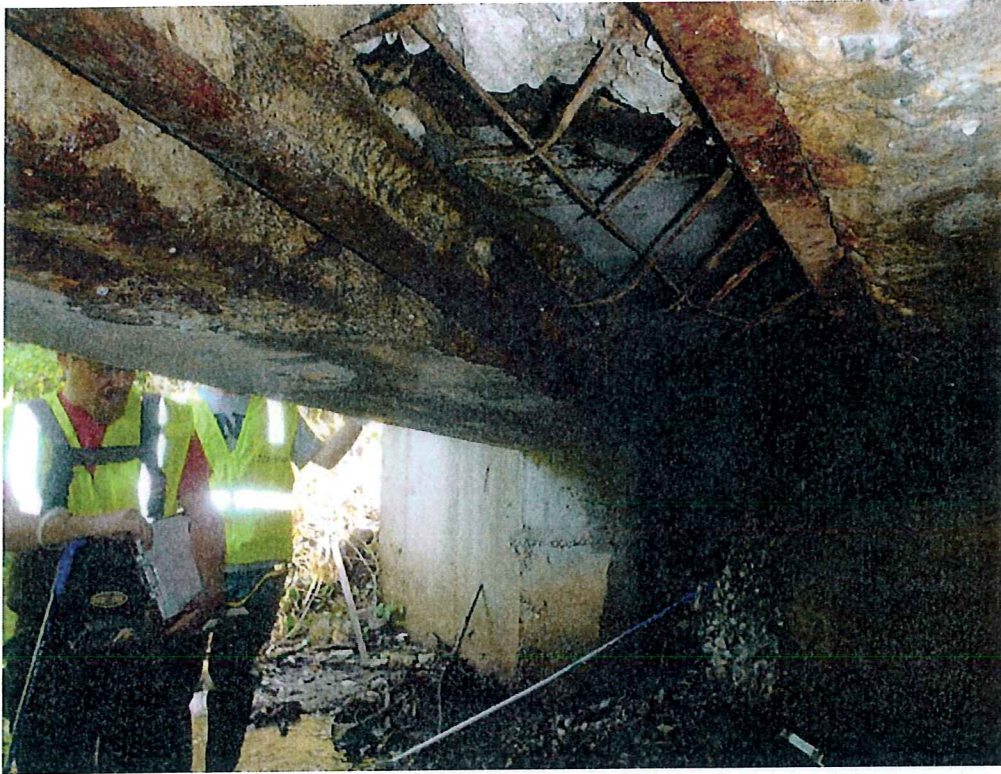
**Photo 1:** Hole in the East side of the roof looking towards the South wall showing unsupported railroad rail and corroded reinforcement

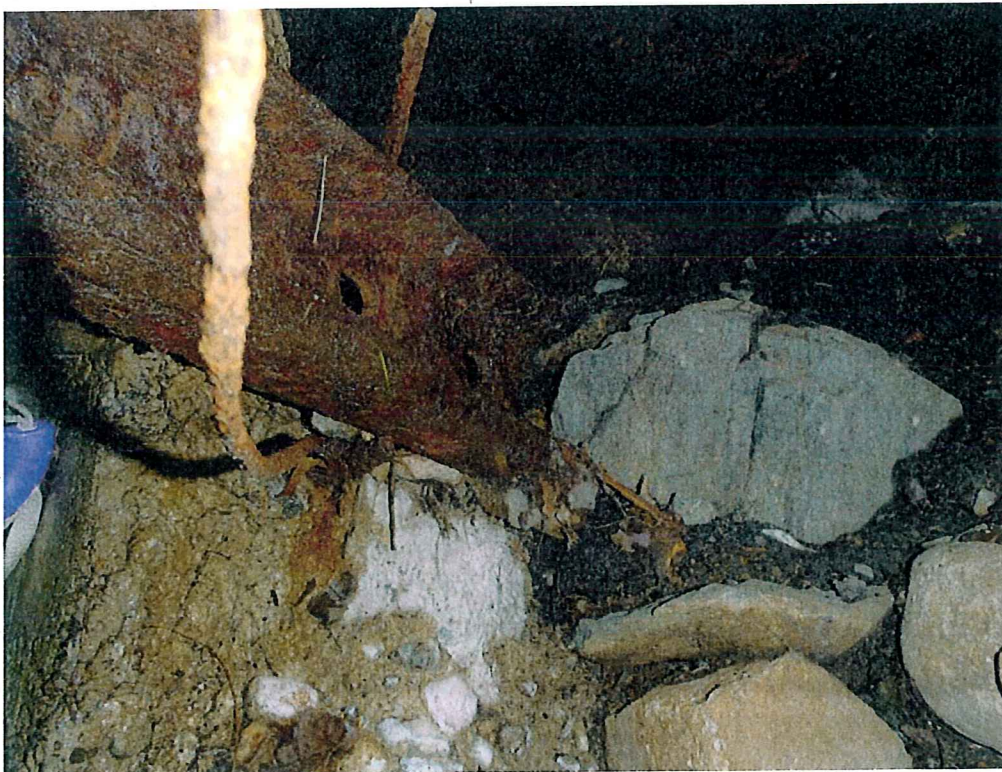
**Photo 2:** East end of roof has an unsupported rail and corroded reinforcement at the Southeast corner at the hole in the South wall

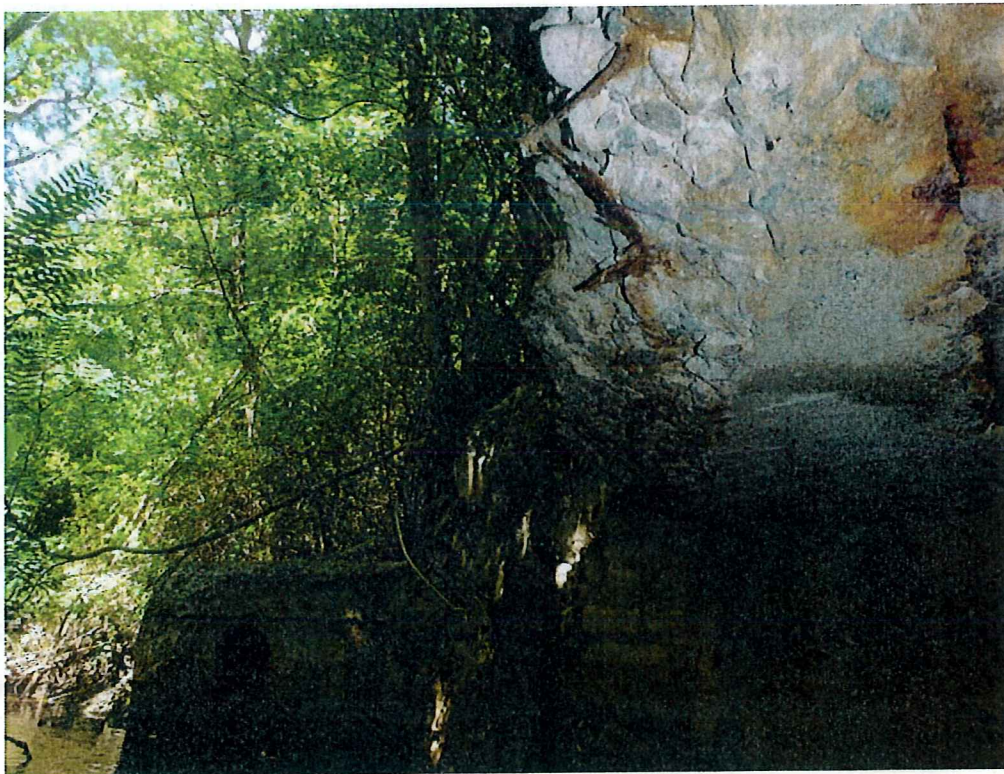
Photo 6: Northwest corner showing spalled edge of roof and corroded reinforcement

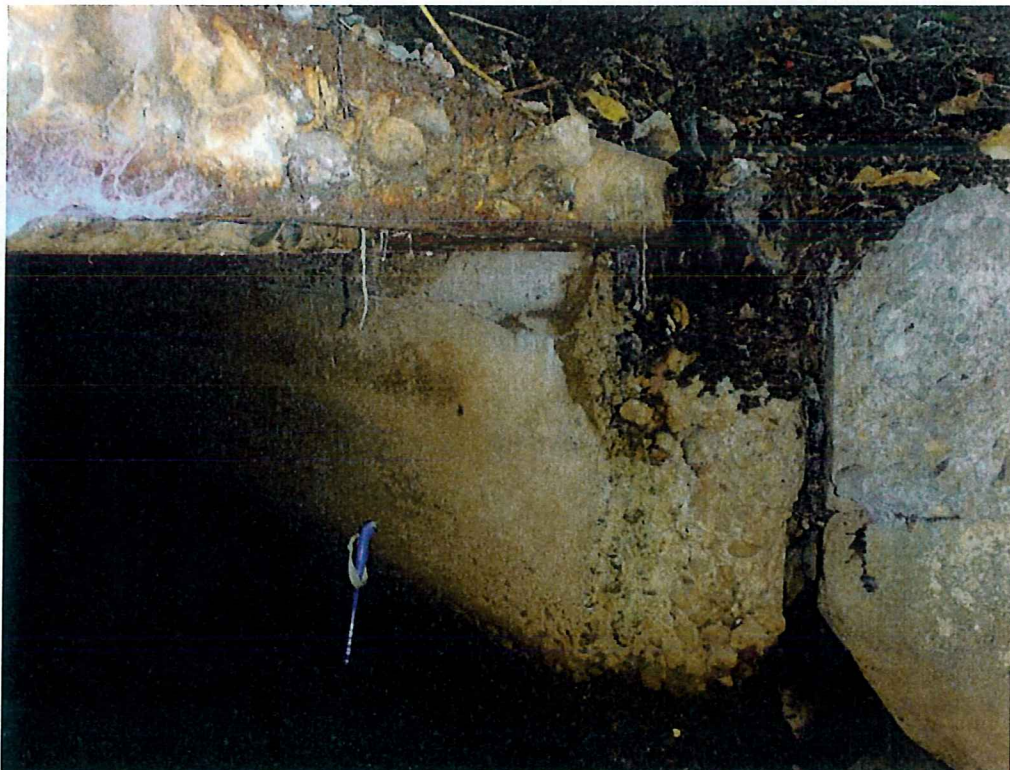
**Photo 8:** South west wingwall is spalled 16" wide x full height

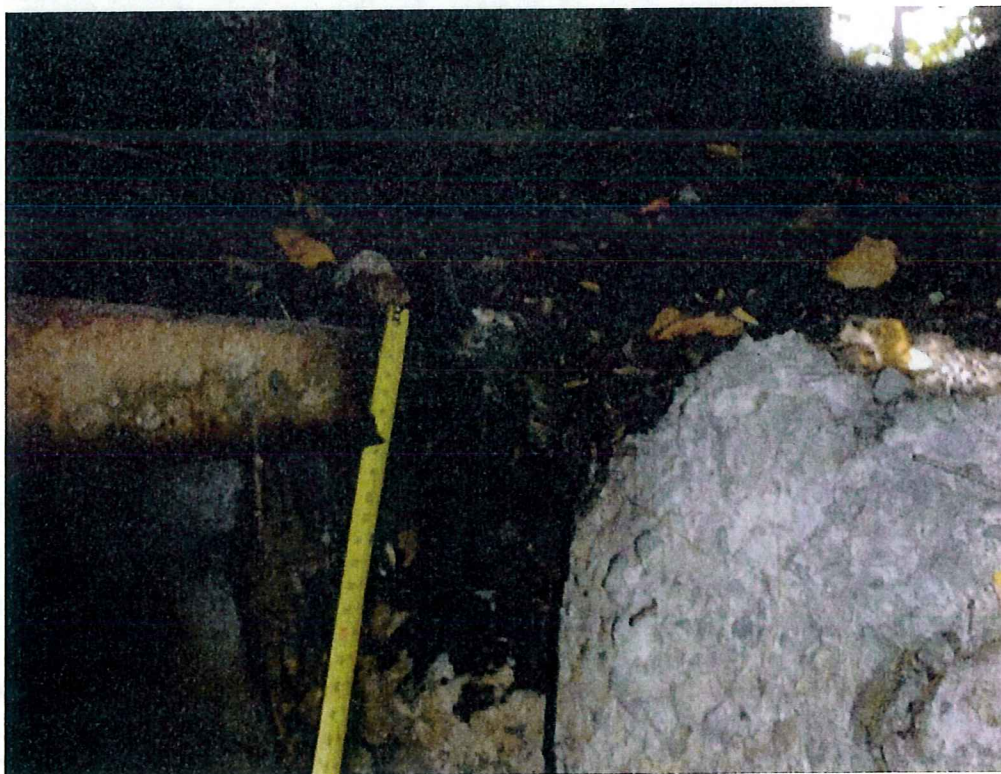
**Photo 10: Unsupported rail at Southwest corner spall of South wall**

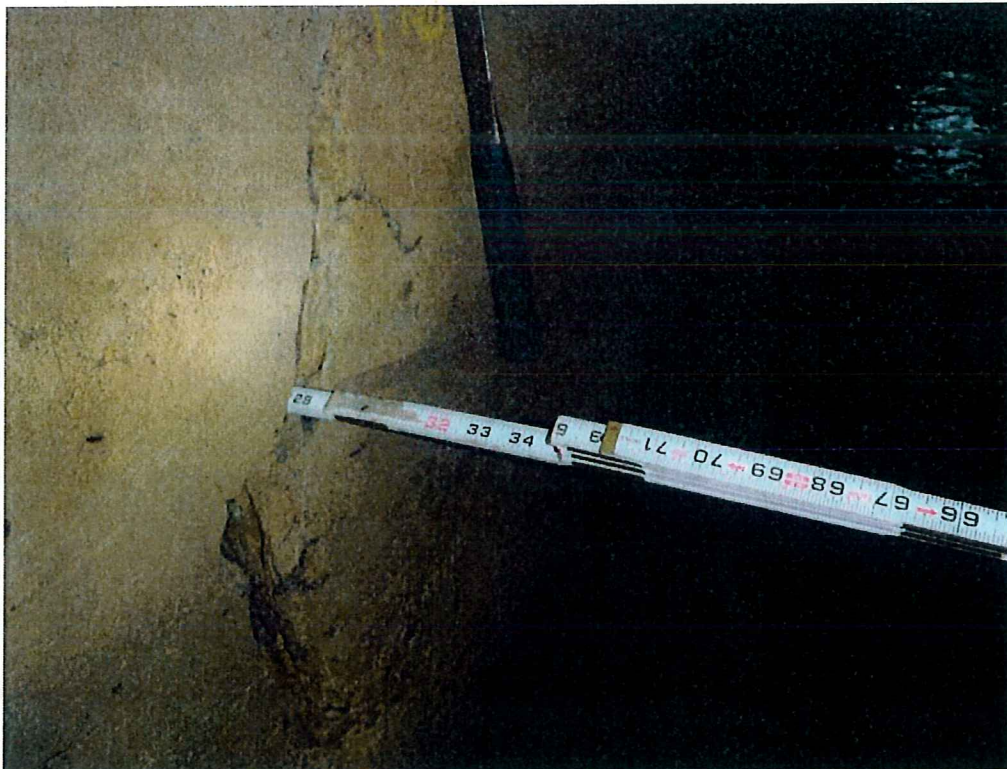
Photo 12: South wall has a crack up to 1-1/4" wide. Tape was able to penetrate wall 29"

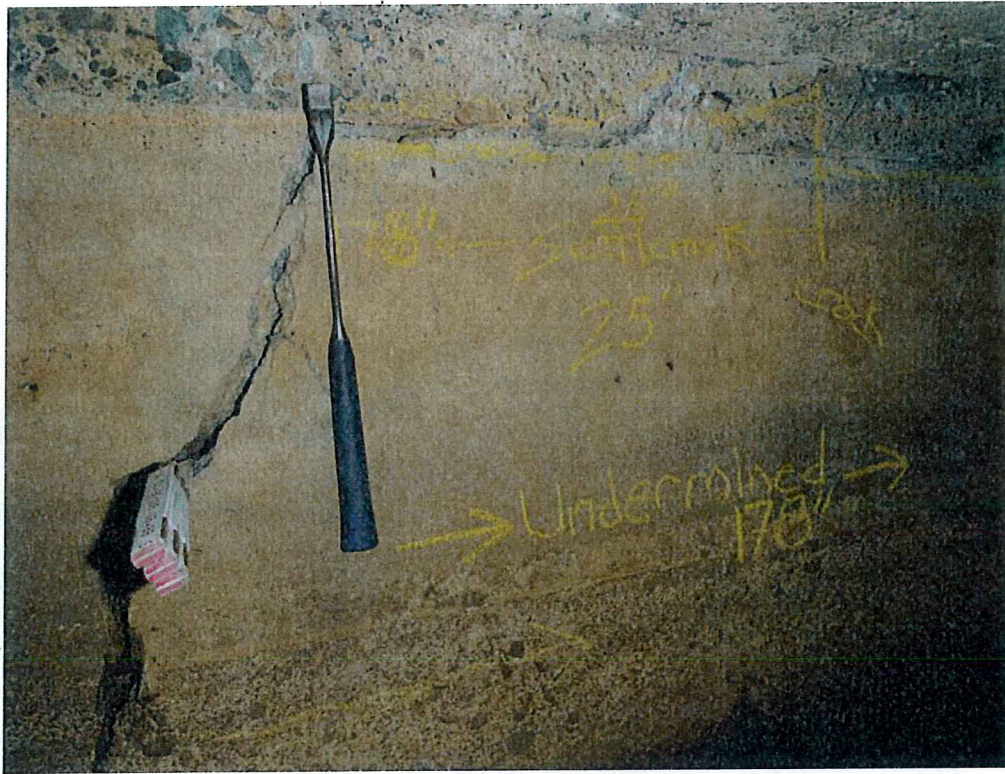
Photo 13: South wall has a full height crack located 14'-10" from the West end

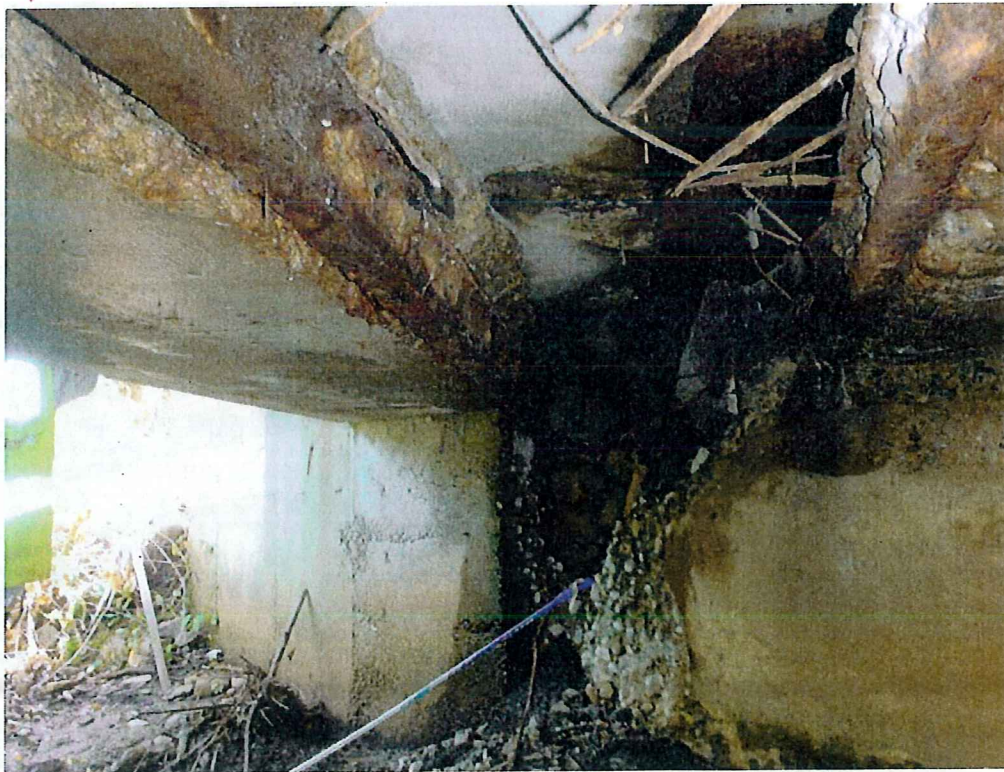
Photo 14: Large hole at the Southeast corner of the bridge in the South wall

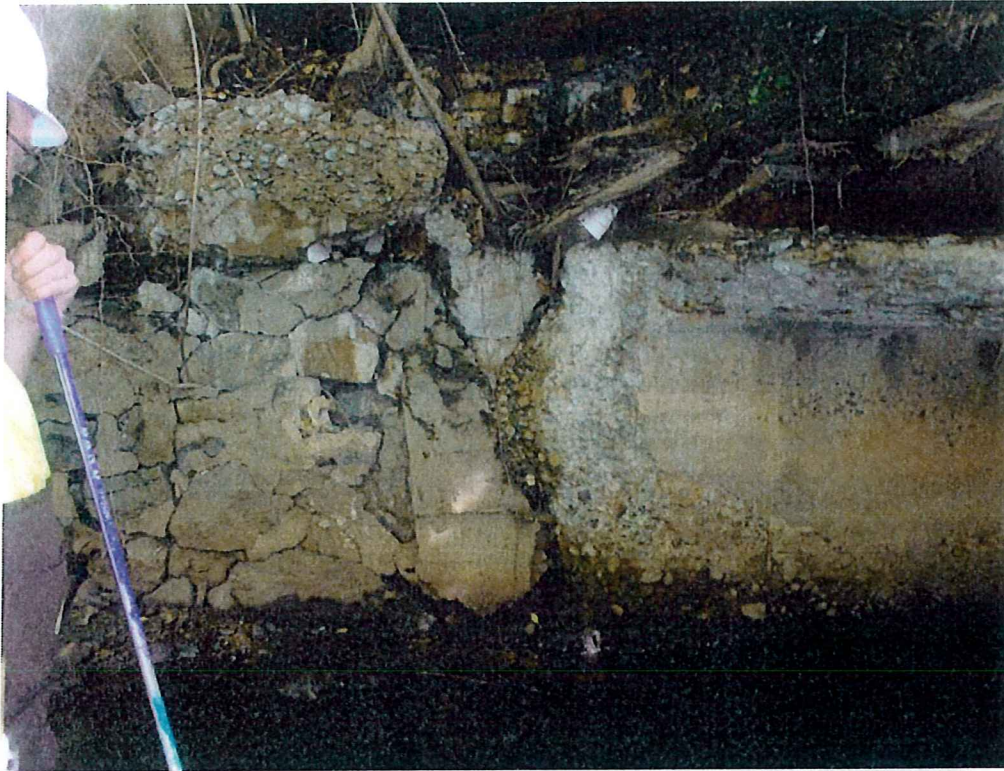
**Photo 15:** North wall has a full height spall at the Northwest corner

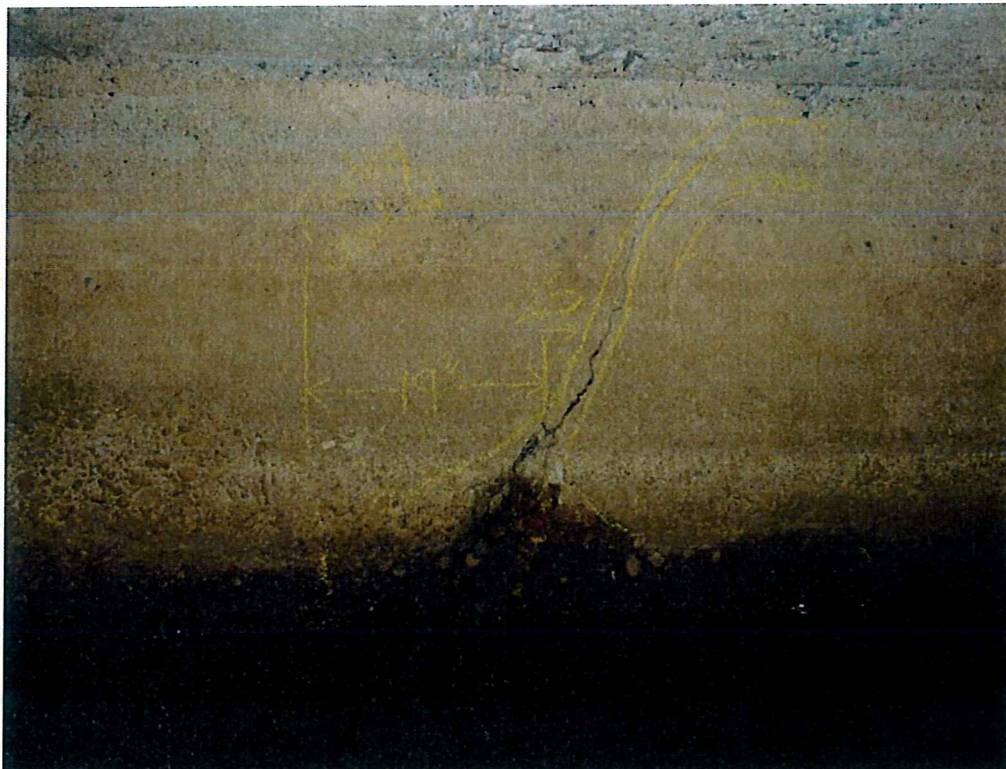
**Photo 16:** North wall has a full height crack; footing is exposed and undermined at this location

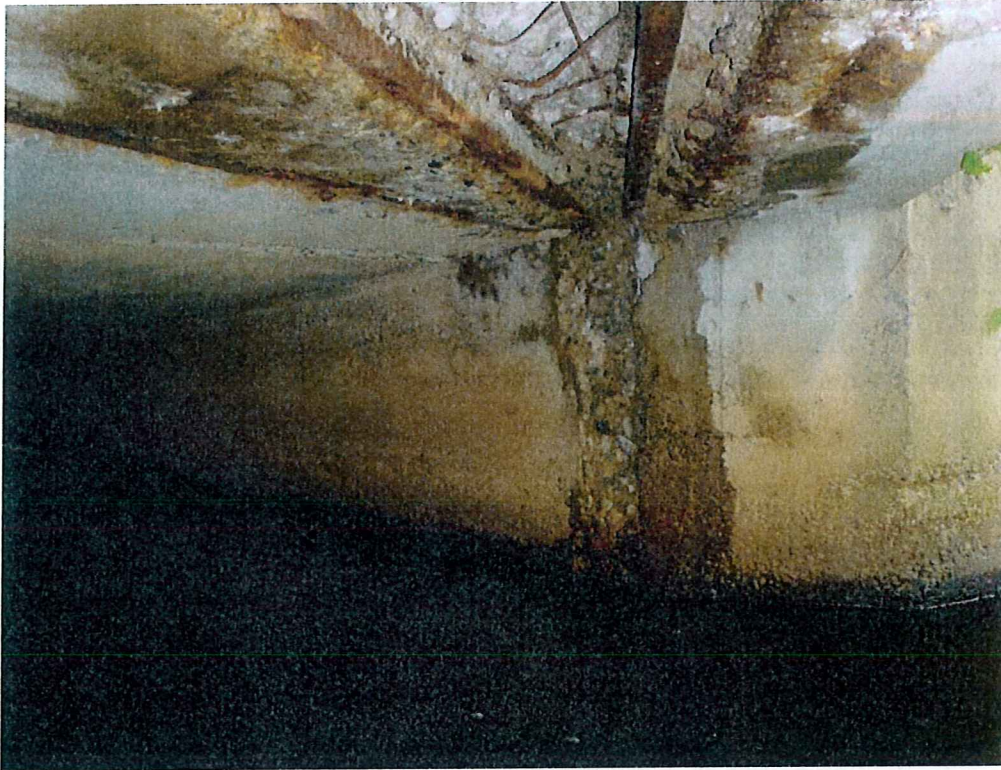
Photo 17: Spall at Eastern end of the North wall measuring 43" high x 14" wide x 7" deep with active leakage

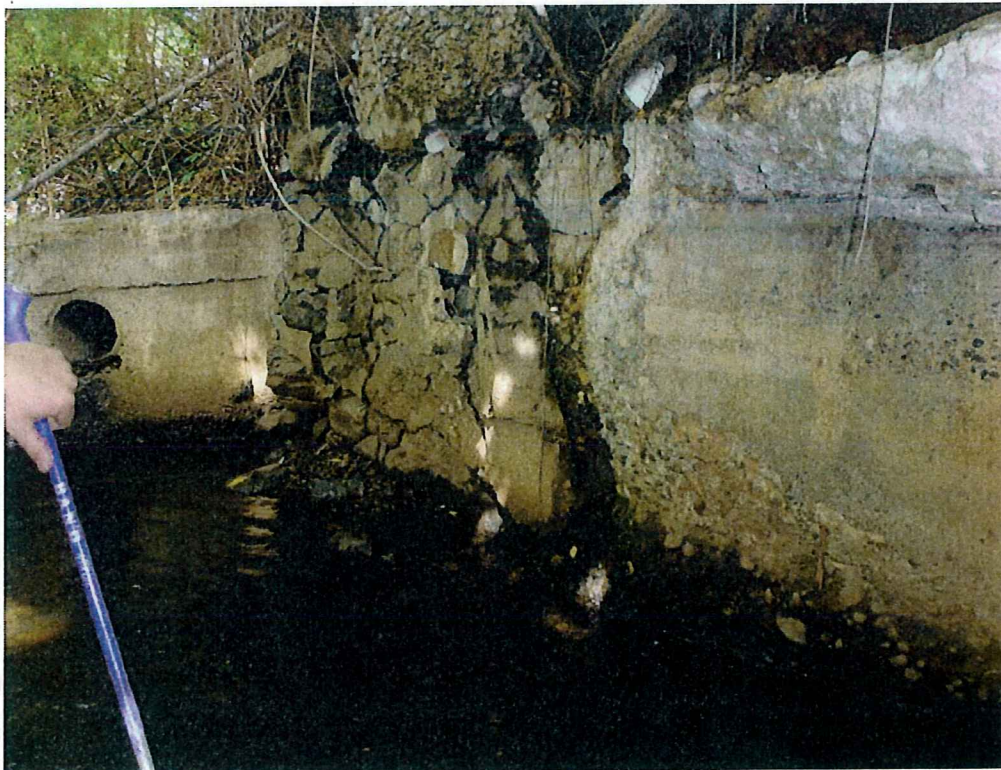
Photo 18: Northwest wingwall is crumbling and leaning in towards the channel

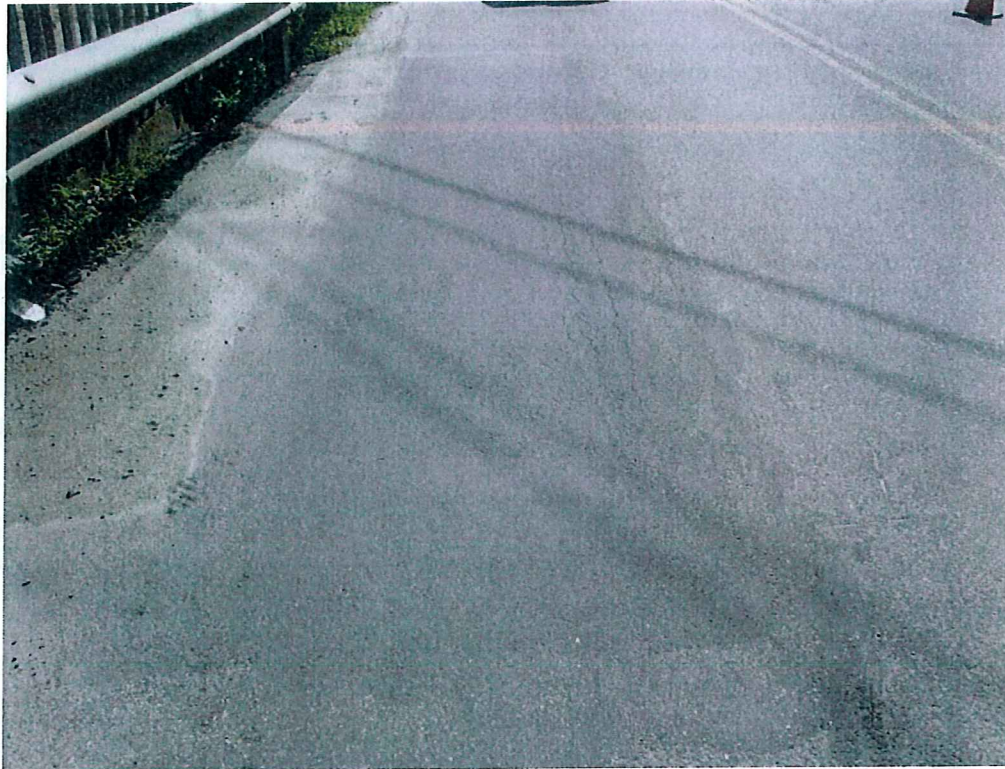
**Photo 23:** Longitudinal cracking are present in the asphalt patch over the steel road plates on the Northbound travel lane

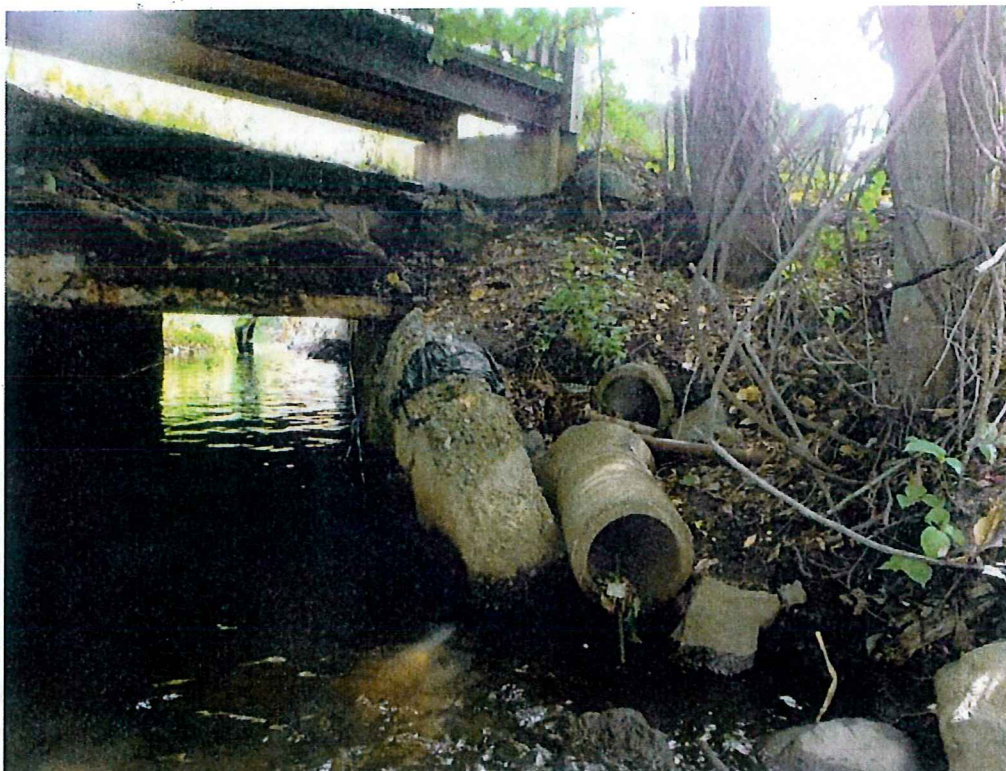
**Photo 24:** Significant erosion and undercutting of the embankment at the Southwest corner

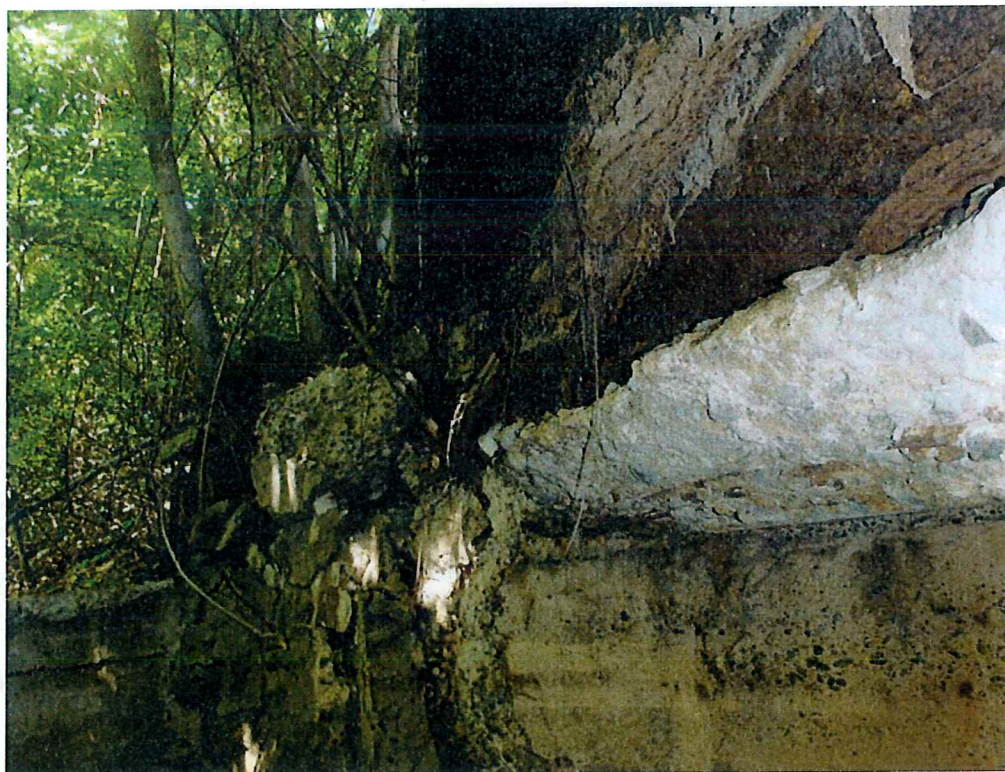
**Photo 26: Tree root & corrosion on 12" CI pipe, Northwest corner**

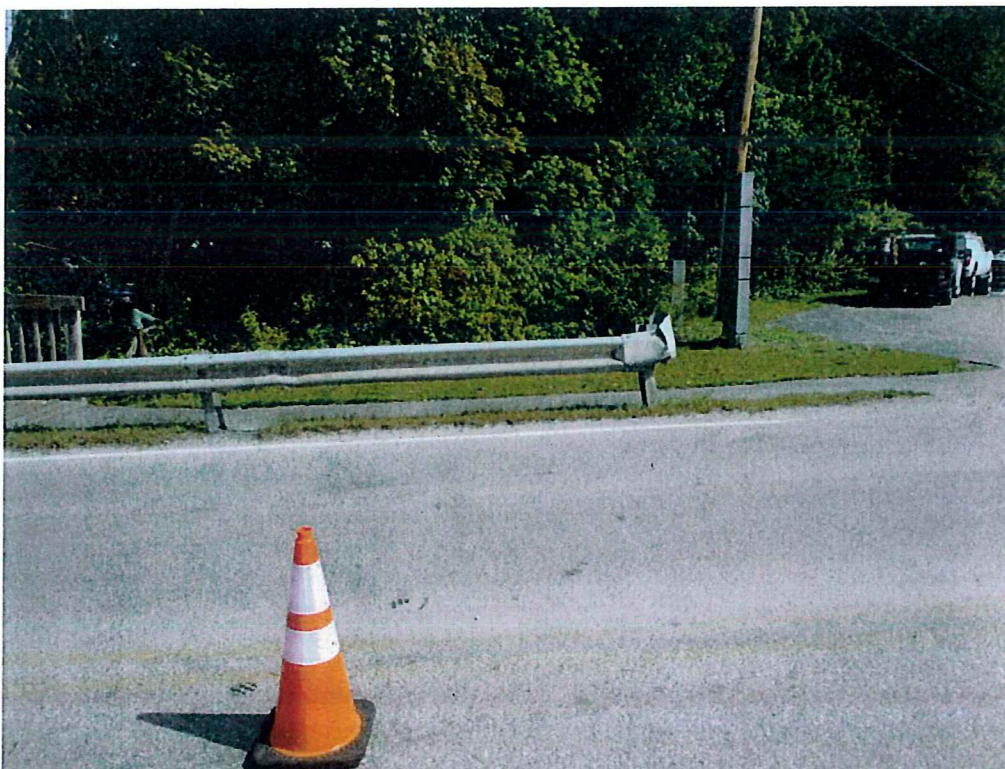
**Photo 32: Impact damage to the Southeast approach guardrail showing excessive spacing and bent posts**

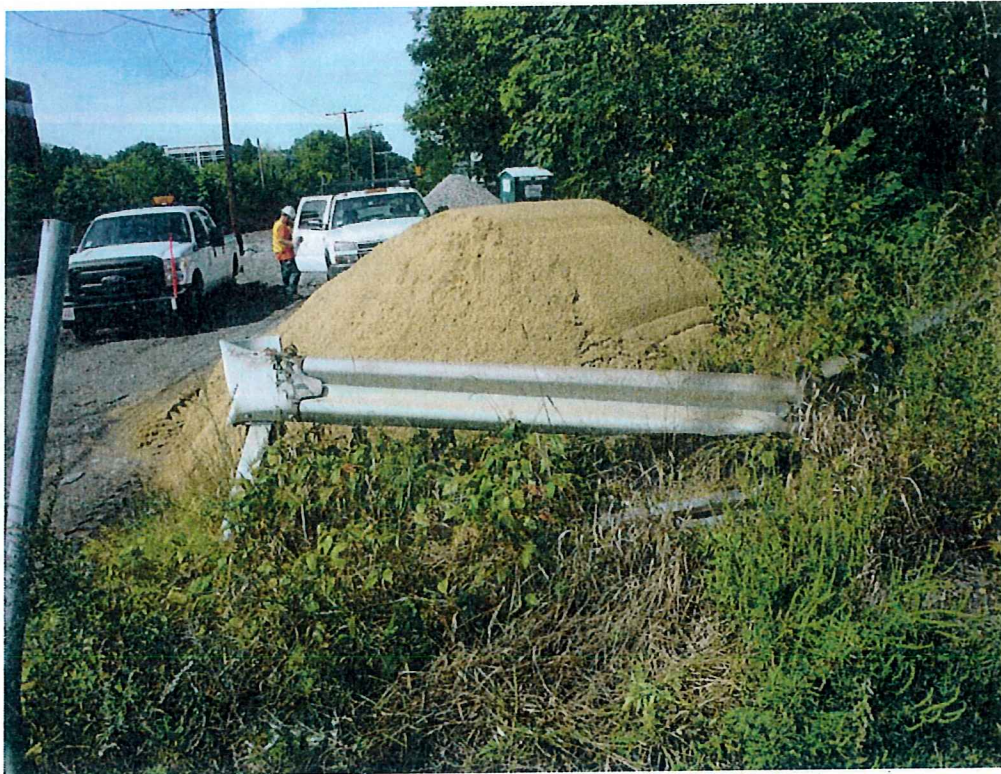
Photo 33: Impact damage to the Southwest approach guardrail

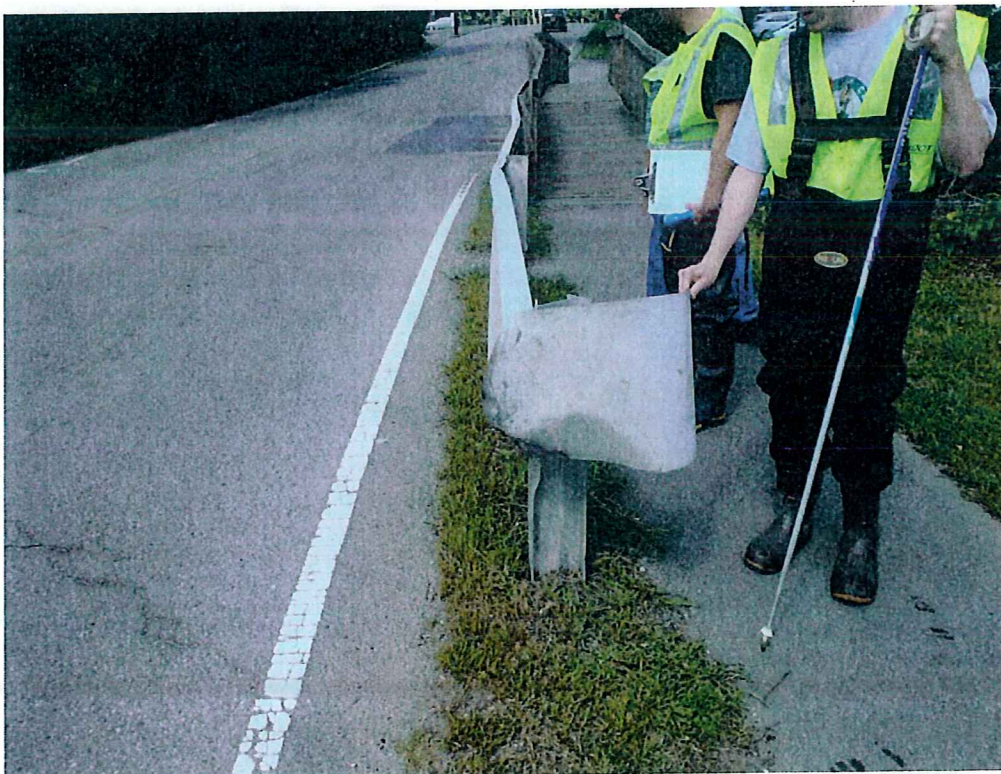
Photo 34: Southeast guardrail end showing impact damage
