PROJECT NOTIFICATION FORM

FERNALD DEVELOPMENTAL CENTER

200 TRAPELO ROAD, WALTHAM, MA

February 27, 2009

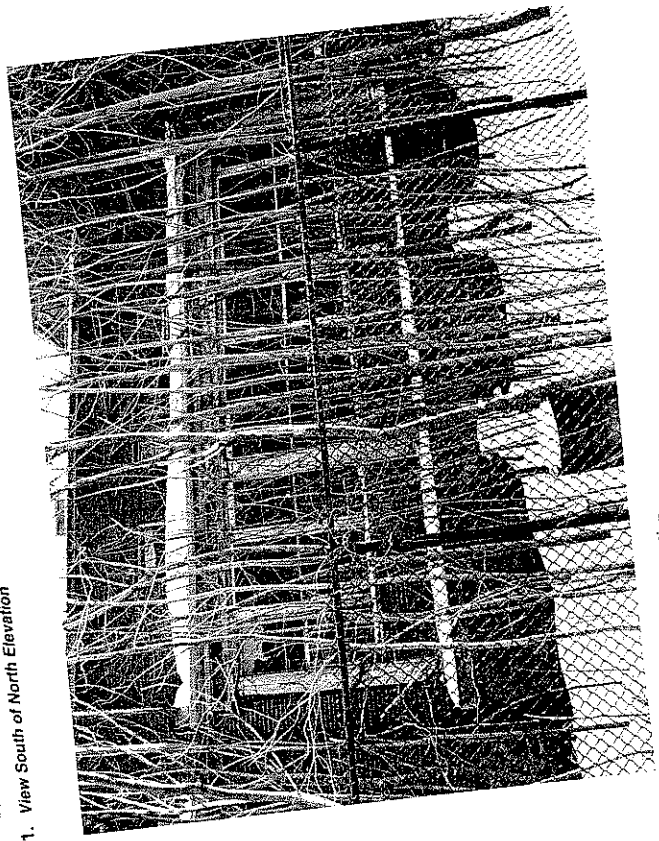
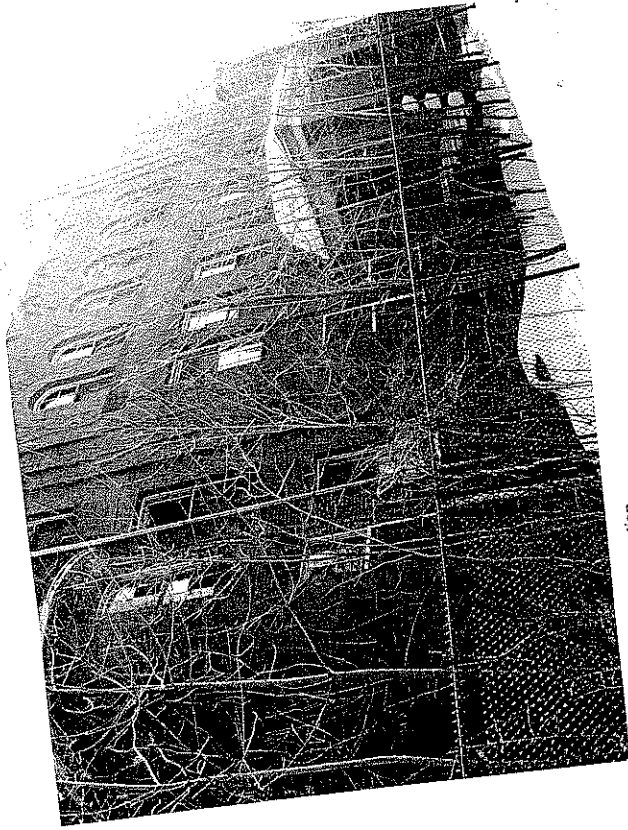
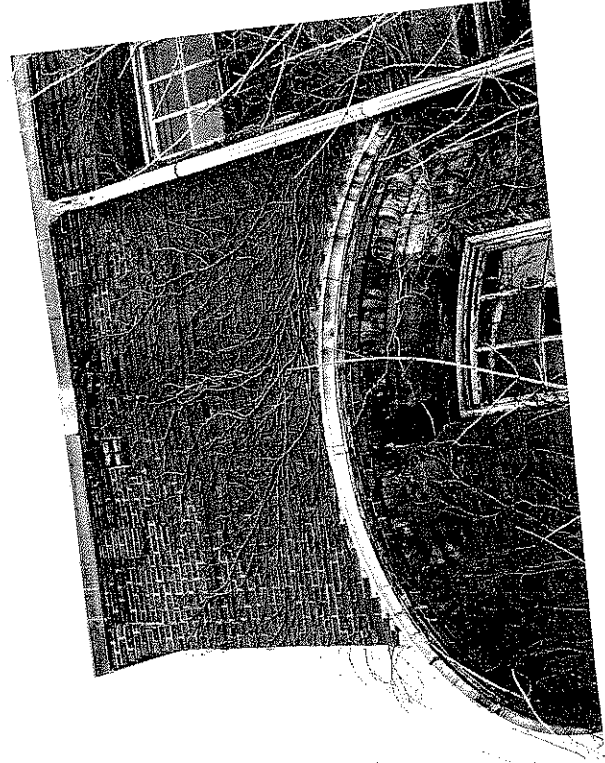
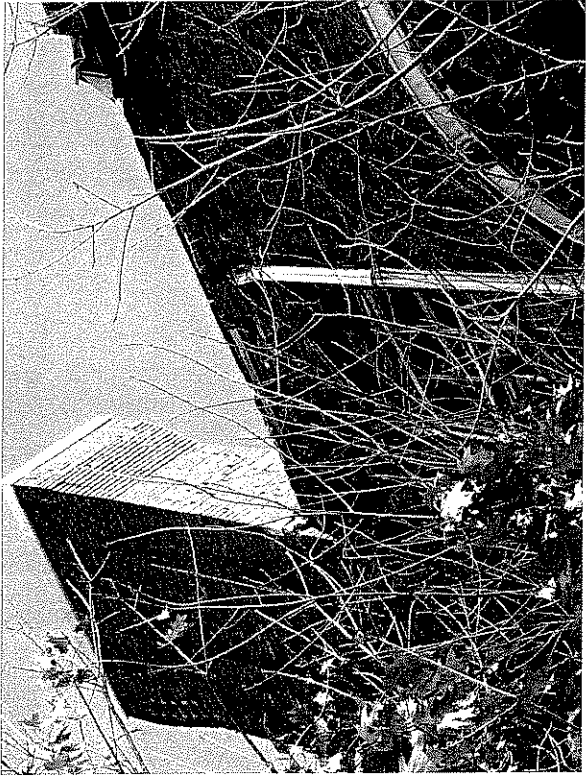
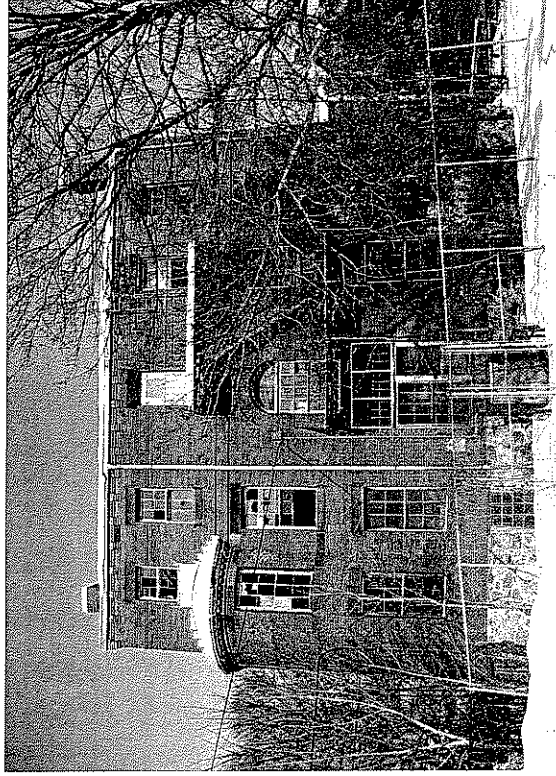
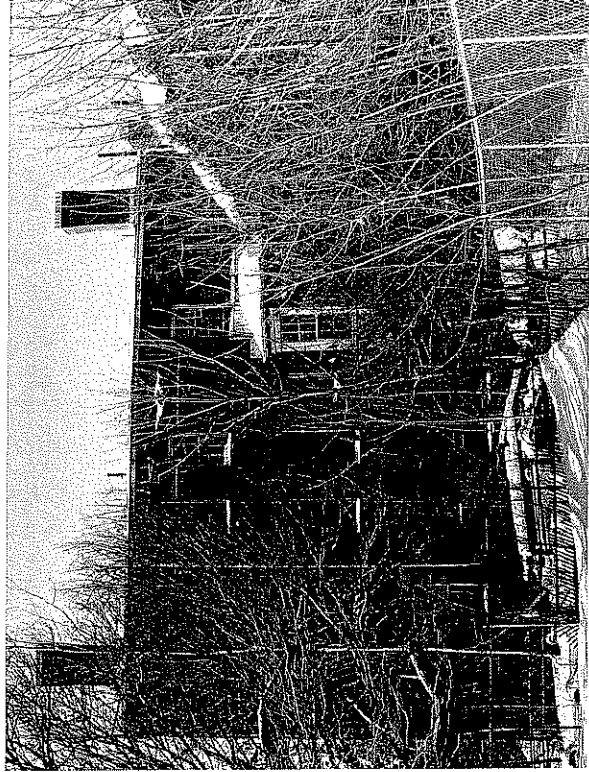
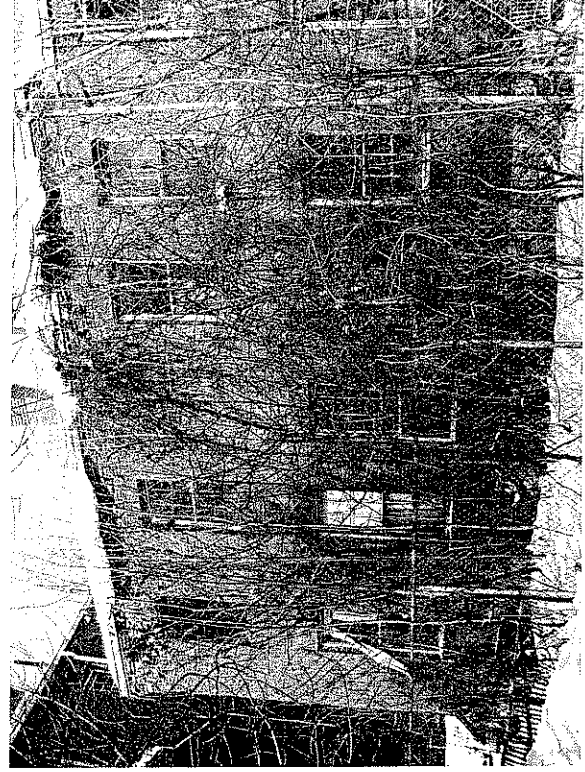
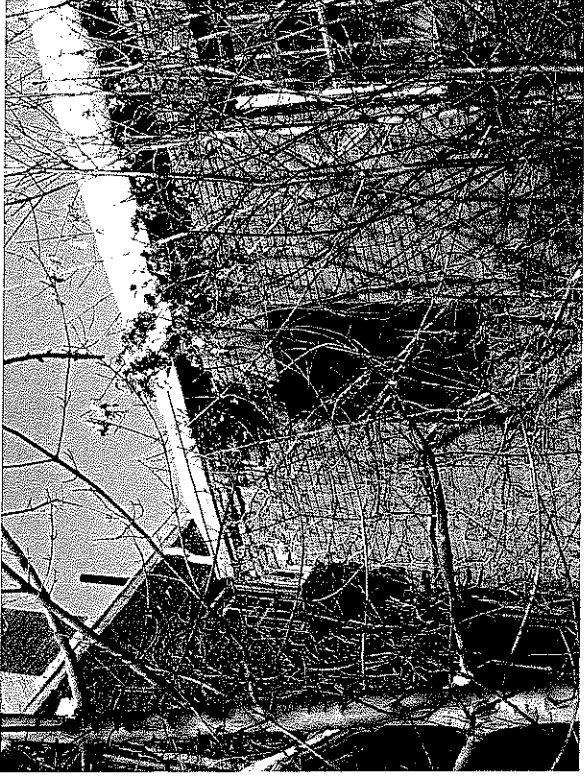
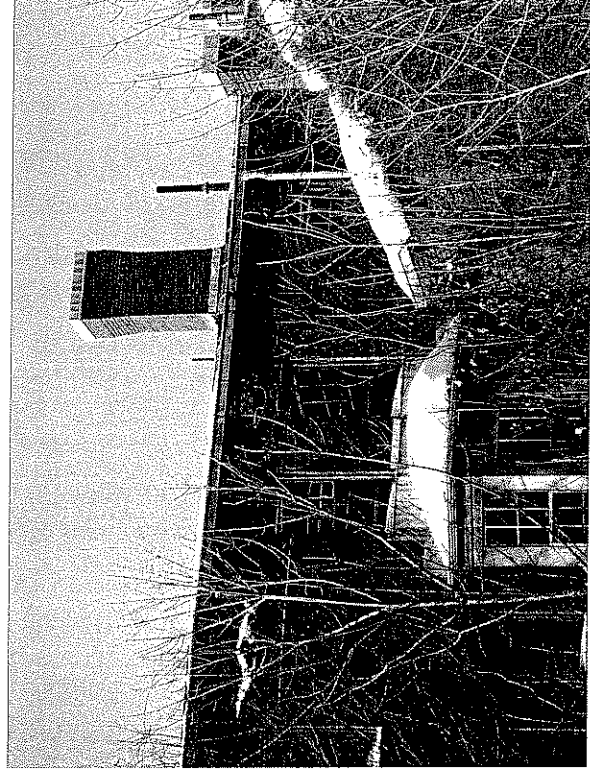
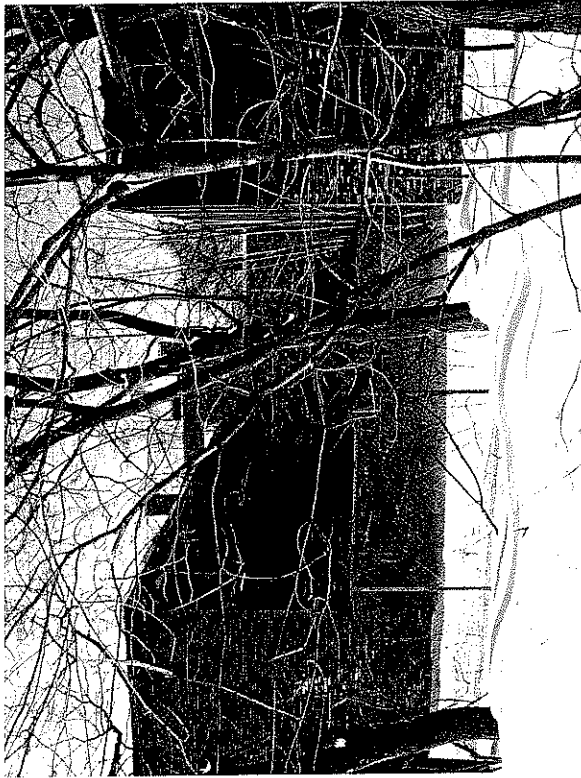
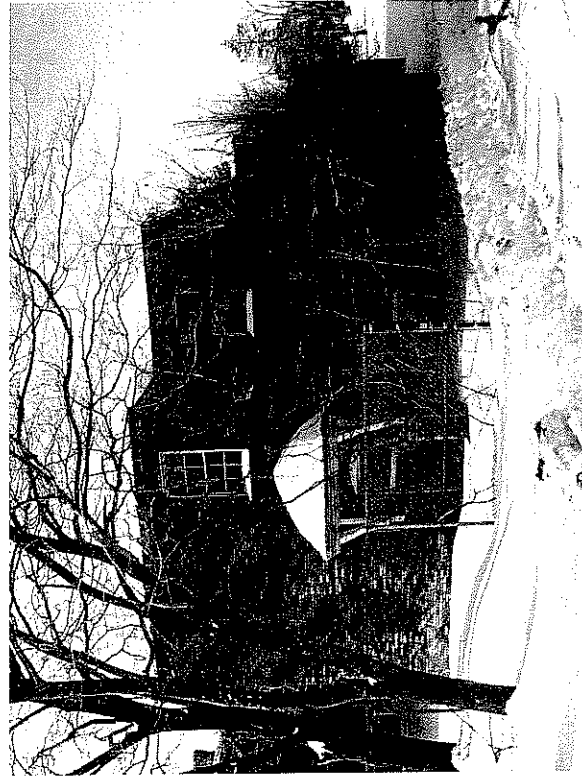
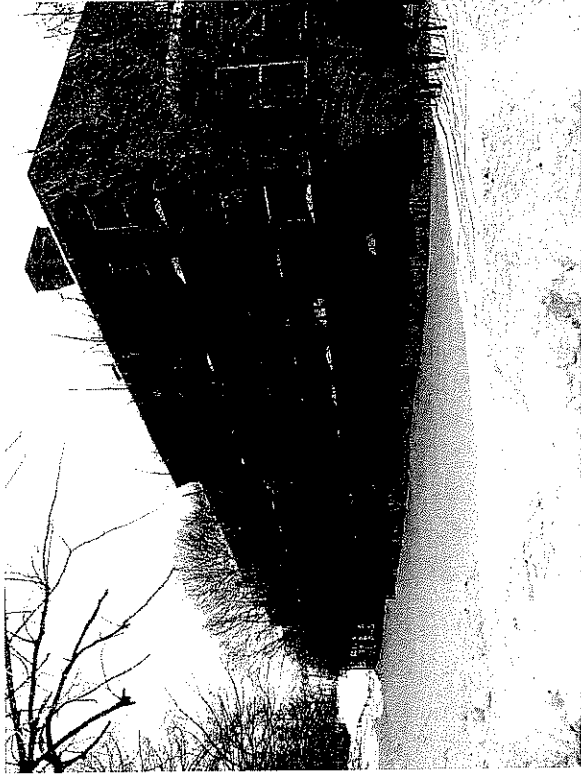
- **Building 1, Waverly Hall:** Waverly Hall is in severely deteriorated condition. The roof has failed in many locations resulting in significant water infiltration into the masonry walls of the building which has resulted in catastrophic collapse of interior floors. The deterioration has been exacerbated by exposure to the elements and multiple freeze/thaw cycles due to lack of heat and broken windows within the building. The exterior walls of the building exhibit areas of broken and missing bricks, with significant losses around the eaves, resulting from years of water infiltration creating spalled brick and deteriorated mortar. Multiple areas of efflorescence are also present on all elevations of the building indicating moisture penetration within the masonry structure. Photographs 1-15 depict the exterior condition of the building.

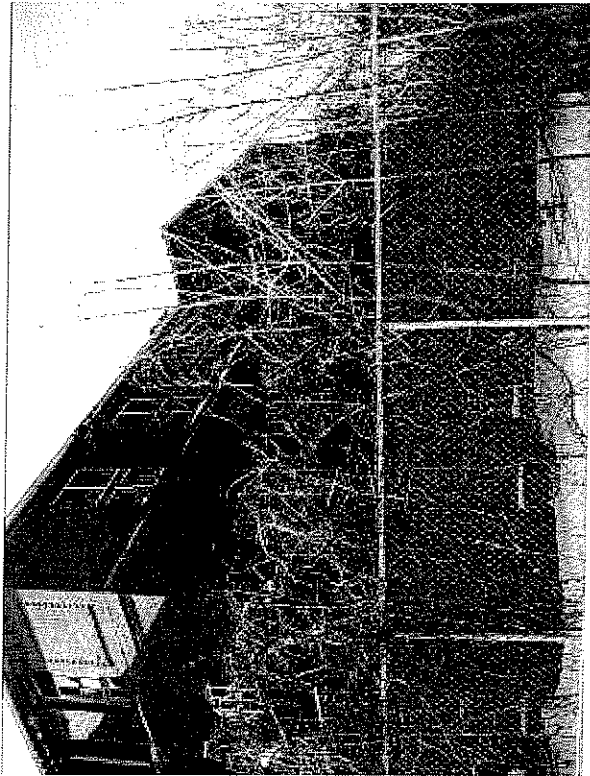
20. View Northwest of East Elevation

- **Building 3, Activity Center:** Situated adjacent to Waverly Hall, the Activity Center is in severely deteriorated condition. The roof has failed in many locations resulting in significant water infiltration into the masonry walls of the building which has

resulted in catastrophic collapse of interior floors. The deterioration has been exacerbated by exposure to the elements and multiple freeze/thaw cycles due to lack of heat and broken windows within the building. The original exterior walls of the building exhibit areas of broken and missing bricks, with significant losses around the eaves, resulting from years of water infiltration creating spalled brick and deteriorated mortar. Multiple areas of efflorescence are also present on all elevations of the building indicating moisture penetration within the masonry structure. Photographs 16-22 depict the exterior condition of the building.

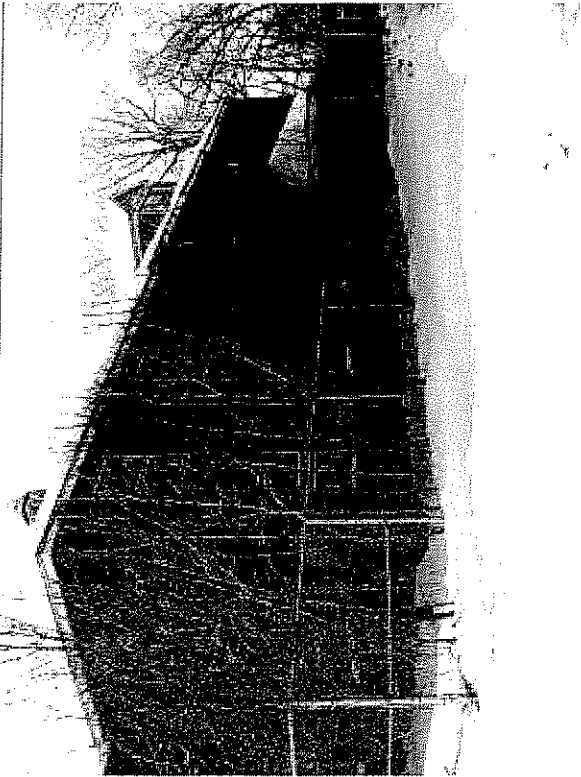
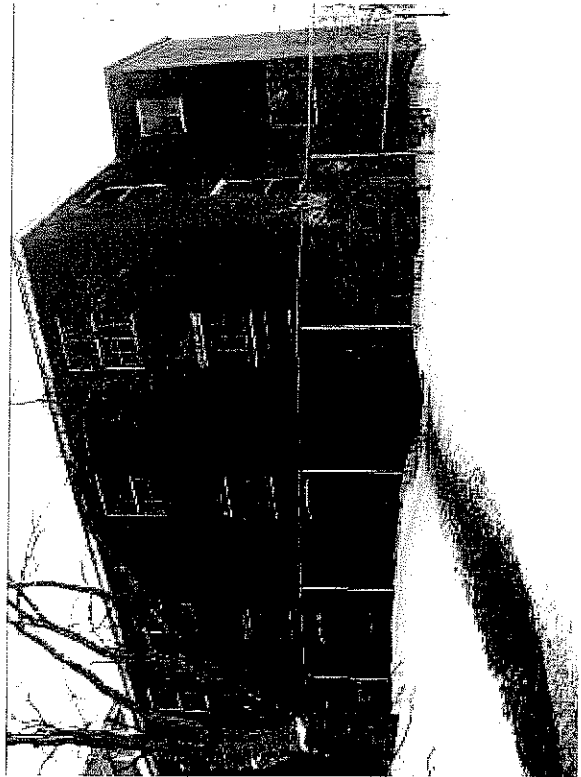
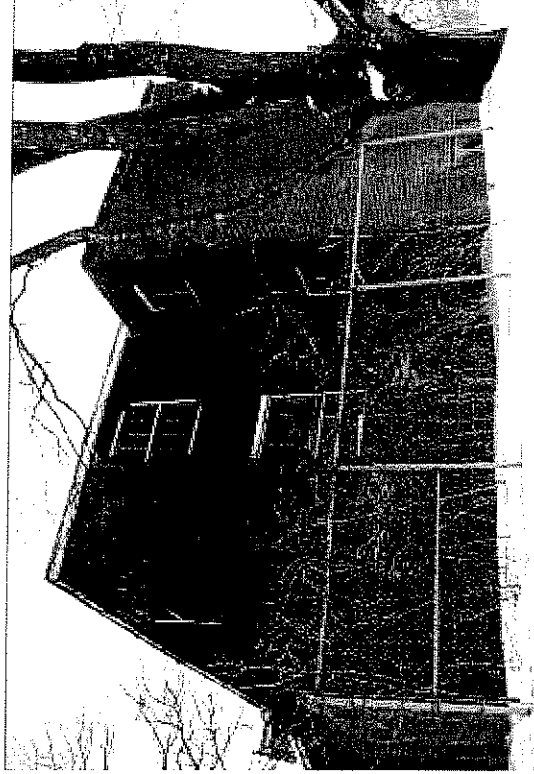
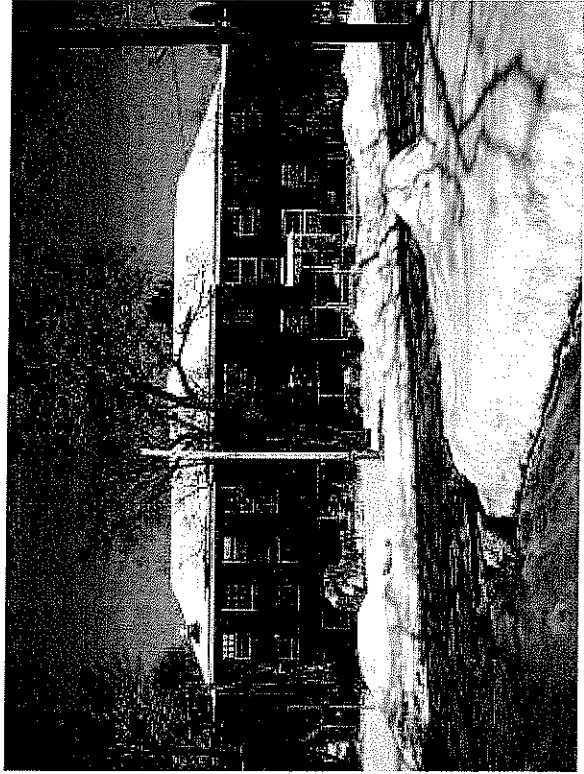
- **Building 6, Chipman:** Located west of Waverly Hall, Chipman is in severely deteriorated condition. The roof flashing has failed in many locations resulting in significant water infiltration into the masonry walls of the building which has resulted in catastrophic collapse of interior floors. The deterioration has been exacerbated by exposure to the elements and multiple freeze/thaw cycles due to lack of heat and broken windows within the building. The original exterior walls of the building exhibit areas of spalling brick and mortar resulting from years of water infiltration. Multiple areas of efflorescence are also present on all elevations of the building indicating moisture penetration within the masonry structure. Photographs 23-27 depict the exterior condition of the building.

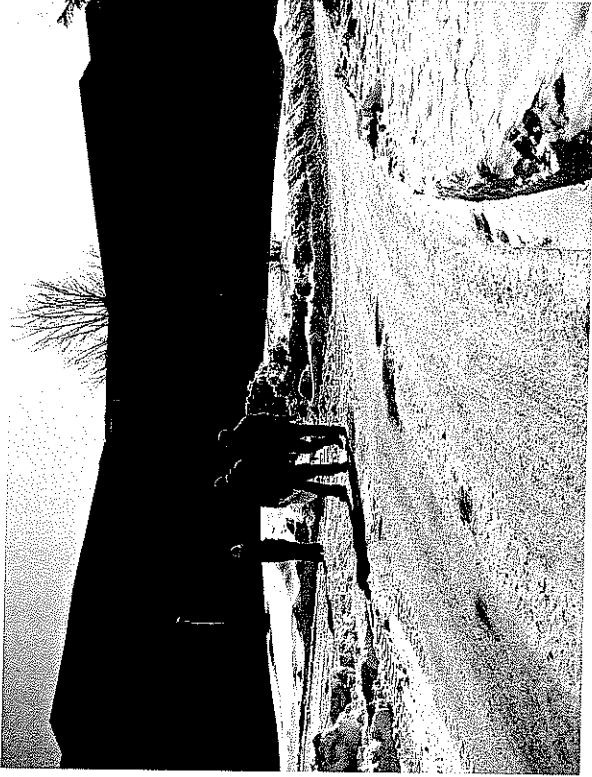
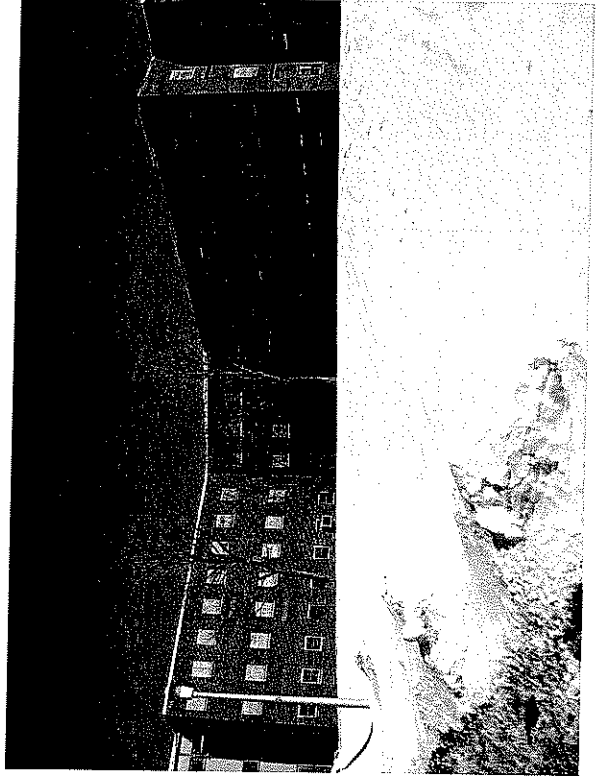
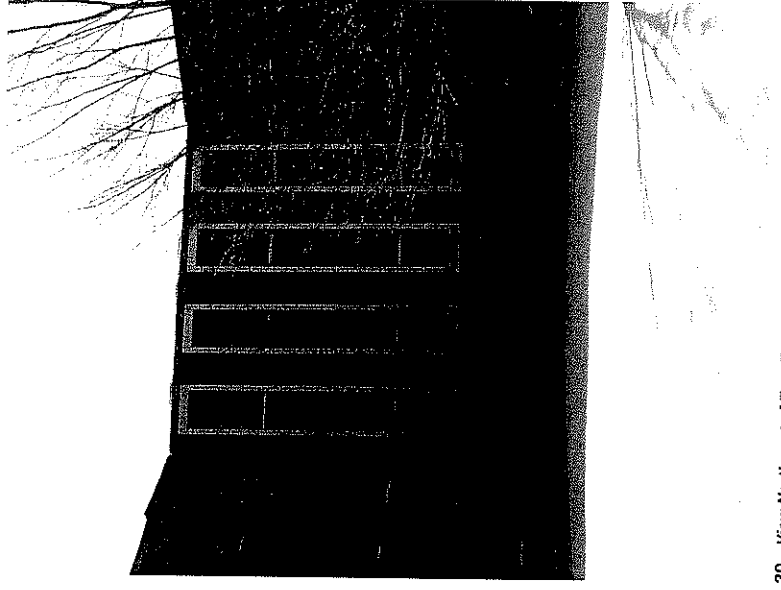
- **Building 60, Kelley Hall:** Located in the southwest quadrant of the site, Kelley Hall is in severely deteriorated condition. The roof has failed in many locations resulting in significant water infiltration into the masonry walls of the building. The exterior walls of the building exhibit areas of spalling brick and mortar and efflorescence resulting from years of water infiltration. Photographs 28-30 depict the exterior condition of the building.

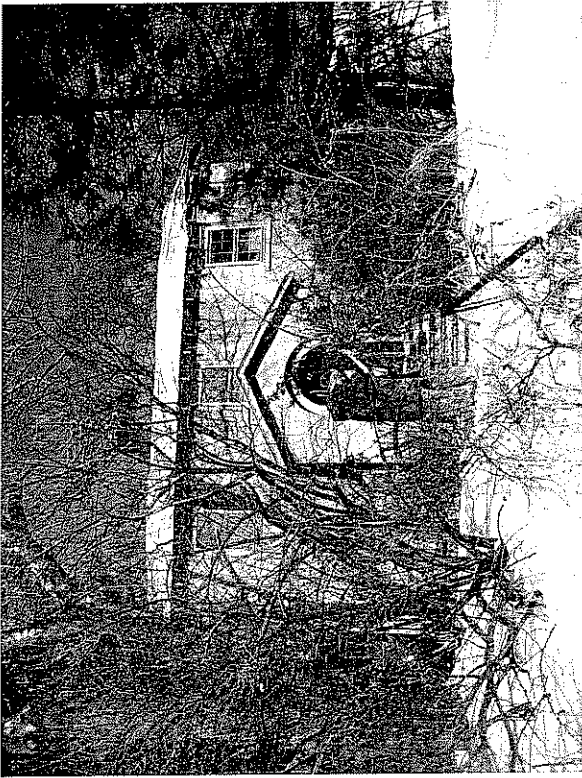
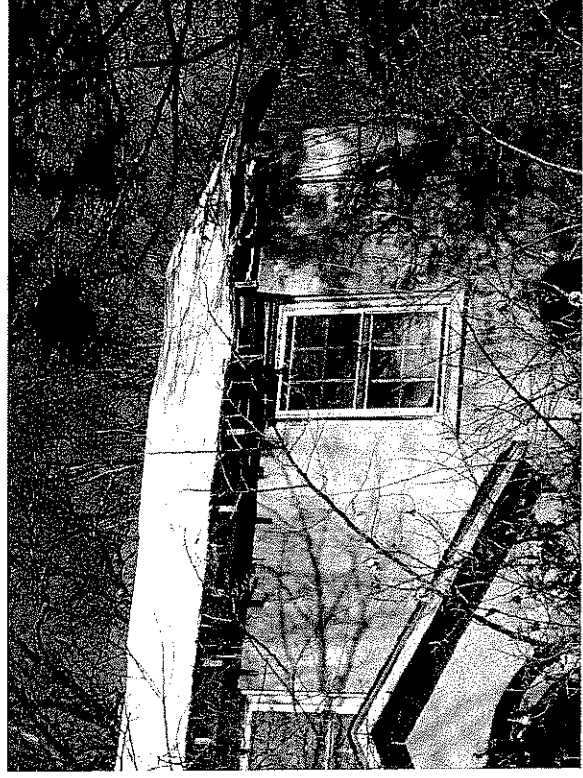
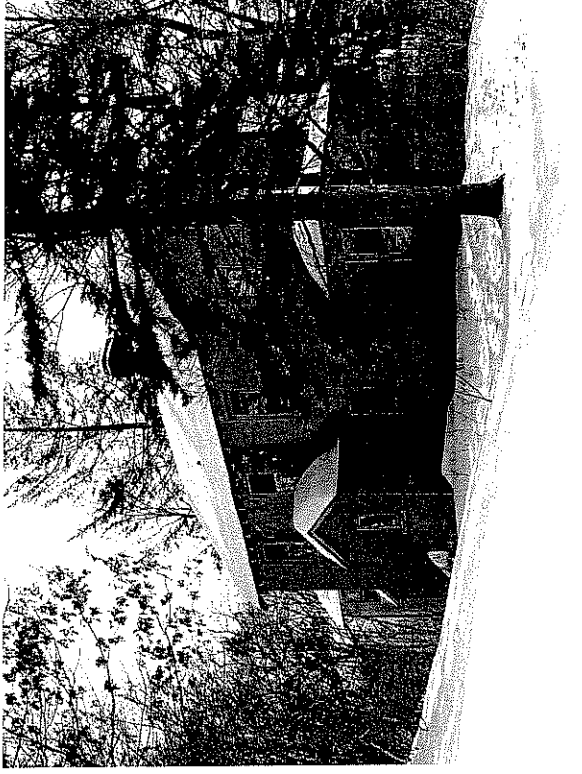
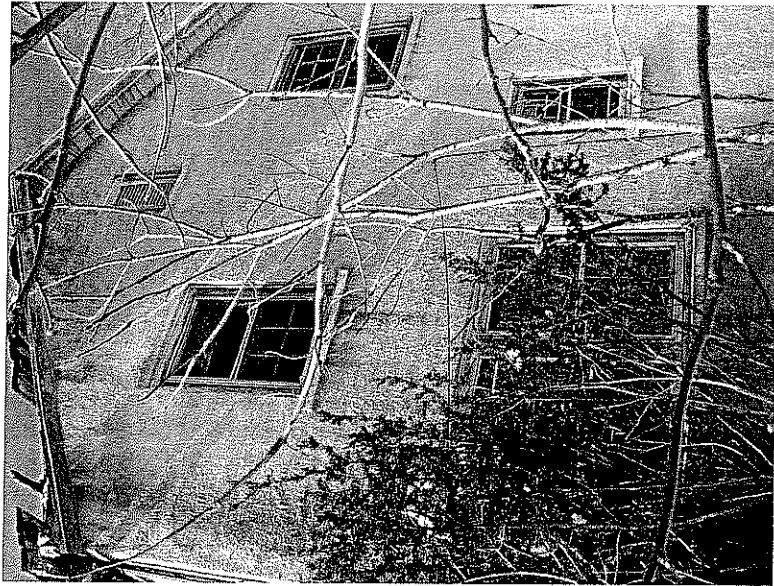
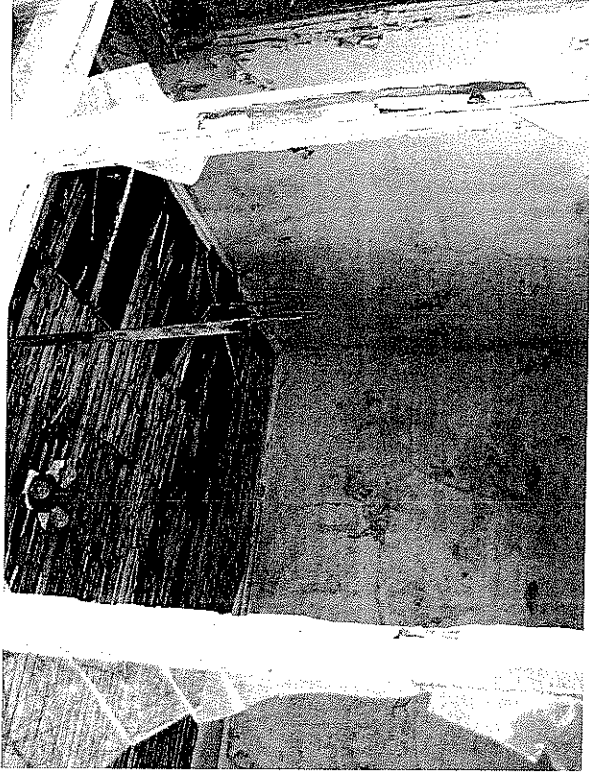
- **Building 17, Cottage #17:** Located at the west end of the site, Cottage #17 is in severely deteriorated condition. The roof has failed in many locations, including a large visible hole on the west elevation, resulting in significant water infiltration into the walls of the building which has resulted in catastrophic collapse of interior floors. The deterioration has been exacerbated by exposure to the elements and multiple freeze/thaw cycles due to lack of heat and broken windows within the building. The exterior walls of the building exhibit areas of spalling stucco resulting from years of water infiltration. Photographs 37-41 depict the exterior and interior condition of the building.

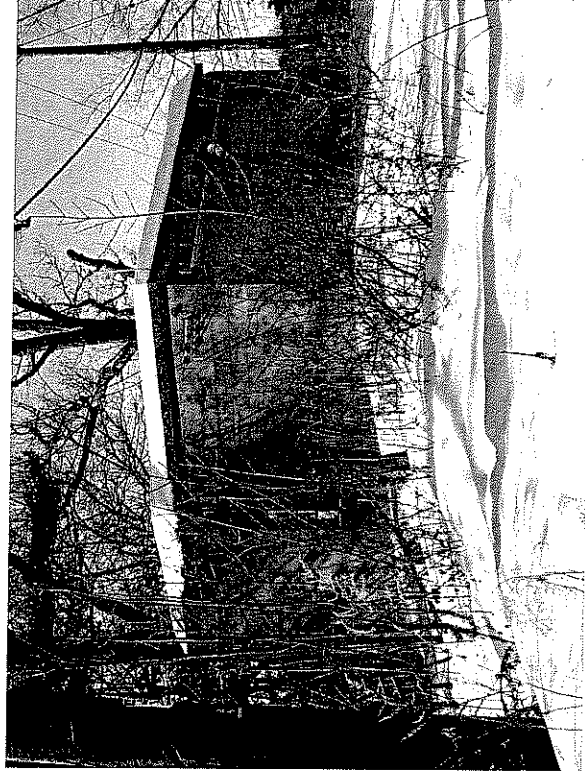
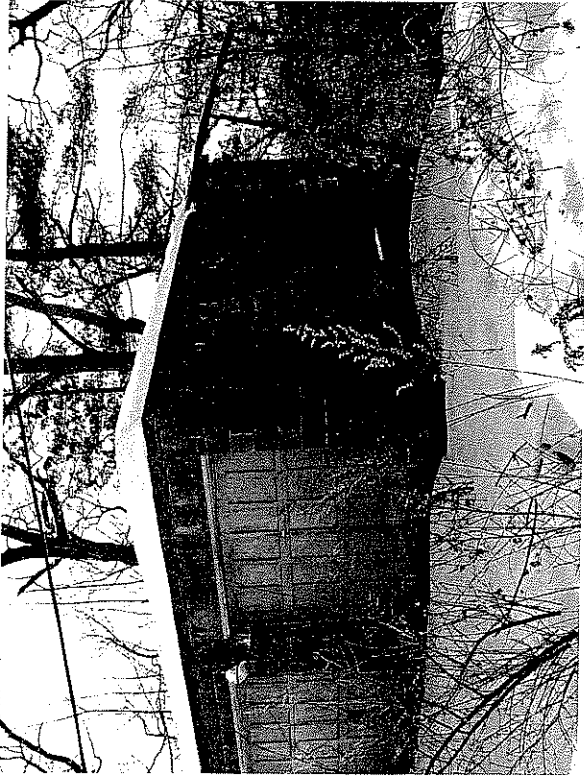
- **Building 55, Cottage #17 Garage:** Located at the southwestern edge of the site, the Cottage #17 Garage is in severely deteriorated condition. The roof has failed in many locations resulting in significant water infiltration into the masonry walls of the building. The exterior concrete block walls and mortar are in poor condition due to exposure to the elements and multiple freeze/thaw cycles. Photographs 42-43 depict the exterior condition of the building.

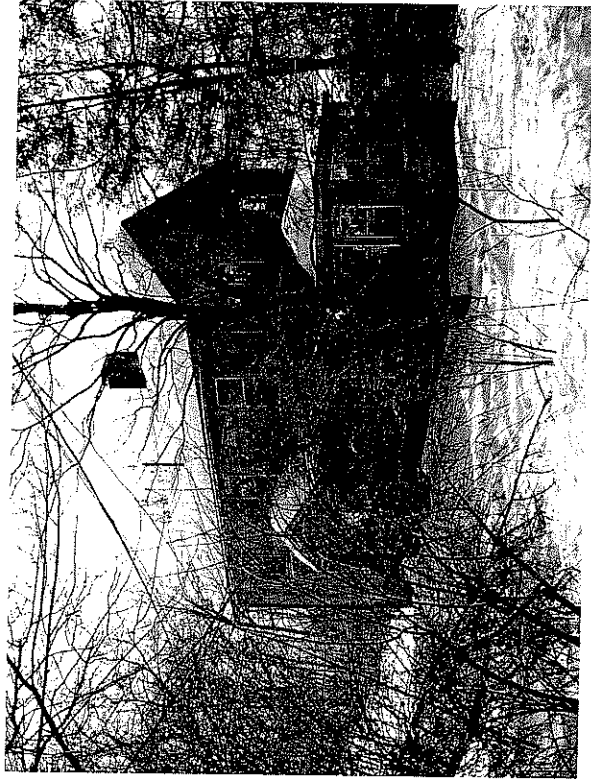
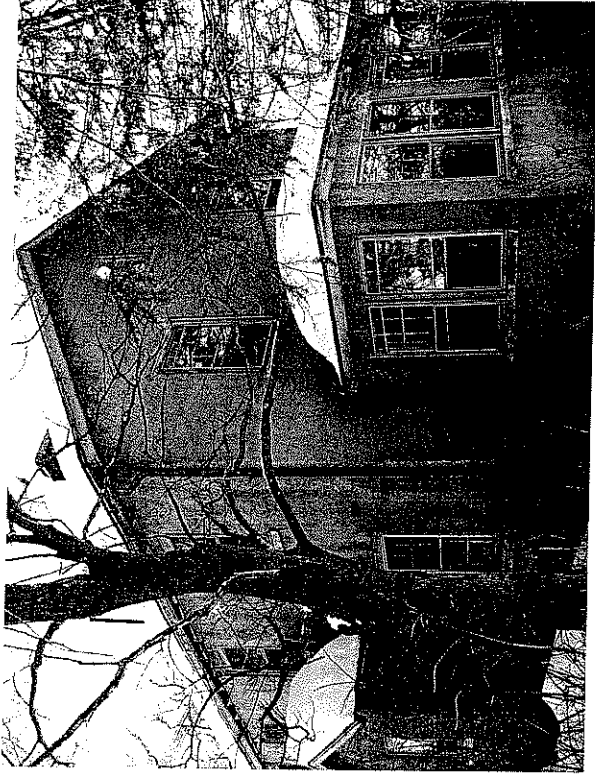
- **Building 18, Cottage #18:** Located at the west end of the site, Cottage #18 is in severely deteriorated condition. The roof has failed in many locations, including a large visible hole on the west elevation, resulting in significant water infiltration into the walls of the building which has resulted in catastrophic collapse of interior floors. The deterioration has been exacerbated by exposure to the elements and multiple freeze/thaw cycles due to lack of heat and broken windows within the building. The exterior walls of the building exhibit areas of spalling stucco resulting from years of water infiltration. Photographs 44-46 depict the exterior condition of the building.

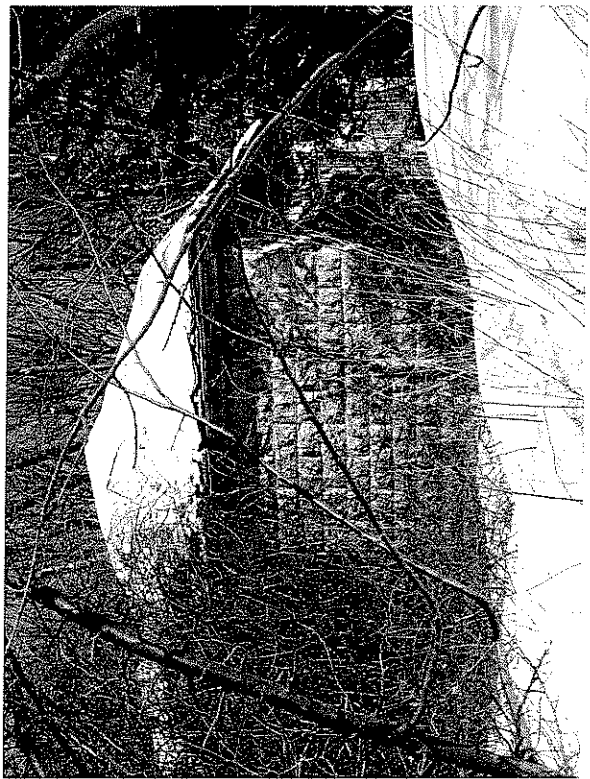
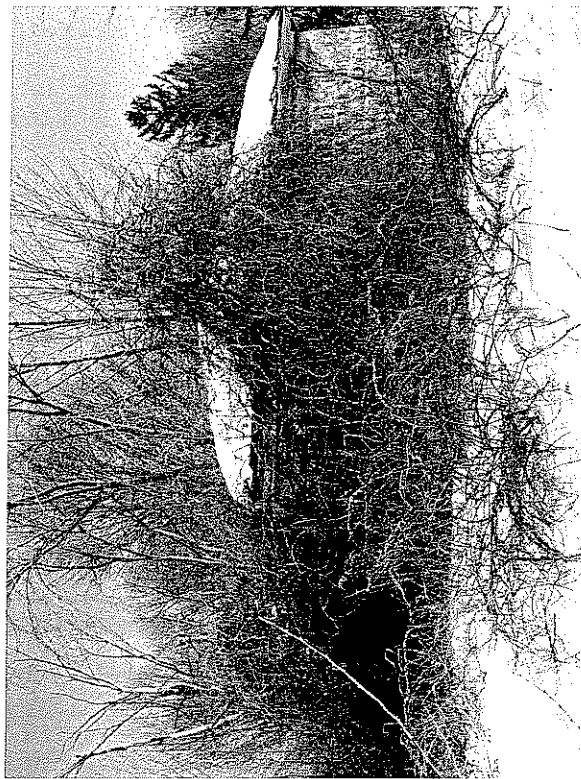
- **Building 44, Hillside Cottage Garage:** Located in the southeast quadrant of the site, the Hillside Garage is in severely deteriorated condition. The roof has failed in many locations resulting in significant water infiltration into the masonry walls of the building. The exterior concrete block walls and mortar are in poor condition due to exposure to the elements and multiple freeze/thaw cycles, lack of heat and severely overgrown vegetation that is undermining the stability of the structure. Photographs 47-48 depict the exterior condition of the building.

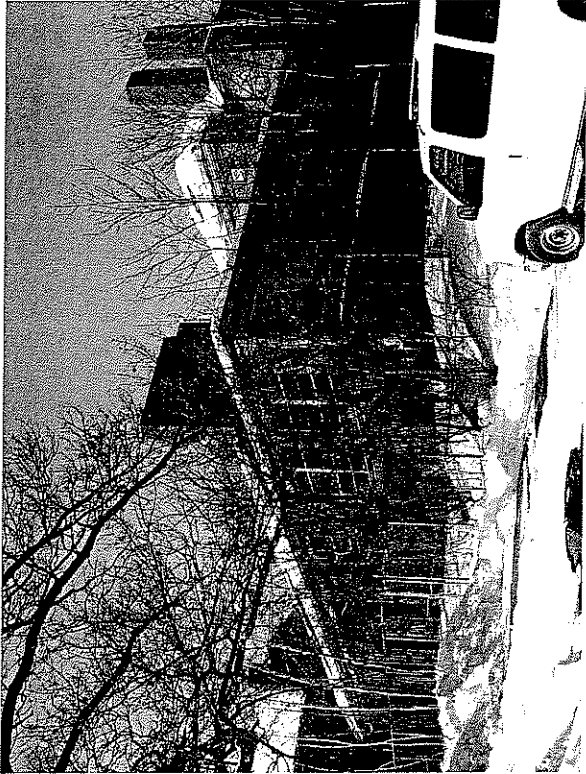
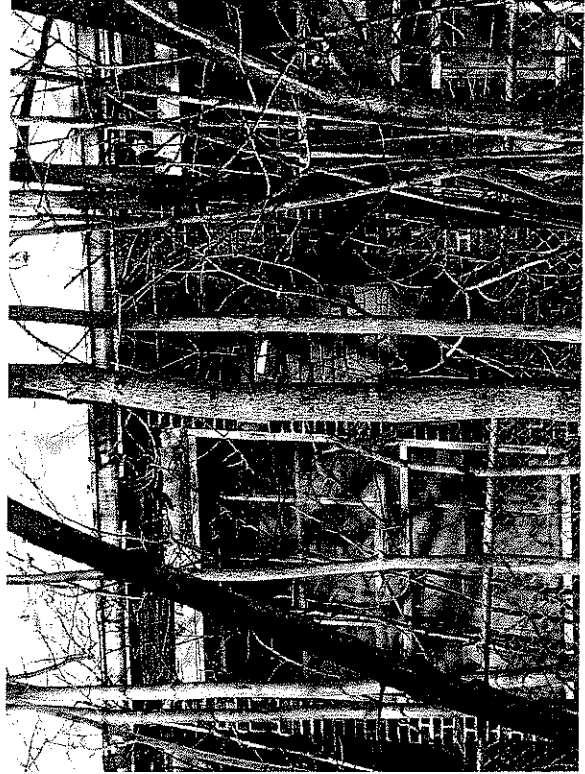
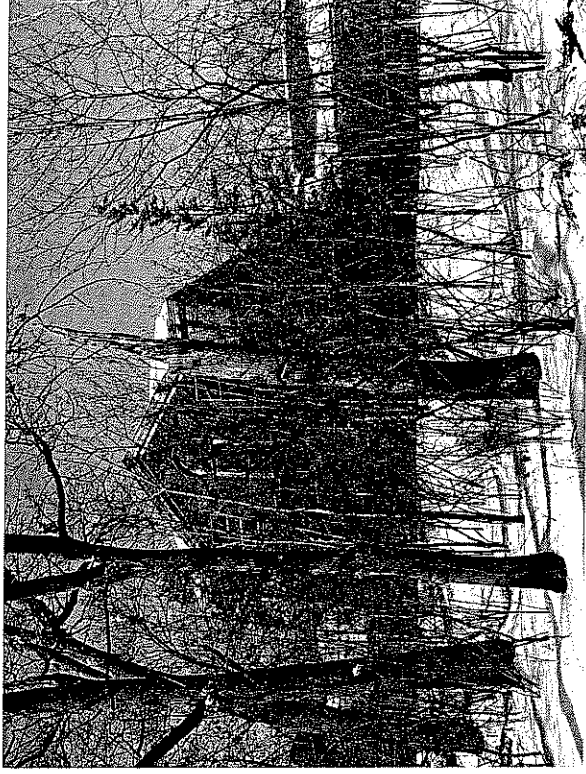
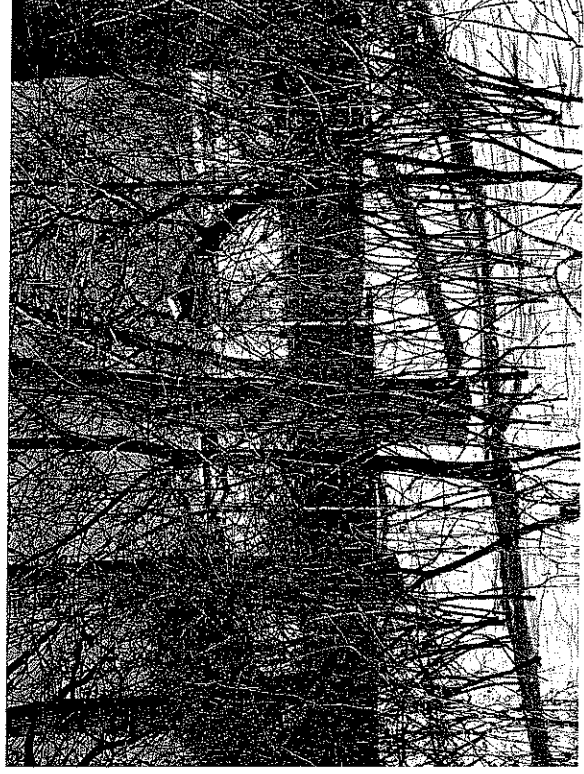
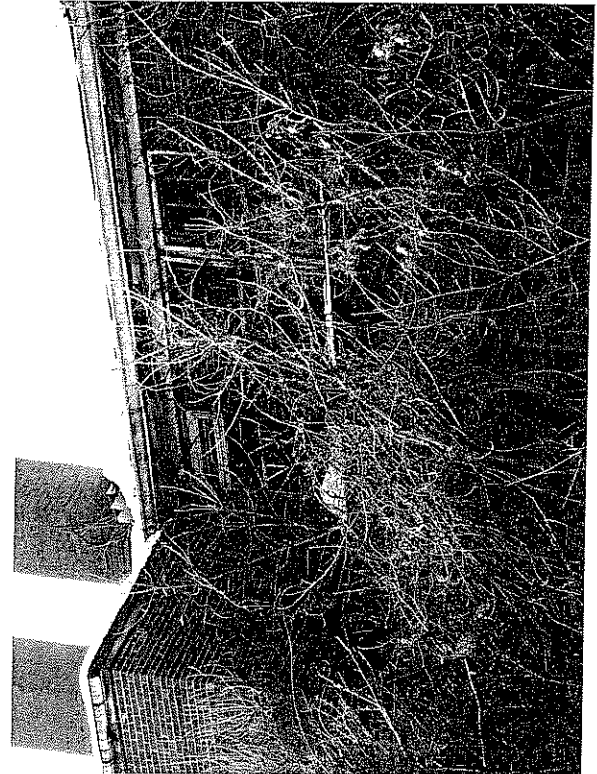
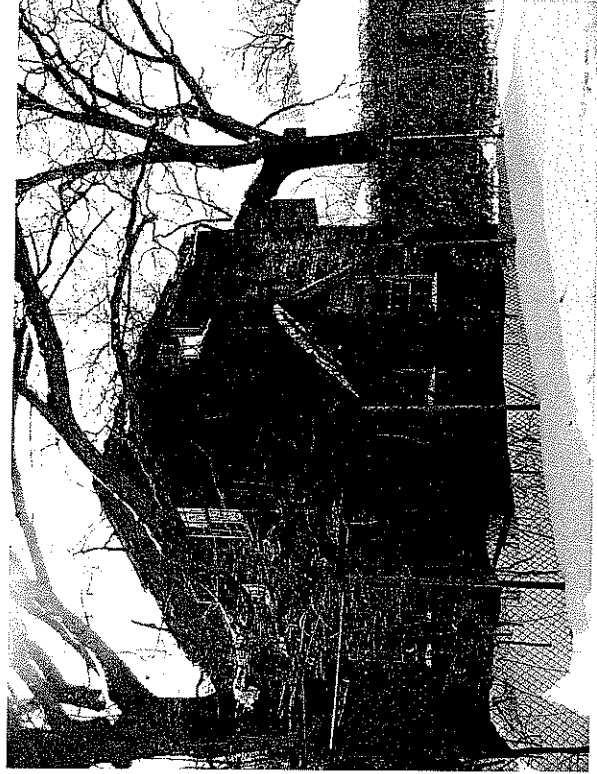
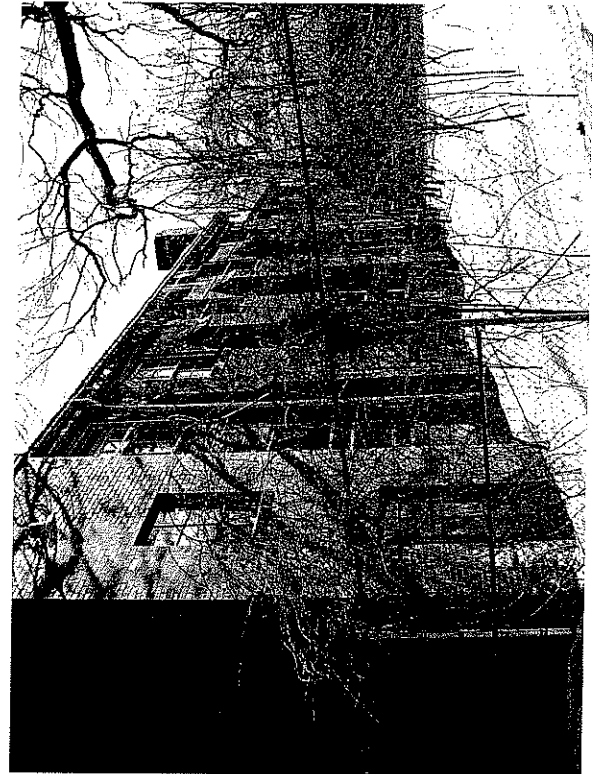
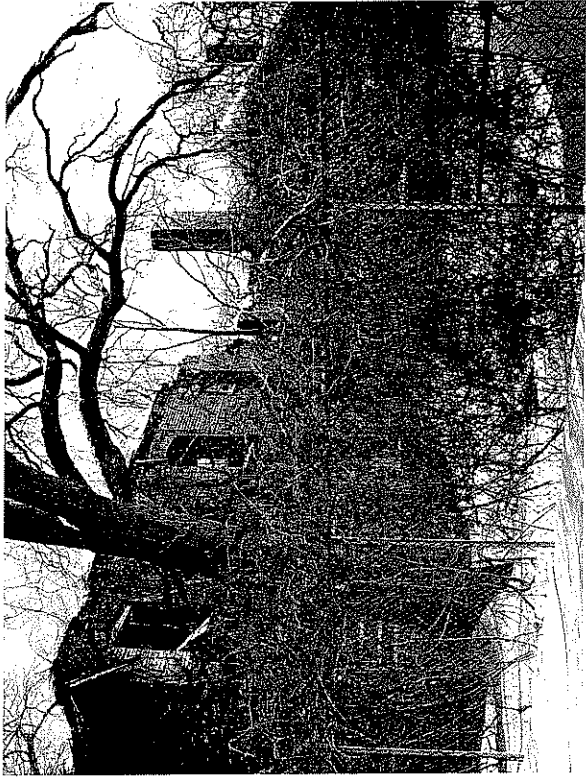
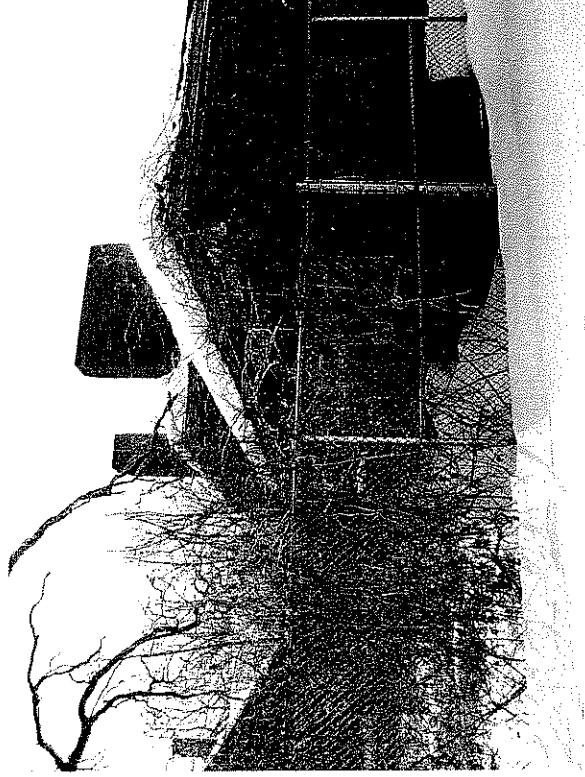
- **Building 33, West Building:** Located in the northwest quadrant of the site, the West Building is in severely deteriorated condition. The roof has failed in many locations, with a substantial collapse at one rear wing, resulting in significant water infiltration into the masonry walls of the building which has resulted in catastrophic collapse of interior floors. The deterioration has been exacerbated by exposure to

the elements and multiple freeze/thaw cycles due to lack of heat and broken windows within the building. The exterior walls of the building exhibit areas of broken and missing bricks resulting from years of water infiltration creating spalled brick and deteriorated mortar. Photographs 49-58 depict the exterior condition of the building.

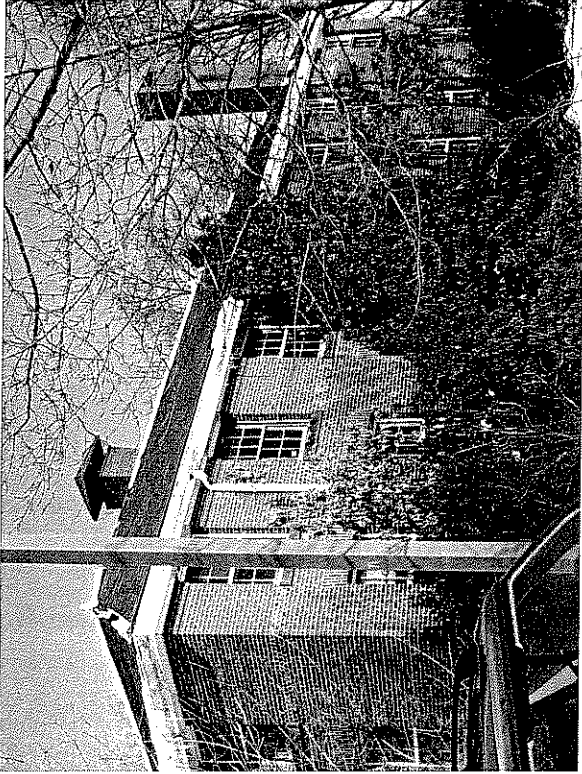
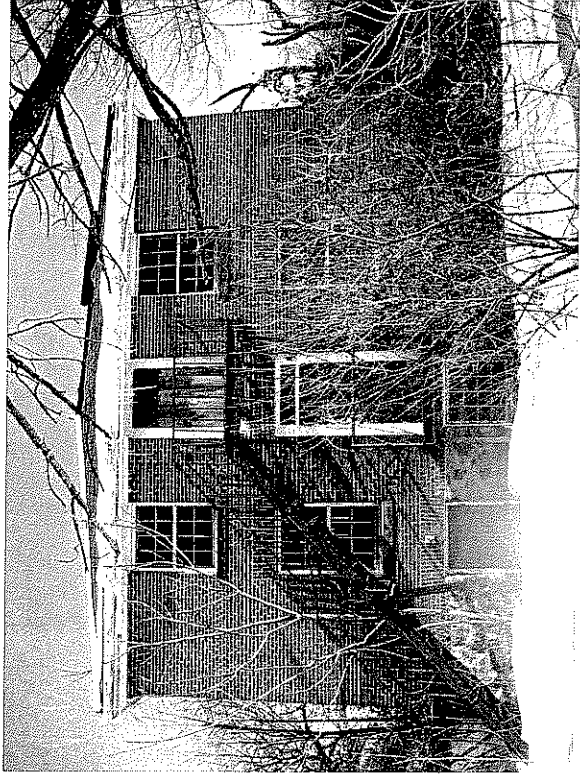
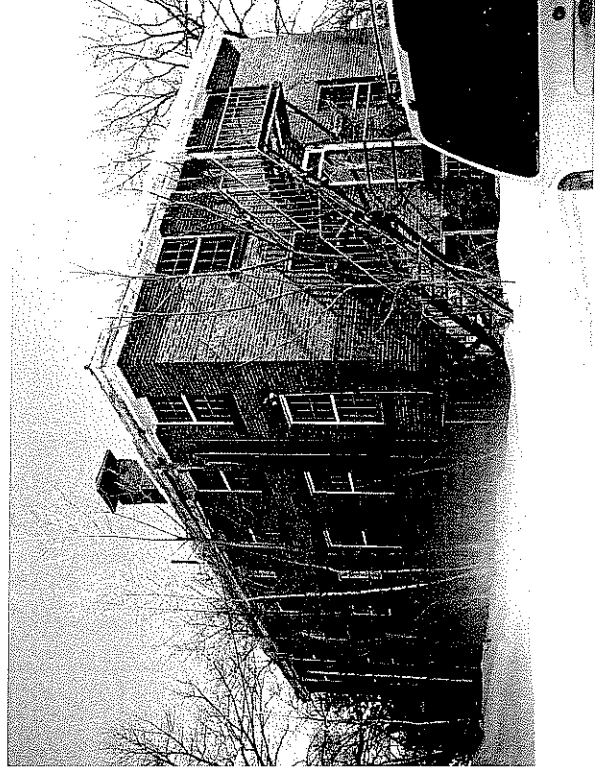
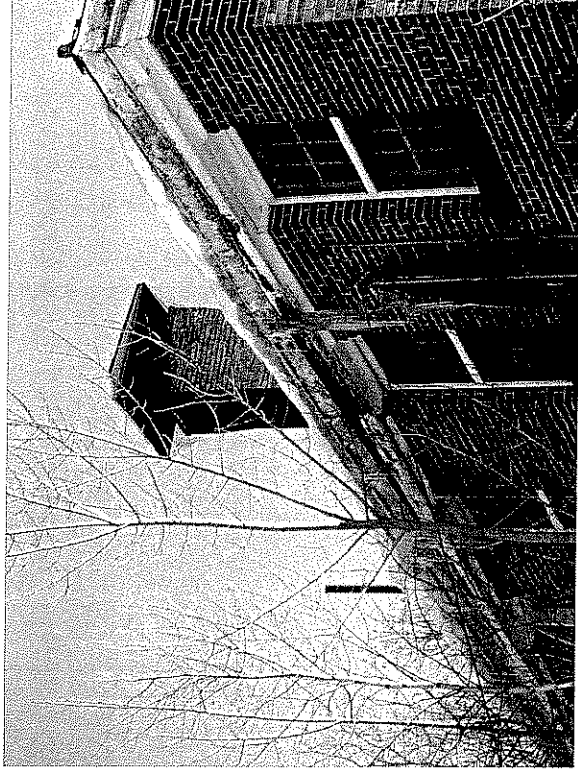
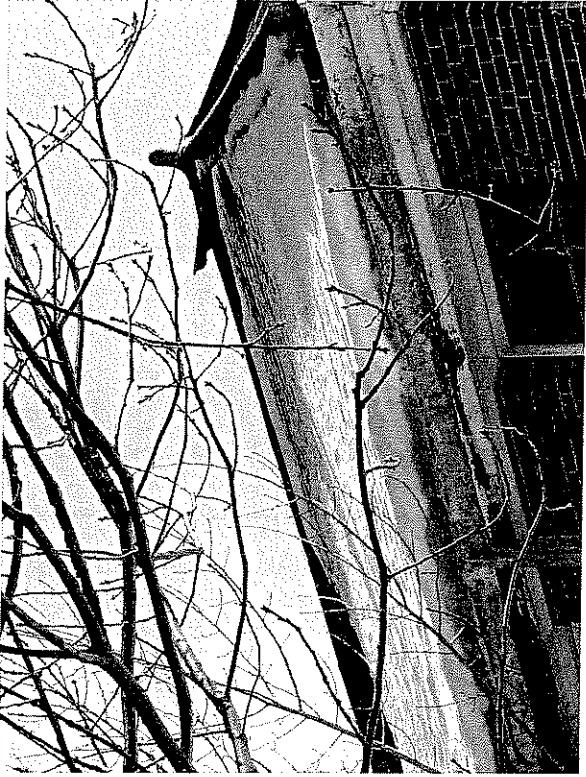
- **Building 38, West Nurses' Home:** Located in the northwest quadrant of the site, the West Nurses' Home is in deteriorated condition. The roof flashing and eaves have failed in many locations resulting in significant water infiltration into the masonry walls of the building which is causing deterioration of the interior floors and ceilings. The deterioration has been exacerbated by exposure to the elements and multiple freeze/thaw cycles due to lack of heat within the building. The exterior walls of the building exhibit areas of spalling brick and mortar resulting from years of water infiltration. Photographs 62-66 depict the exterior condition of the building.

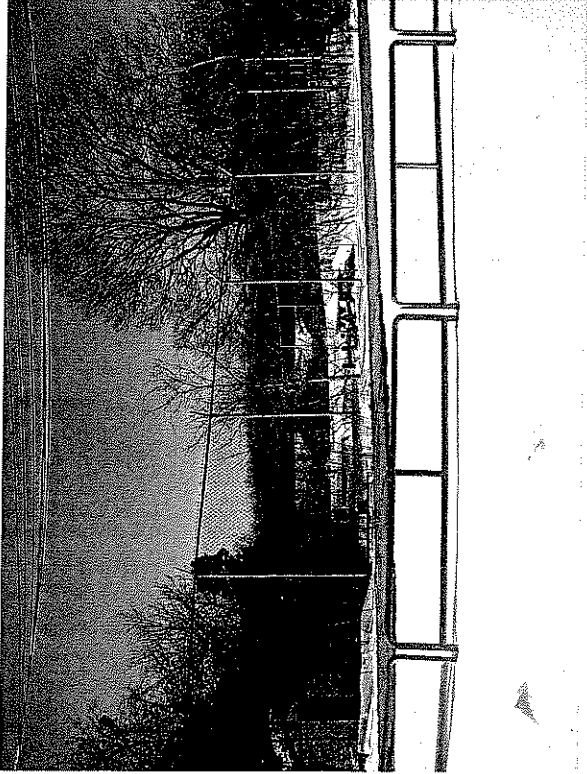
67. View North of Pool Area

- **Building 87, Pool/Playground:** The Pool/Playground area is located near Wheatly Hall. The area is surrounded by a chain link fence and incorporates a modern, wood frame shed structure. The poured concrete pool has not been used in years and is cracking and in poor condition. Photograph 67 depicts the condition of the area.
