PROJECT NOTIFICATION FORM

FERNALD DEVELOPMENTAL CENTER

200 TRAPELO ROAD, WALTHAM, MA

February 27, 2009

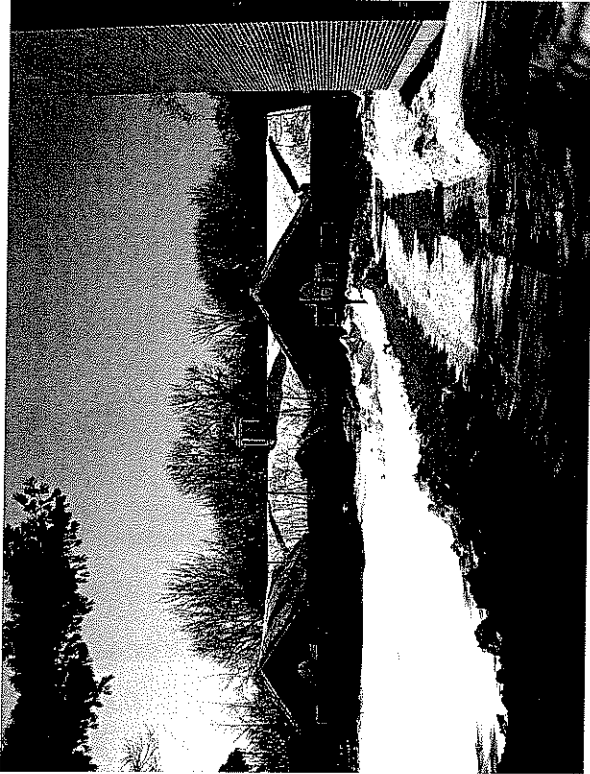
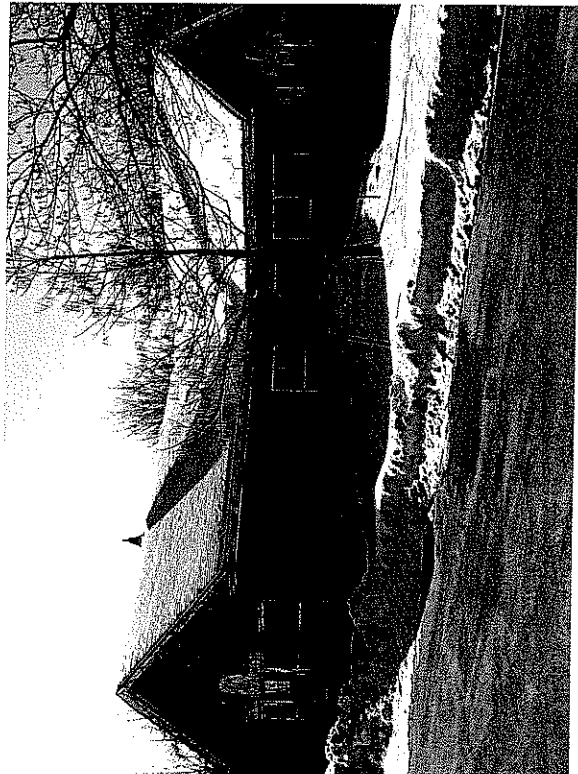
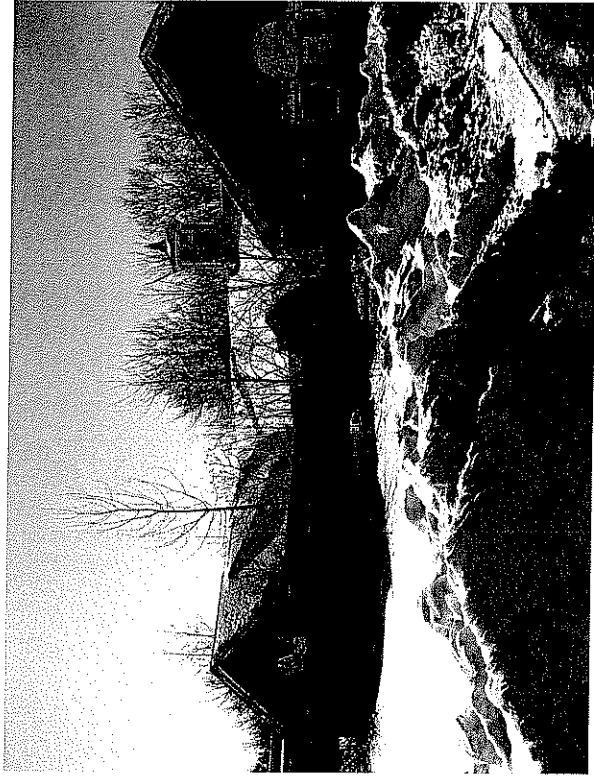
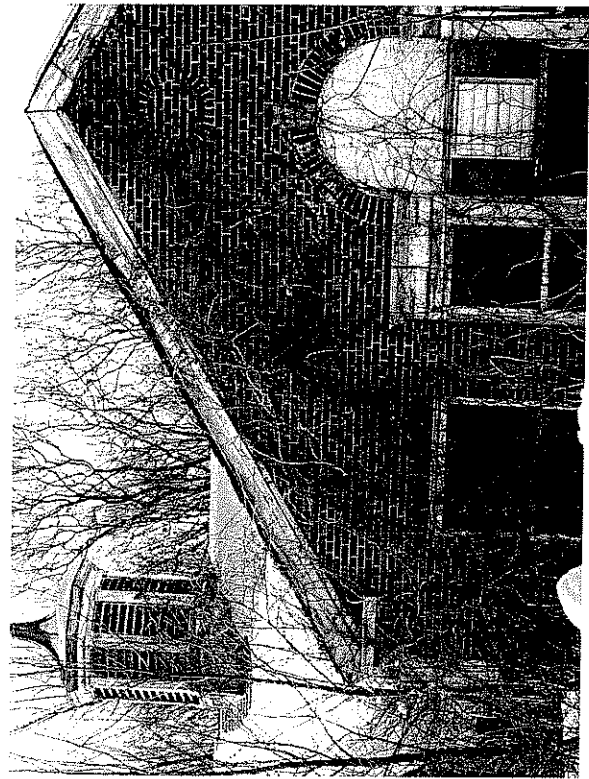
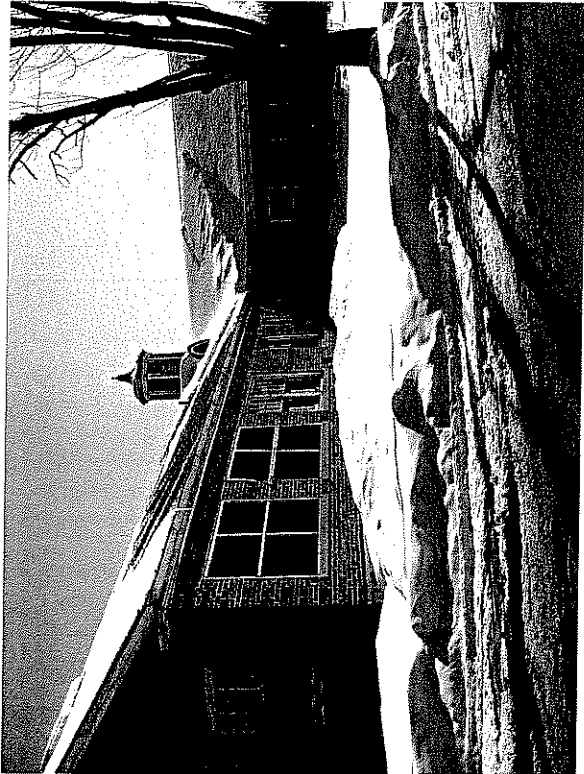
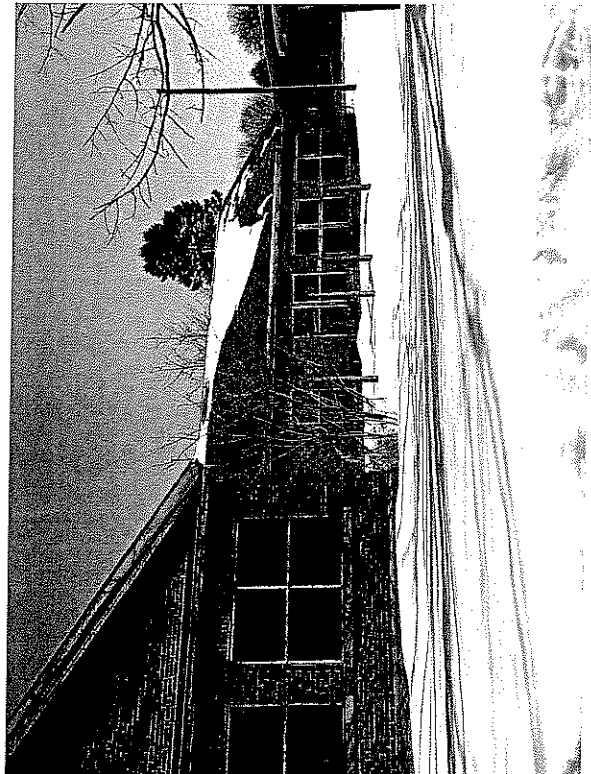
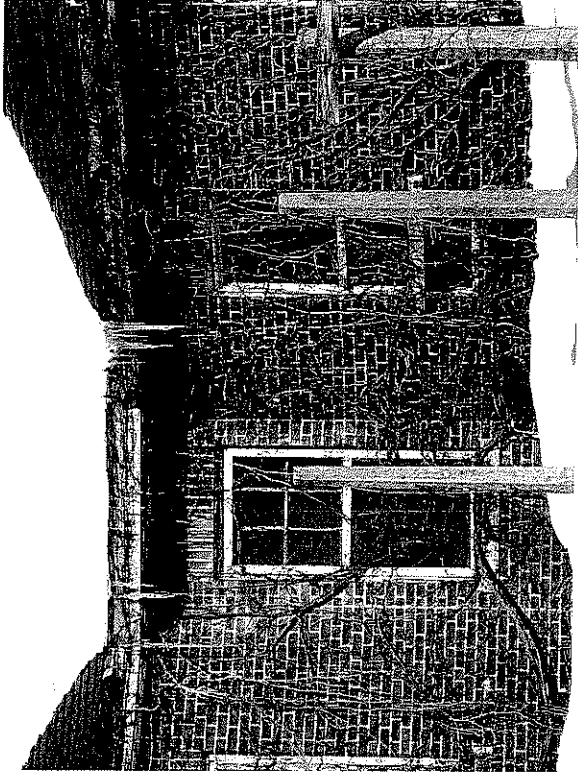
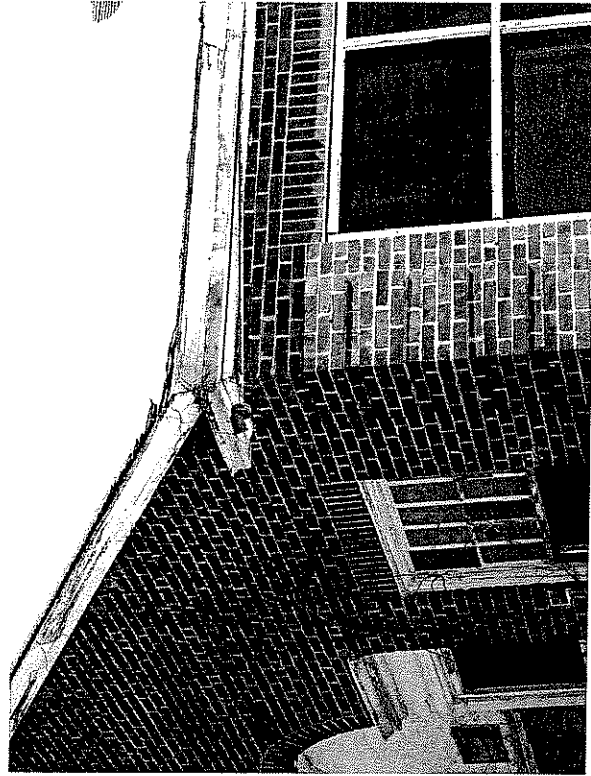
- **Building 39, Wheatly Hall:** Located at the northern end of the site, Wheatly Hall is in severely deteriorated condition. The roof and roof flashing have failed in many locations resulting in significant water infiltration into the masonry walls of the building which has resulted in catastrophic collapse of interior floors and ceiling, particularly in areas where ice dams have repeatedly developed over the years. The deterioration has been exacerbated by exposure to the elements and multiple freeze/thaw cycles due to lack of heat and broken windows within the building. The exterior walls of the building exhibit areas of spalling brick and mortar and efflorescence resulting from years of water infiltration. Photographs 68-75 depict the exterior condition of the building.
