MEMORANDUM

RE: **City of Waltham – IDDE Program**
July 2022 Program Update
Pare Project No.: 20104.01

2022 ILLICIT DISCHARGE DETECTION AND ELIMINATION PROGRAM

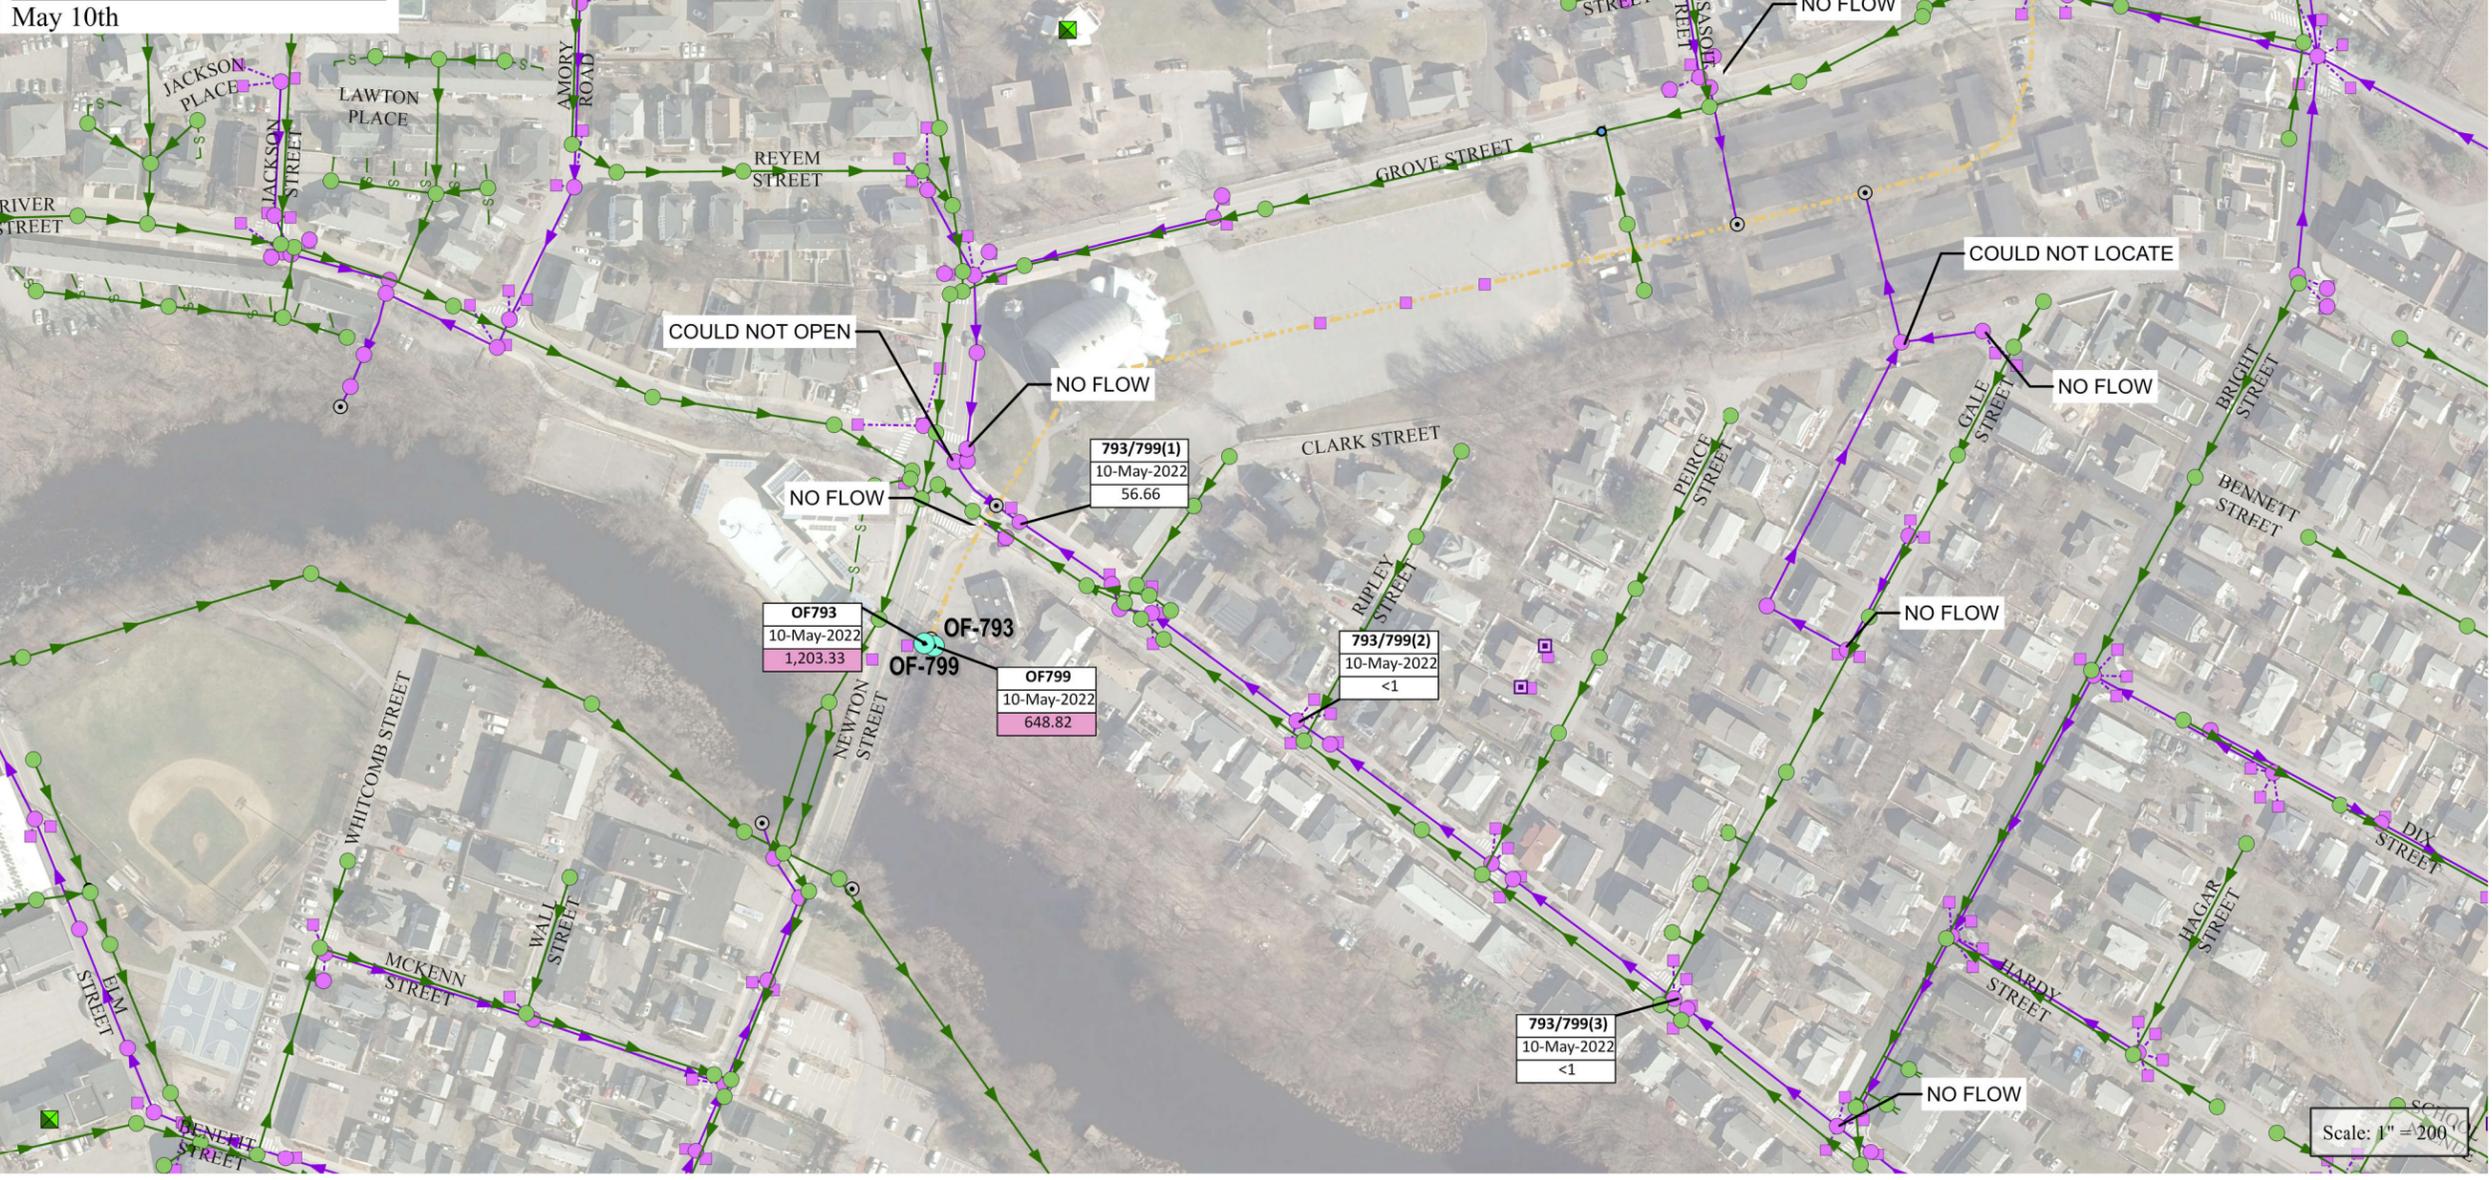
OUTFALLS 793 & 799

Analytical Method	Outfall ID	Sample Date	Value	Notes
E. coli (col/100ml)	OF-9	23-Sep-2020	4.13	Class of receiving waterbody: Blue = Class A, Not Highlighted = All other classes
Tot. Res. Chlorine (mg/l)	793/799	10-May-2022	0.23	Exceeds benchmark value
Nitrogen Ammonia (mg/l)	793/799	10-May-2022	0.164	Exceeds TMDL
Total Phosphorus (mg/l)	793/799	10-May-2022	0.147	Exceeds TMDL
MBAS (mg/l)	793/799	10-May-2022	0.06

Spring 2022 Sampling Results

Background	
Location	Newton Street
Outfall	Concrete Box Culverts
Receiving waterbody	Charles River
September 2020 Outfall Sampling and Analysis	
Sampling date	September 2020
Results	<ul style="list-style-type: none"> E. coli (OF-793): 387.32 mg/L (exceeded TMDL). E. coli (OF-735): 260.25 mg/L (exceeded TMDL).
Spring 2022 Upstream Flow Tracing Sampling and Analysis	
Sampling date	May 10, 2022
Description of field work	<ul style="list-style-type: none"> Samples were collected at both outfalls. Samples were collected at 3 upstream manholes.
Findings	<p>E. coli was found to exceed the TMDL at both outfalls, as follows:</p> <ul style="list-style-type: none"> E. coli (OF-793): 1,203.333 mg/L (exceeded TMDL). E. coli (OF-799): 648.82 mg/L (exceeded TMDL).
Results	<ul style="list-style-type: none"> E. coli was found to exceed the TMDL at both outfalls. However, samples collected at 3 upstream manholes did not exceed the TMDL for E. coli.

Recommendations	
<ul style="list-style-type: none"> Sampling performed on May 10, 2022, replicated high concentrations of E. coli at each outfall, but samples collected immediately upstream did not identify potential locations of illicit connection. These outfalls represent the discharge point of a significant reach of the buried stream (i.e., box culverts) as well as the open stream further to the north, which receives stormwater flow from the relatively large Beaver Brook watershed. Several other upstream outfalls discharge to this stream which flows to outfalls OF-793 and OF-799. Exceedances reported at these outfalls may be impacted by stormwater from upstream outfalls. Samples collected at and in the vicinity of outfalls OF-793 and OF-799 did not establish that suspected illicit connections are localized to these outfalls. As such, additional sampling upstream of these outfalls to locate illicit connections is not recommended.
