RE: City of Waltham
EPA Clean Water Act Administrative Docket No. 05-06
IDDE Program – Semi-Annual Report No. 26

EPA IDDE Program Progress Report No. 26

Inspections, Sampling and CCTV of Drainage System in Cedarwood Area

CCTV Inspection Technical Memorandum

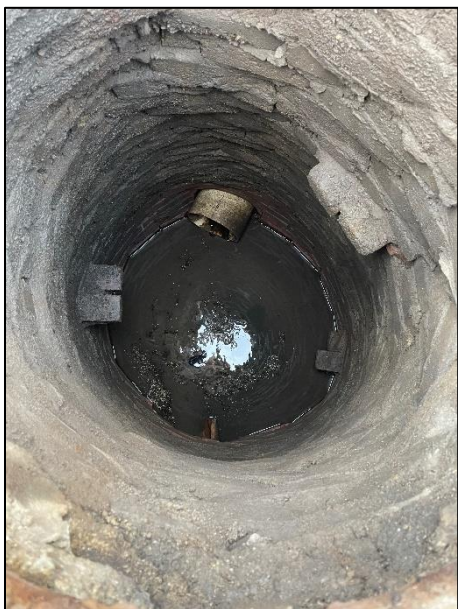
CCTV inspections along Cedarwood Avenue focused on the drainage line between DM-18450 (E.coli concentration = 7.45 MPN/100 ml) and DM-18435 (E.coli concentration = 35,780 MPN/100 ml). No illegal sewer lateral connections were encountered. After drainage CCTV was completed along Cedarwood Avenue, the City opened (2) sewer manholes on Cedarwood – labeled as DM-18450C and DM-1. DM-18450C is marked as a sewer manhole but connects to the drainage system at DM-18450B. DM-18450C had toilet paper, excessive sediment accumulation, and gray/murky water along the bottom of the manhole. Truax cleaned and jetted the inlet line prior to CCTV inspection. DM-1 is also labeled as sewer, but has an underdrain running through the manhole parallel to the sewer line. The interior of the manhole is coated in epoxy. A CCTV inspection was performed from DM-1 to DM-18450C – the line had multiple fractures along the top of pipe and there was evidence of paper fibers in the water along the bottom of the pipe. Photos 1-3 present the conditions encountered at the (2) manholes.

Photo 1 – DM-18450C prior to cleaning.

- It is evident, through laboratory analysis, that there is an exceedance of E.coli within the drainage system along Cedarwood Avenue, Villa Street, and through the easement located between Villa and Weston Street. Further investigations are needed for the sewer main on Cedarwood Avenue – sewer manhole at intersection of Cedarwood Avenue and Florence Road to sewer manhole at intersections of Cedarwood Avenue and Villa Street. This section of the sewer should undergo a condition assessment, specifically

the area passing through DM-1, where cross-contamination could be occurring between the sewer main and underdrain.

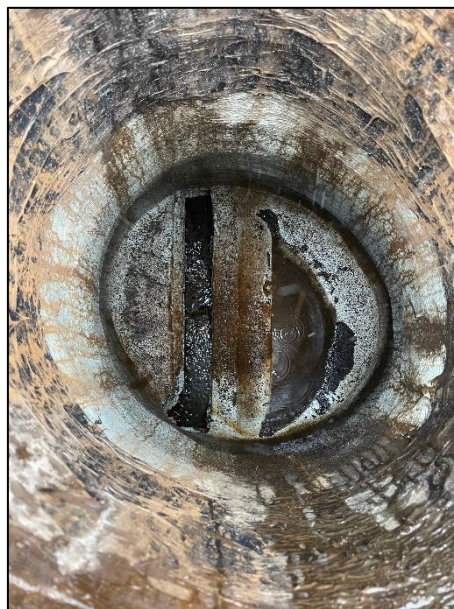
Photo 2 – DM-1 w/ underdrain and sewer main.

- There was no direct evidence of illegal sewer lateral connections for the drainage lines CCTV'd – Cedarwood Avenue, Villa Street and Weston Street.
- An underdrain was located on Cedarwood Avenue. The underdrain enters DM-18450C and connects to DM-18450B (drainage system).
- DM-1 is upstream to DM-18450C. DM-1 contains the underdrain, flowing parallel to the sewer main (approx. 12-in separation). The sewer main (vitrified clay pipe) is encapsulated in epoxy, but underdrain showed evidence of lateral flow away from sewer main (no direct evidence – possibly groundwater).
- DM-18450C had graywater, toilet paper, and an odor similar to that of a sewer manhole (more severe when manhole was cleaned).

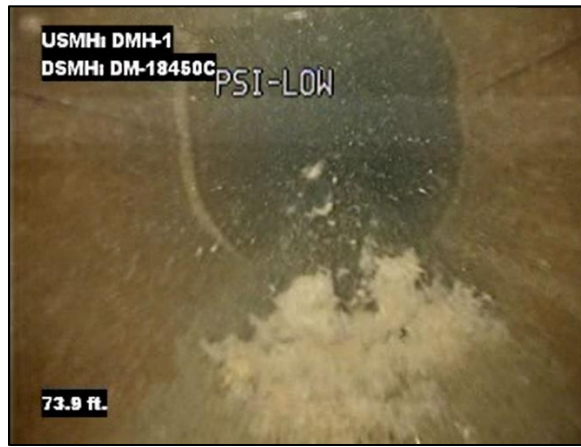
Photo 3 – Paper accumulation in pipe between DM-1 and DM-18450C.
