APPENDICES
K1-K7

TOPOGRAPHIC PLAN OF LAND
 WALTHAM FERNALD SITE
 WALTHAM, MASSACHUSETTS

PREPARED FOR:
SYMME MAINI & MCKEE ASSOCIATES
 1000 MASSACHUSETTS AVENUE, CAMBRIDGE, MASSACHUSETTS 02138

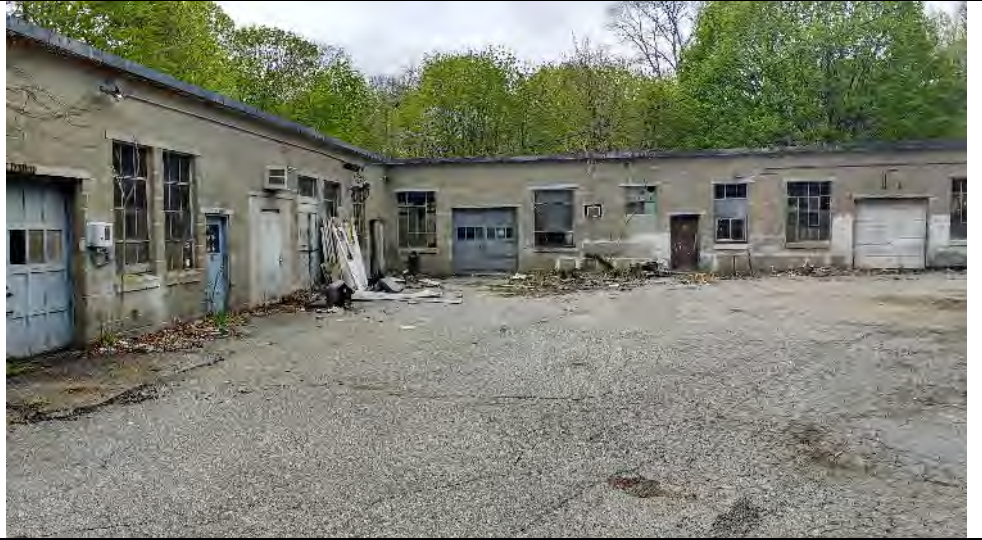
PHOTO #43
FACILITY:
South Portion of
Former Fernald
Developmental Center
200 Trapelo Rd.
Waltham, MA
INSPECTOR: Lauren
Konetzny
DATE: 5/4/16
DETAILS: View of
Exterior Eastern Side of
Building #24

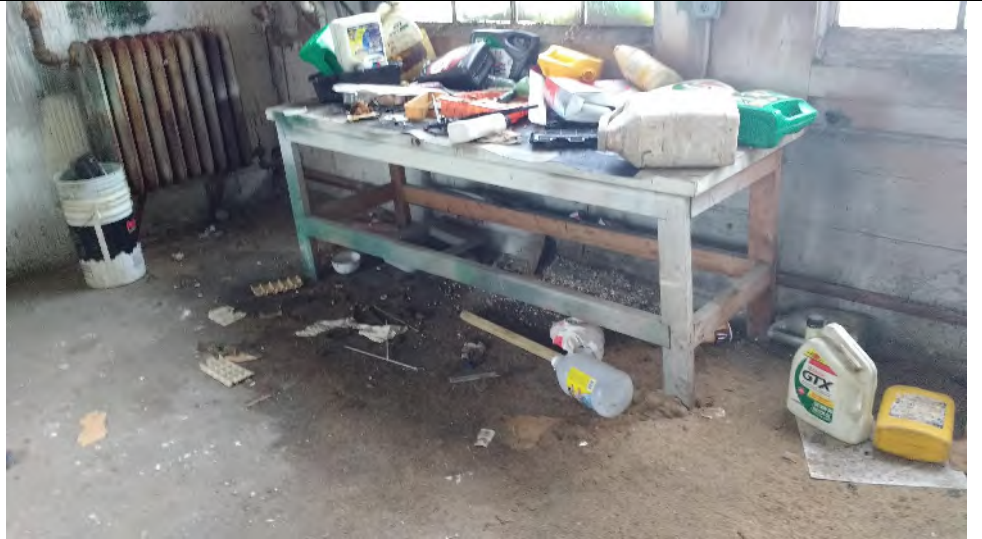
PHOTO #44
FACILITY:
South Portion of
Former Fernald
Developmental Center
200 Trapelo Rd.
Waltham, MA
INSPECTOR: Lauren
Konetzny
DATE: 5/4/16
DETAILS: Empty
Containers & Floor
Staining in Building #24

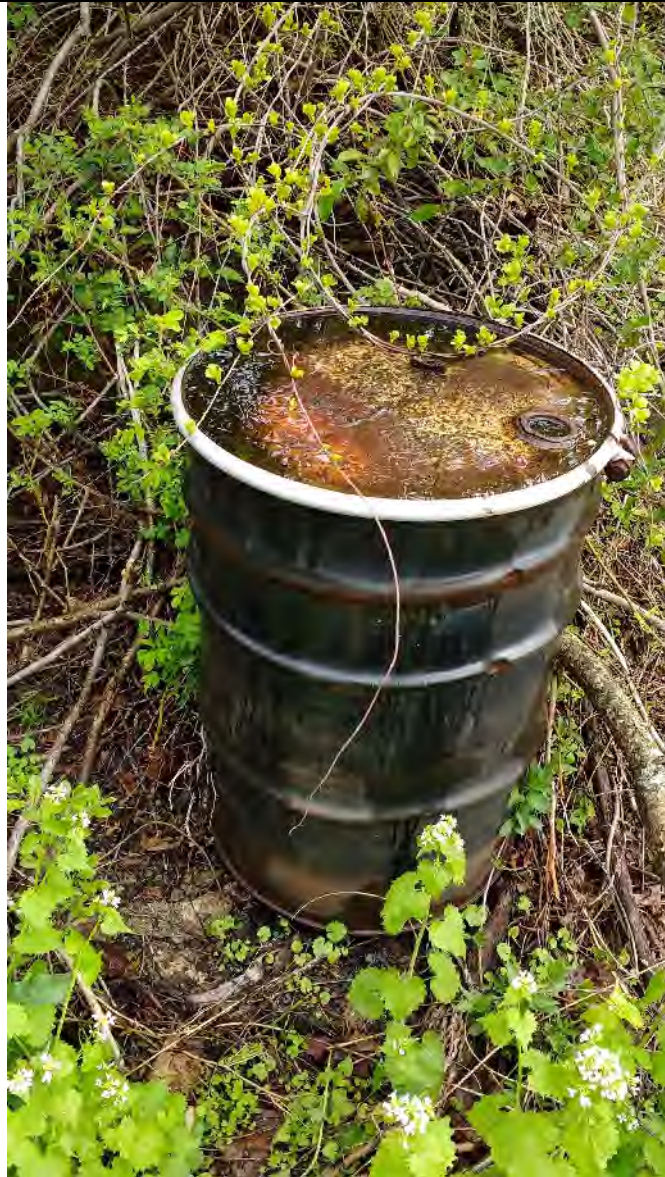
DETAILS: Partially Filled
Drum North of Butcher
Shop North of Building
#124

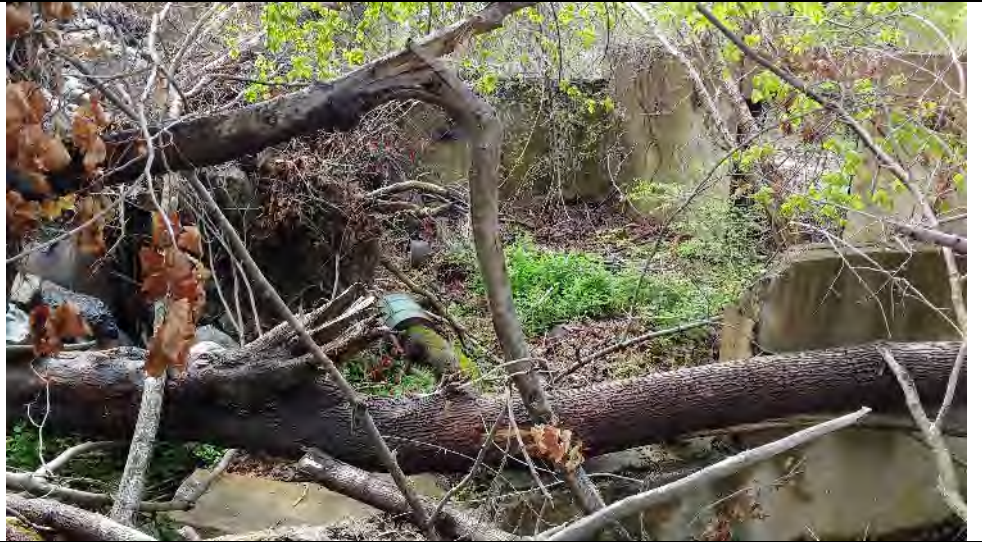
PHOTO #110
FACILITY:
South Portion of
Former Fernald
Developmental Center
200 Trapelo Rd.
Waltham, MA
INSPECTOR: Lauren
Konetzny
DATE: 5/6/16
DETAILS: Burried Drums
& Tank in Foundation
North of Former Butcher
Shop North of Building
#124

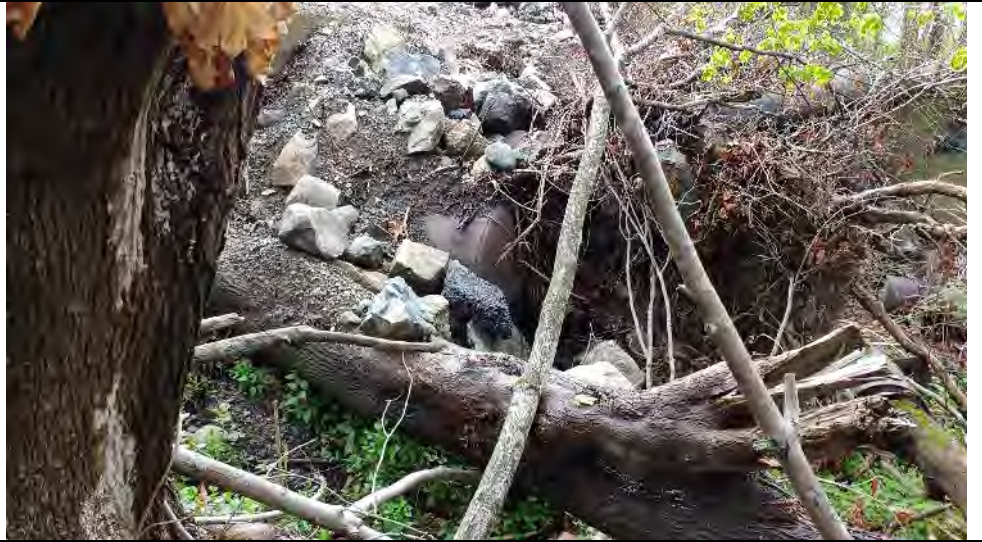
PHOTO #111
FACILITY:
South Portion of
Former Fernald
Developmental Center
200 Trapelo Rd.
Waltham, MA
INSPECTOR: Lauren
Konetzny
DATE: 5/6/16
DETAILS: Burried Tank
in Foundation North of
Former Butcher Shop
North of Building #124
